PRELIMINARY RECONNAISSANCE REPORT ON
THE 2004 CHUETSU EARTHQUAKE (Mid Niigata Earthquake)

INVESTIGATION DETAILS

- Date: October 29 and 30, 2004
- Area: Ojiya, Kawaguchi, Tokamachi and Horiuchi
- Team members: I. Morimoto, T. Yamashita, T. Tochio, M. Kamei and M. Cubrinovski (Kiso-Jiban Consultants)

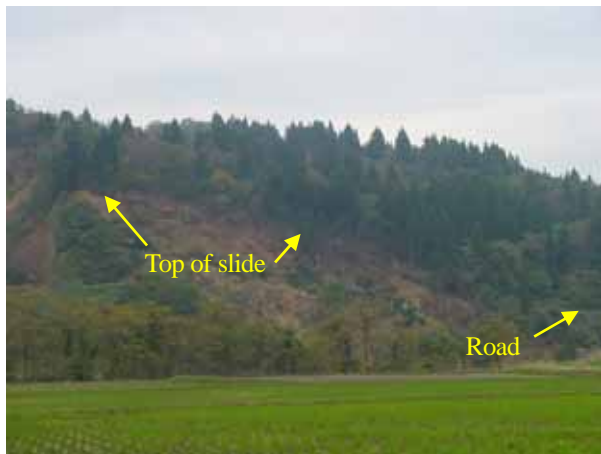
(2) Large landslide crosscut and buried a long section of Road No. 196. The slide was about 400m wide. The debris included rocks and large boulders. **Location -2**

View from the other side of the river

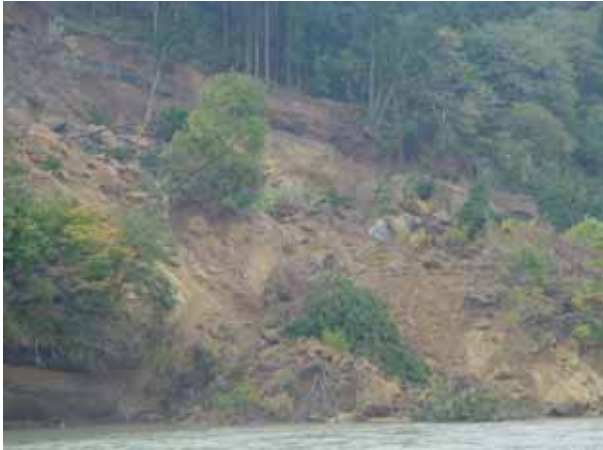
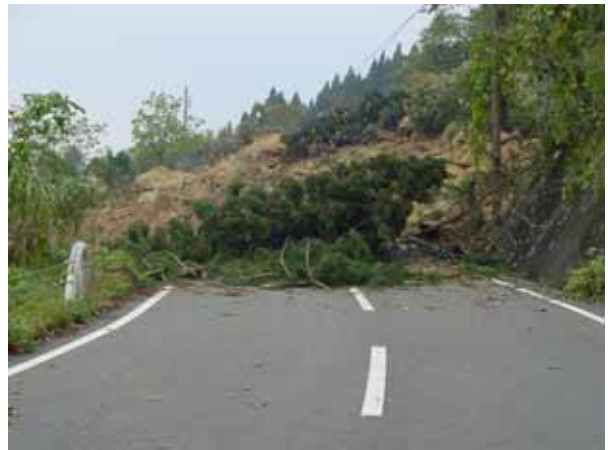
The photo on the right shows view from the road (see the indication on the previous page).

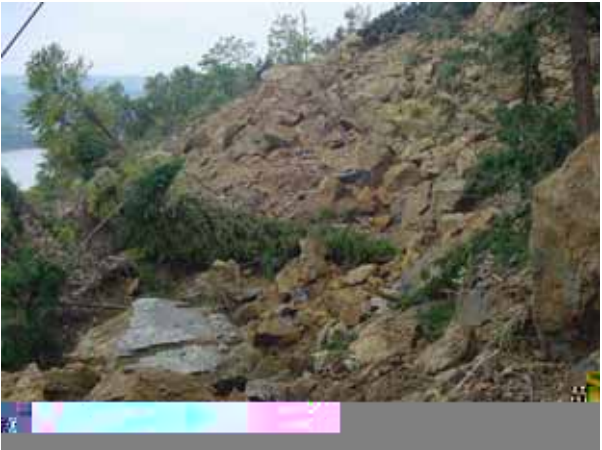
Upper part of the slide (showing the scarp)

Debris in the mid part of the slide

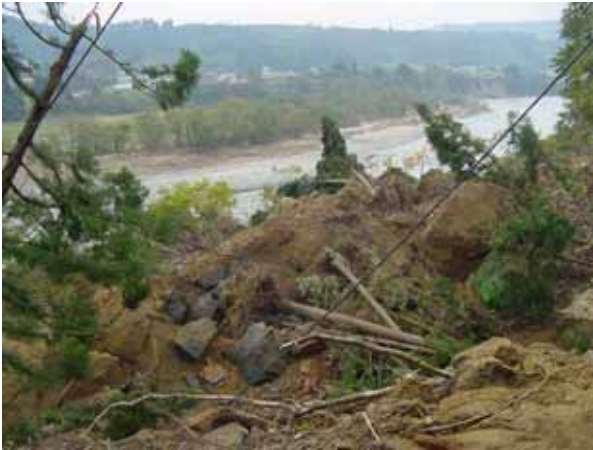
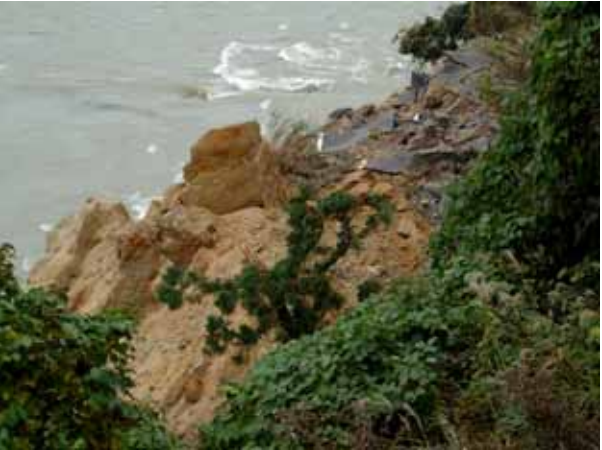
Mid-lower part (on the left) and part of the road seen collapsed into the river (on the right).

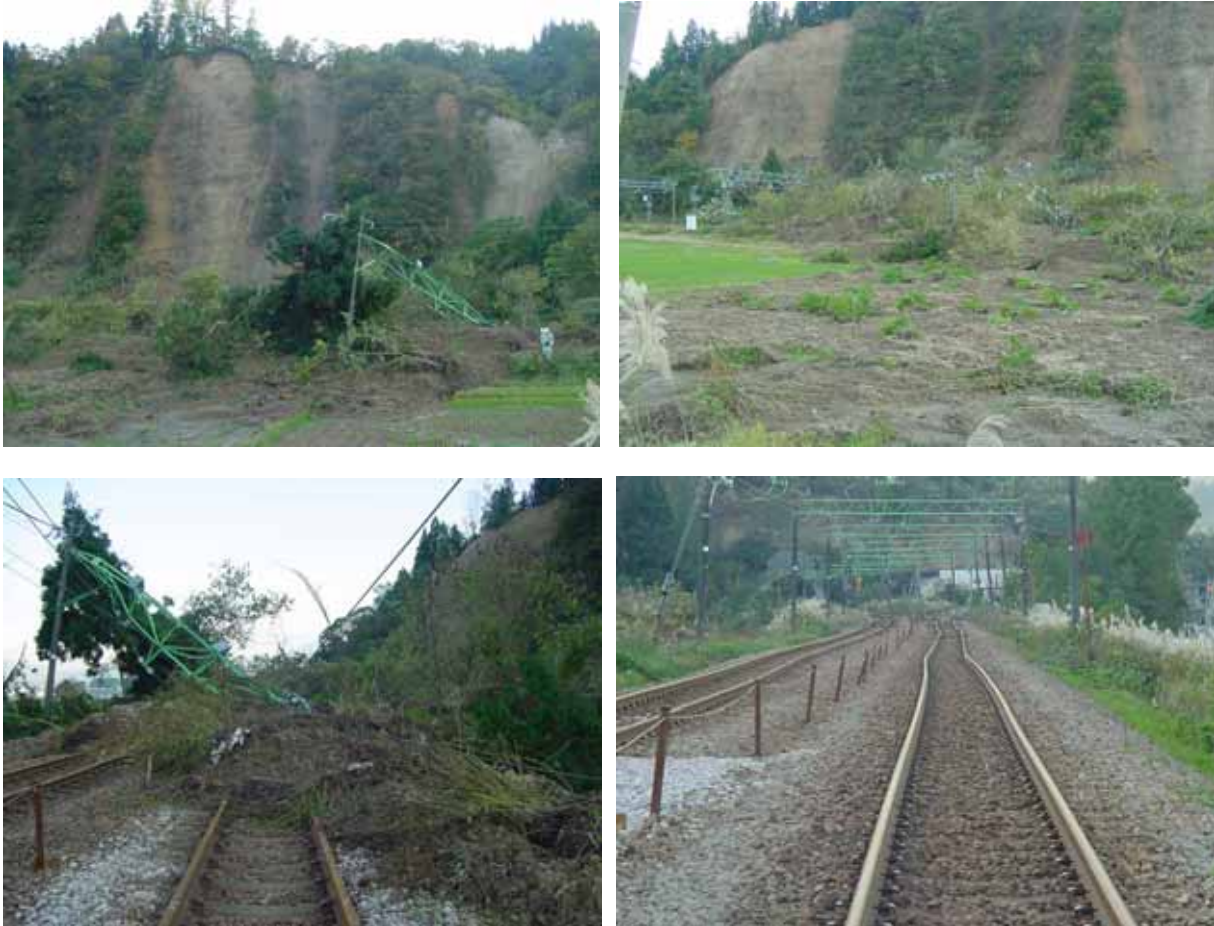
(1) Failure of a very steep natural slope. The debris buried the railway at the foot of the slope and spread laterally about 50-60m. Location -1

View towards the buried railway (on the left) and in the opposite direction (on the right).

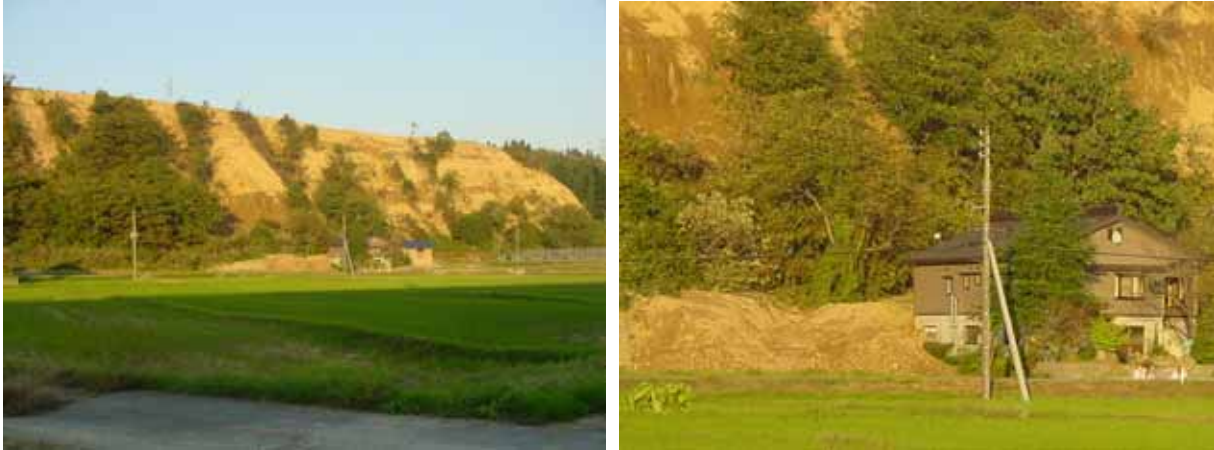
(2) Failure of steep natural slopes with debris partially burying a nearby house. Location -2

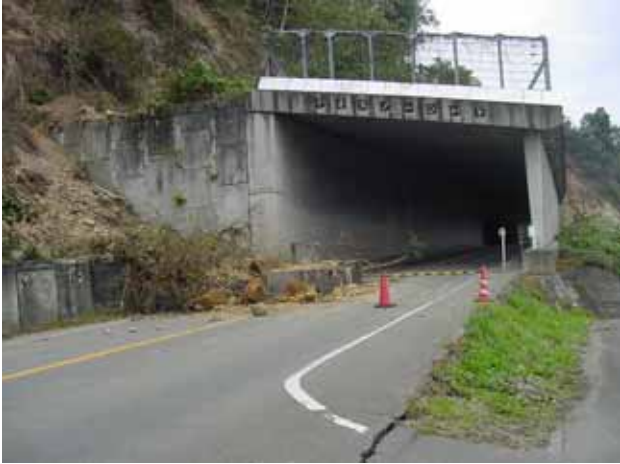
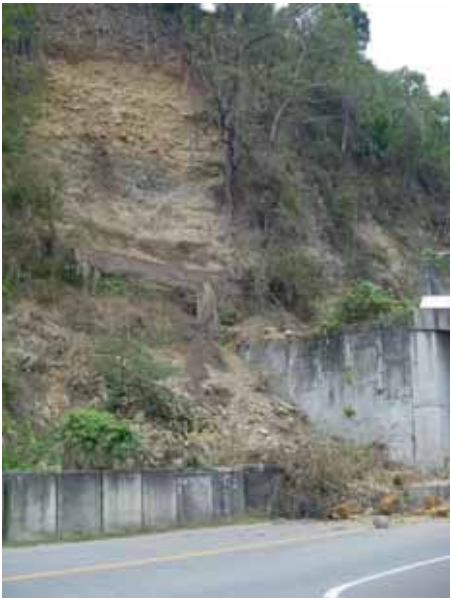
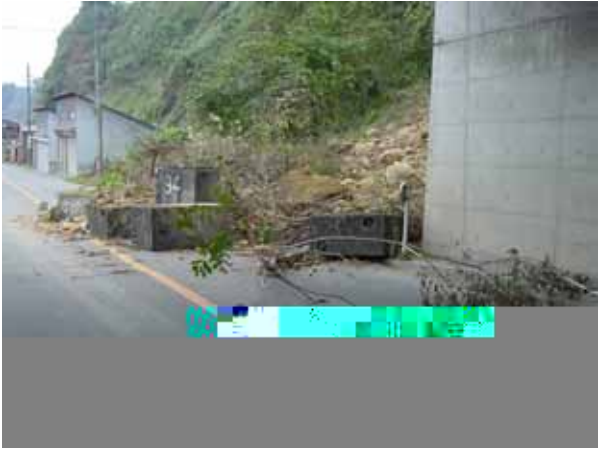
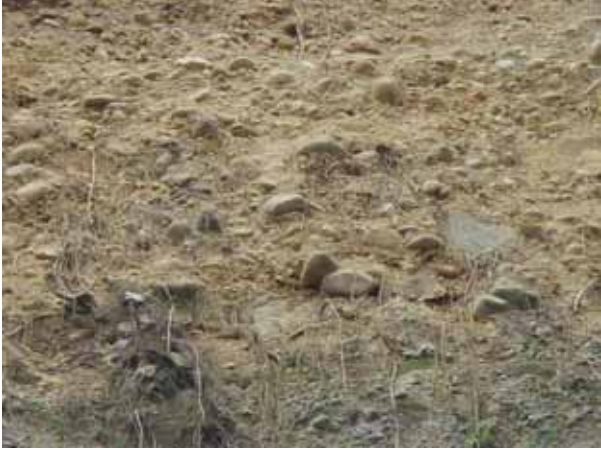
(3) Rock falls and partial collapse of a retaining wall. Location -3

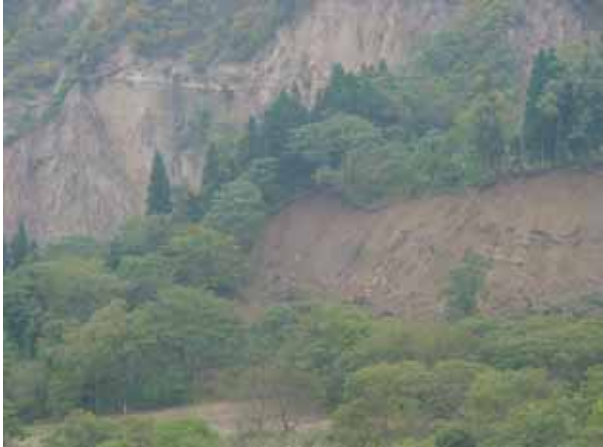
(4) Slides and rock falls took place at numerous locations on steep slopes, mountain walls and road cuts.

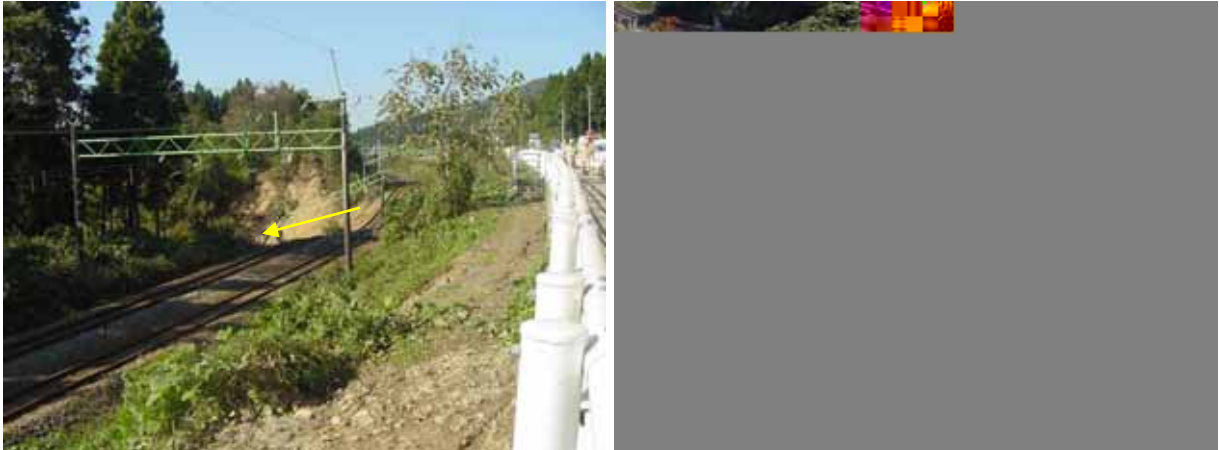
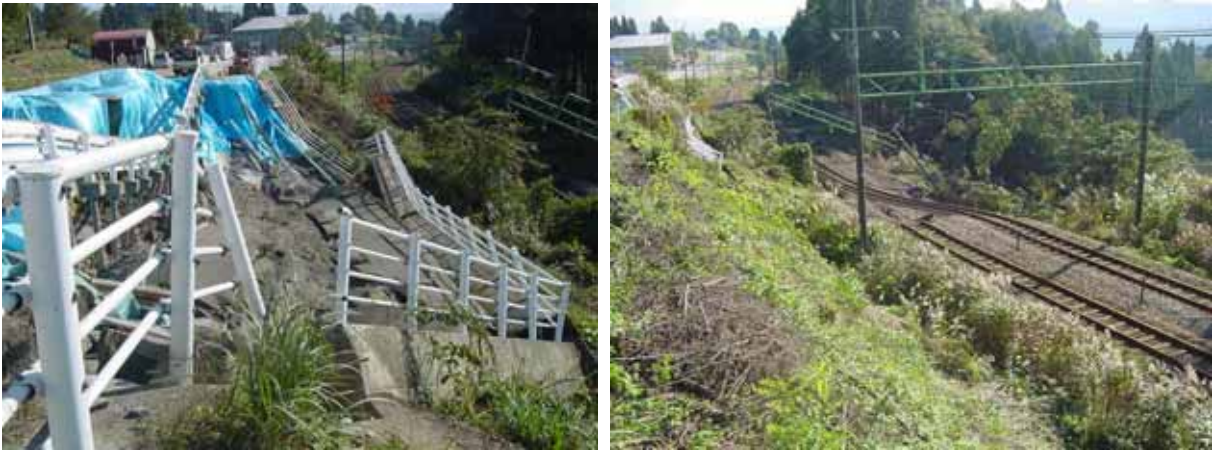
(1) A slide occurred underneath the railway embankment causing collapse of the embankment and partial collapse of the road running above it. The railways lost the support over a section of about 15 m in length. Location -1

Slide-induced collapse of the railway embankment and road running above it

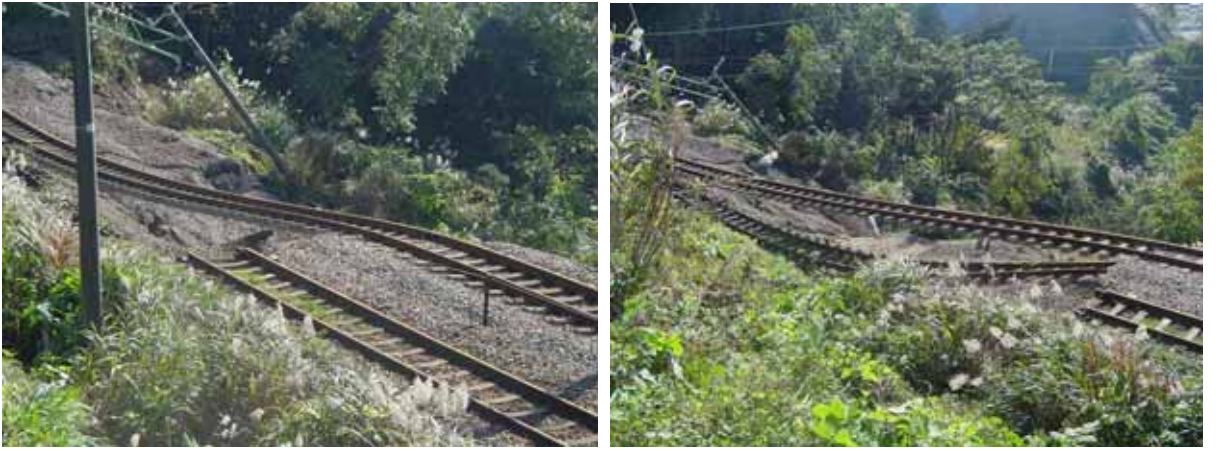
Hanging railways over the collapsed portion of the railway embankment

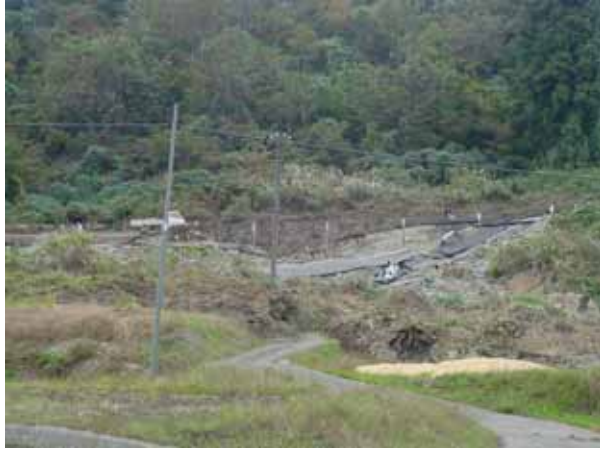
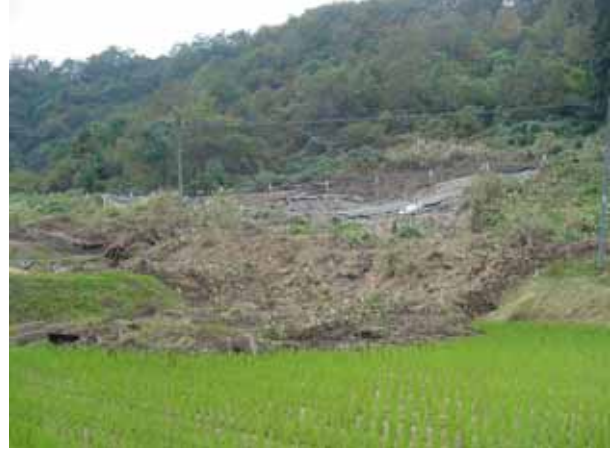
Location -2

(2) Collapse of a section of Road No. 117 due to sliding/flow and loss of foundation support. The slope above the road was not involved and/or affected by the sliding. The slope at this site was not so steep and it was much gentler than other slopes where collapses were observed.

The debris reached the flat terrain (on the right photo).

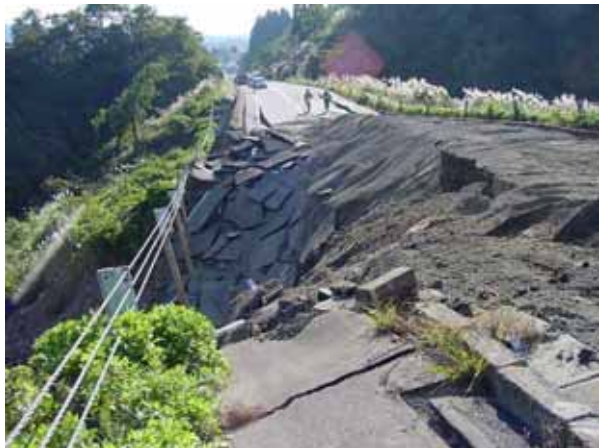
(3) Another similar failure was observed in the close vicinity. At this location, however, the slope beneath the road was much steeper. Location -3

Large run out distance is seen until the debris reached the flat terrain (on the left photo)

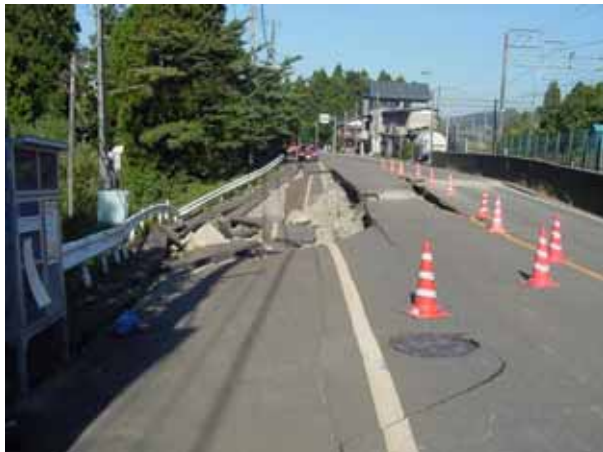
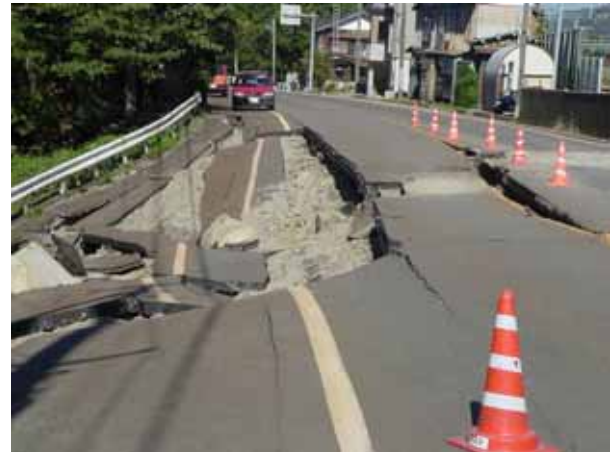
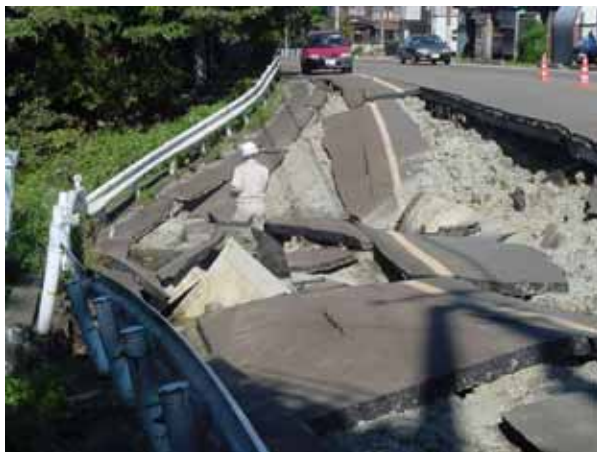
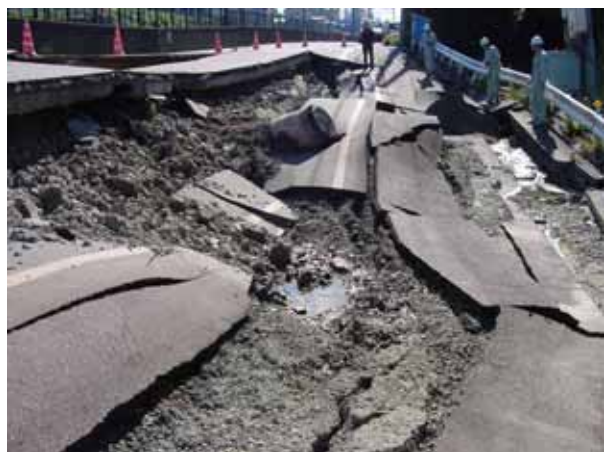
(4) Down slope movement with partial collapse of the road. The slope was rather gentle at this site. Location -4

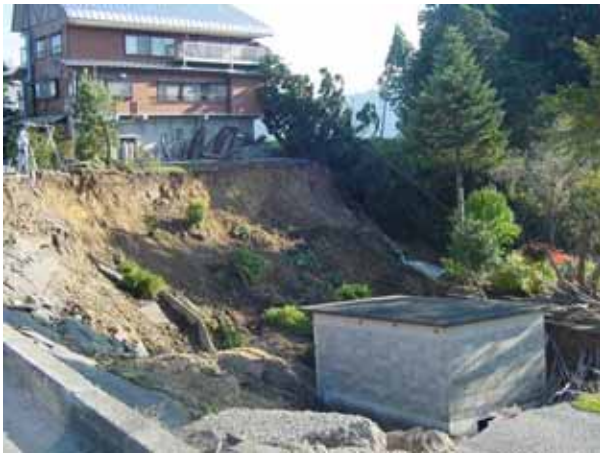
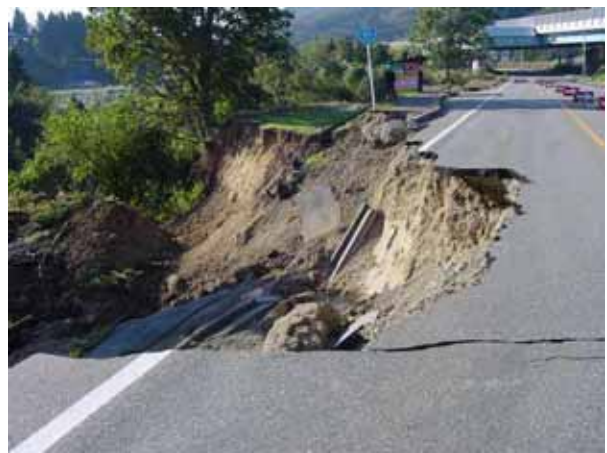
(5) A pair of slides with a width of about 20-30 m each occurred at steep natural slopes causing collapse of the road and large lateral and down slope movement of a storage house and a piece of farm land. Location -5

The storage house sunk into the open hole about 6-7 m below its original elevation (on the left photo). Collapse of the road is seen on the photos to the right and below.

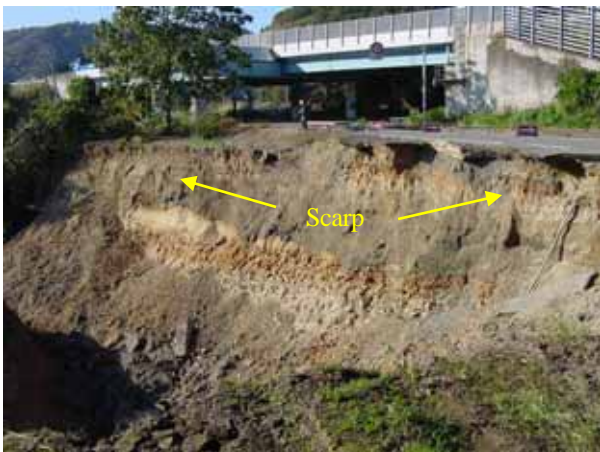
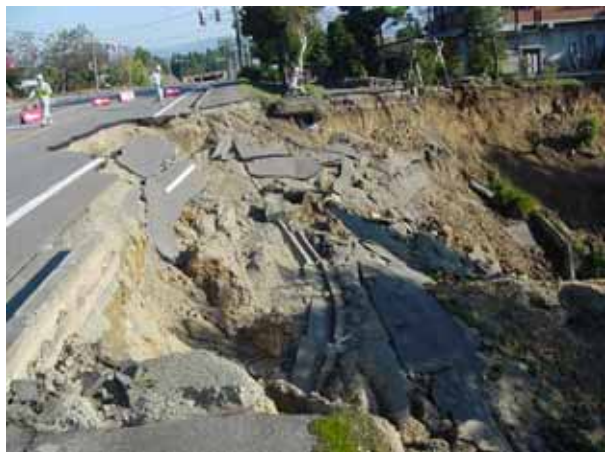
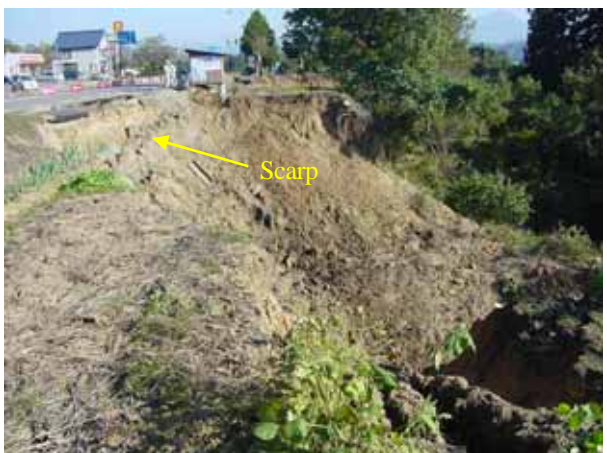
Photos depicting the second slide

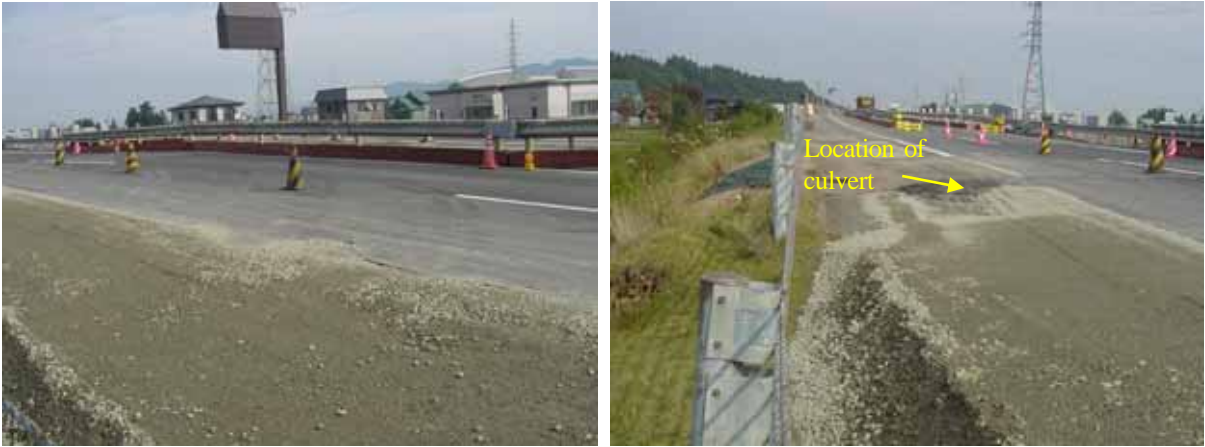
Uneven settlement due to lateral movement of slopes and subsidence of the crest of the highway embankment was observed at Ojiya IC area. Location

View of the highway from the top of the embankment.

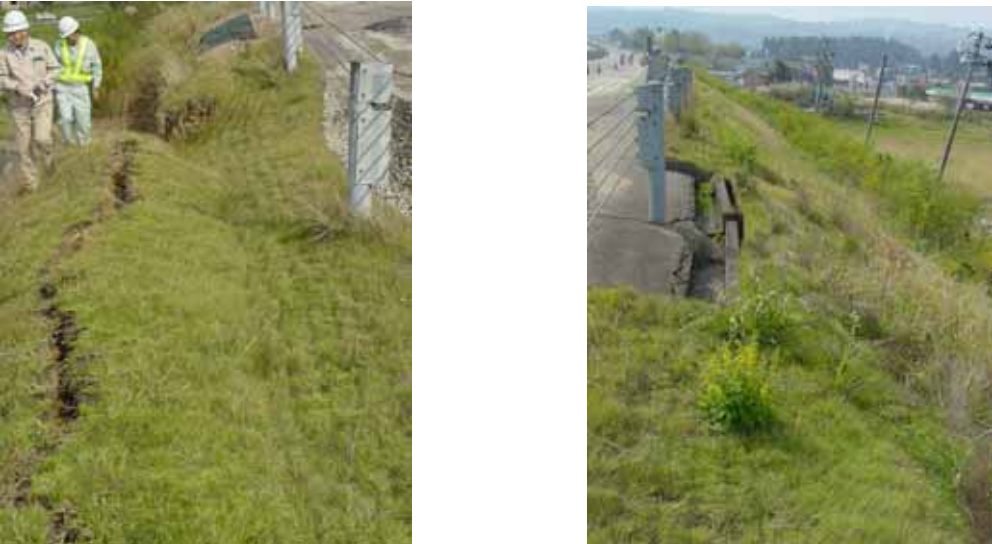
Longitudinal cracks at the top of the embankment (due to lateral movement)

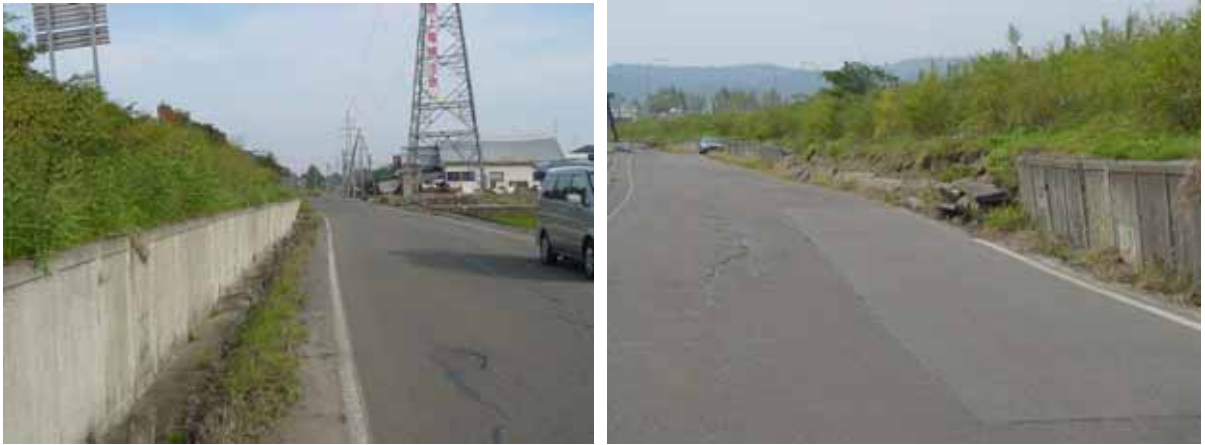
Lateral movement and collapse of the retaining wall at the foot of the embankment (Ojiya side)

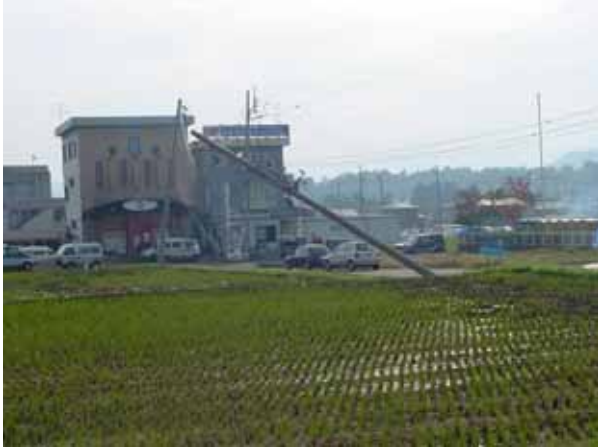
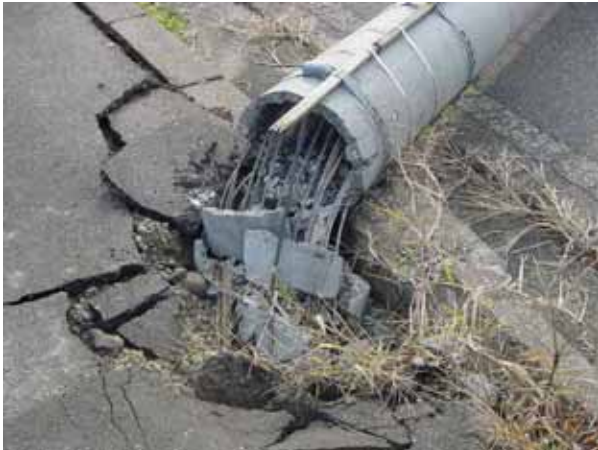
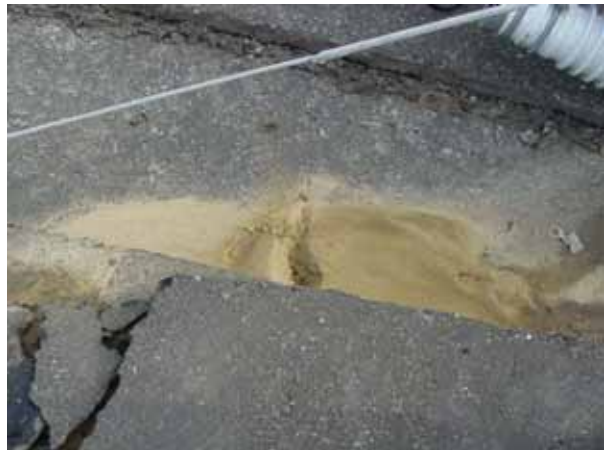
(1) Tilting of distribution poles was observed at several locations in the investigated area. Particularly large tilts and damages were observed in the highway area described in the previous section. One of the poles fell over. Sand boils were found near the overturned pole. **Location**

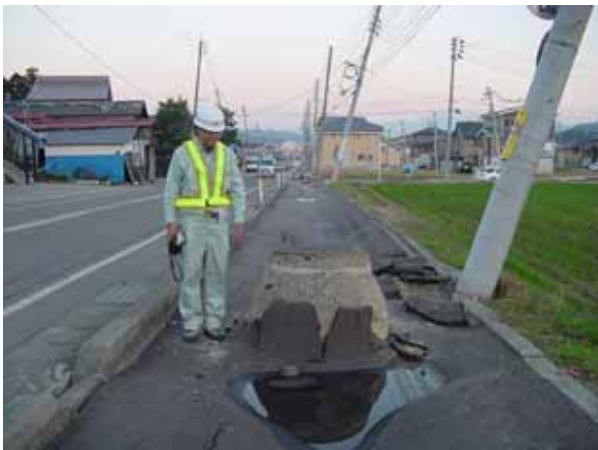
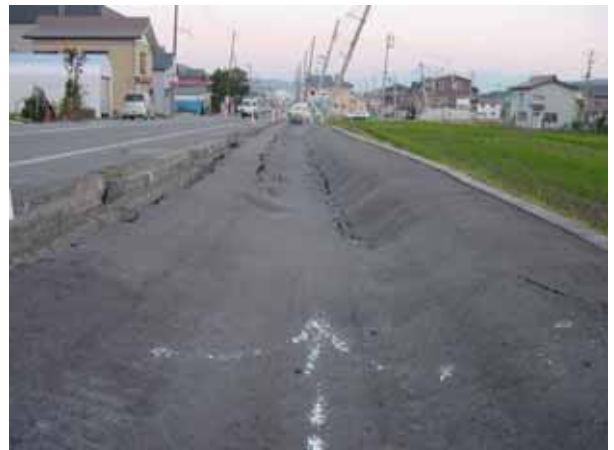
(2) Cracks on the surface and settlement of the asphalt pavement of about 10-20 cm were observed along buried pipelines. The uplift of the man-hole is about 80 cm. There were no signs of massive liquefaction or large sand boils. Tilting of distribution poles is also visible in these photos. **Location**

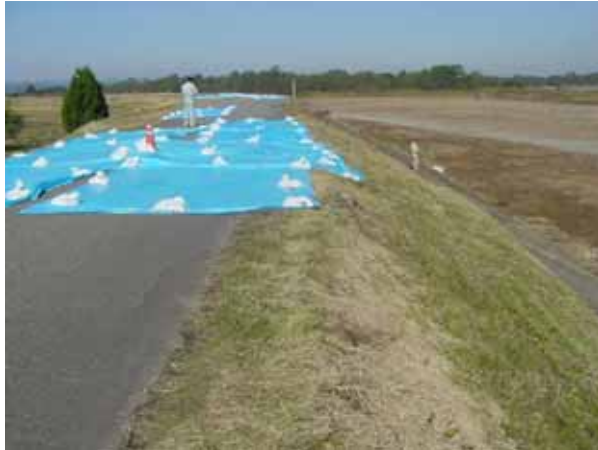
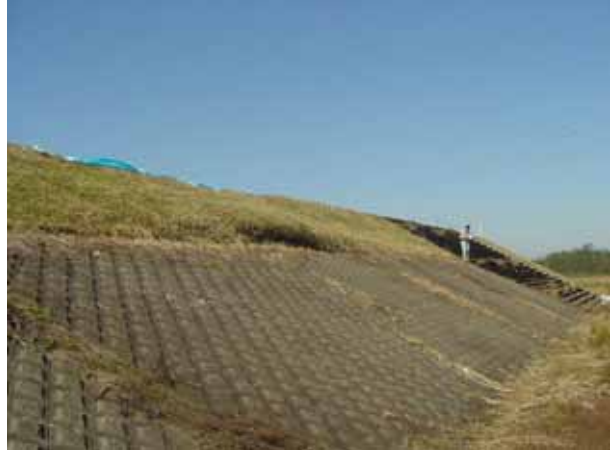
Location -1

(1) Light damage of the embankment and collapse of small section of the revetment wall was found in the vicinity of Koshino Bridge. There were clear signs of liquefaction in the area.

Cracks at the crest (area covered by the blue sheet); small lateral movement of the embankment (bulging on the right photo).

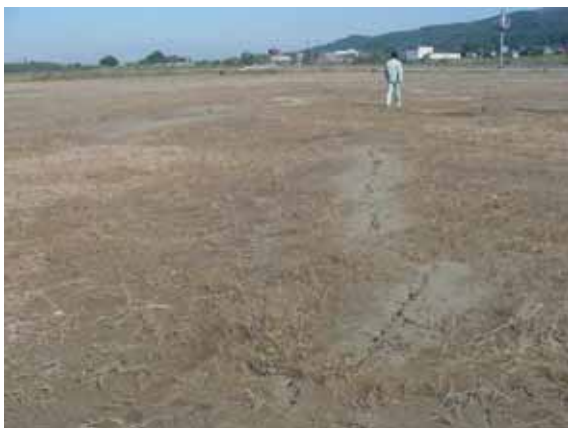
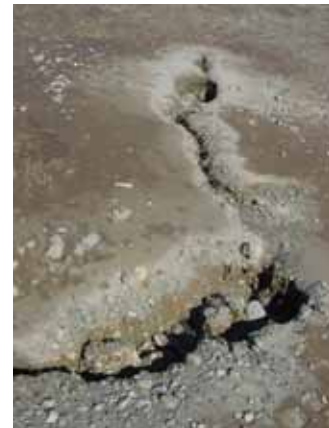
Cracks on the ground surface and sand boils were observed in the area between the embankment and the quay wall.

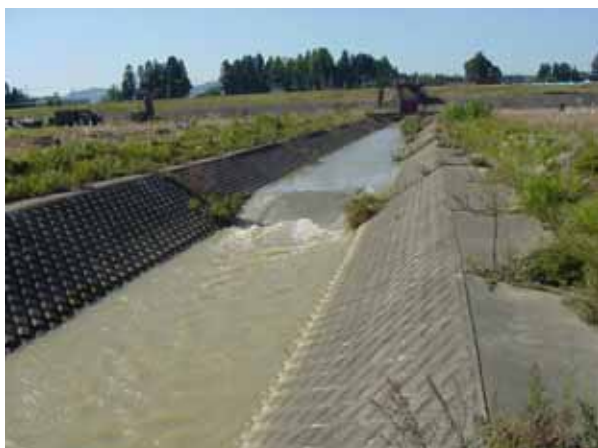
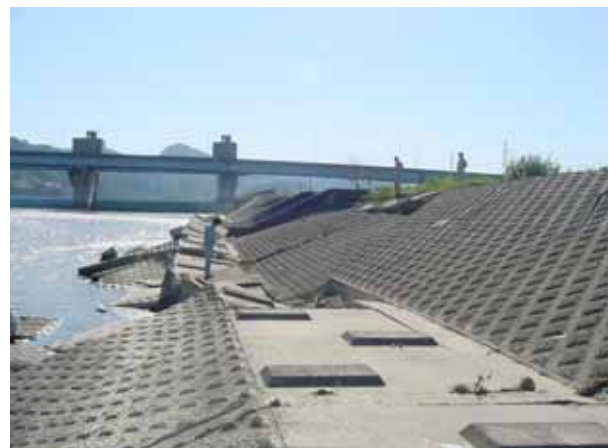
The quay wall moved laterally and part of it collapsed into the river. (Photo on the right)

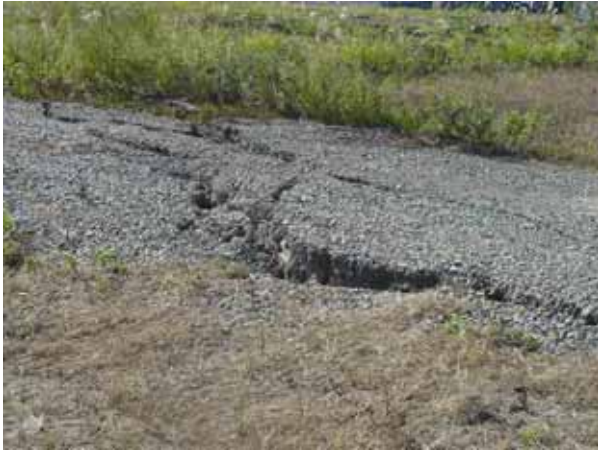
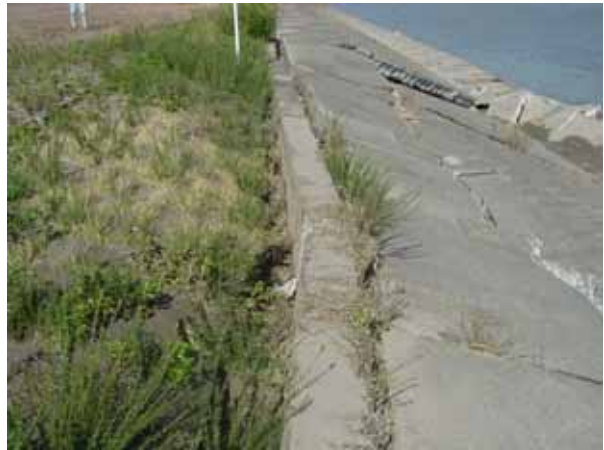
Ground cracks and lateral movement toward the river near the top of the revetment wall.

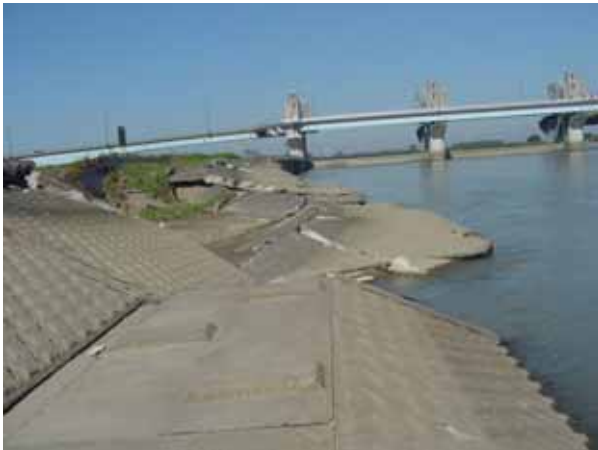
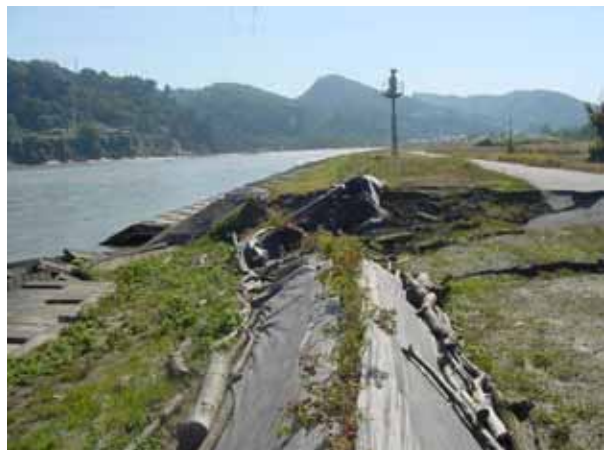
(2) About 200 m towards south (on the same river bank, but on the opposite side of Koshino Bridge), another portion of the revetment wall (about 6-8 m in length) collapsed into the river. Large sand boils were found within the collapsed portion and in the backfills. Location -2

Collapsed portion of the quay wall (Koshino Bridge is seen in the background)

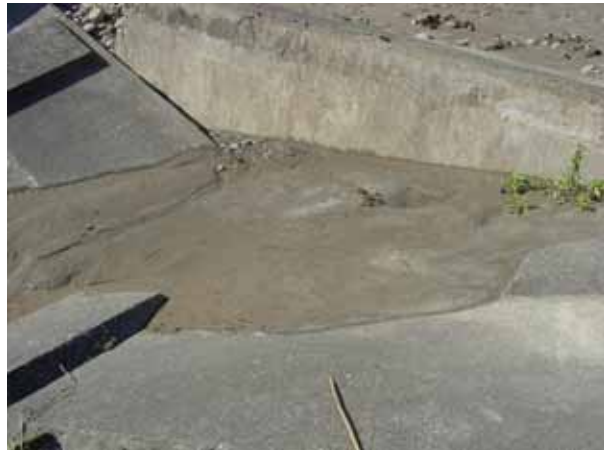
Ground distortion behind the quay wall;

Sand boils

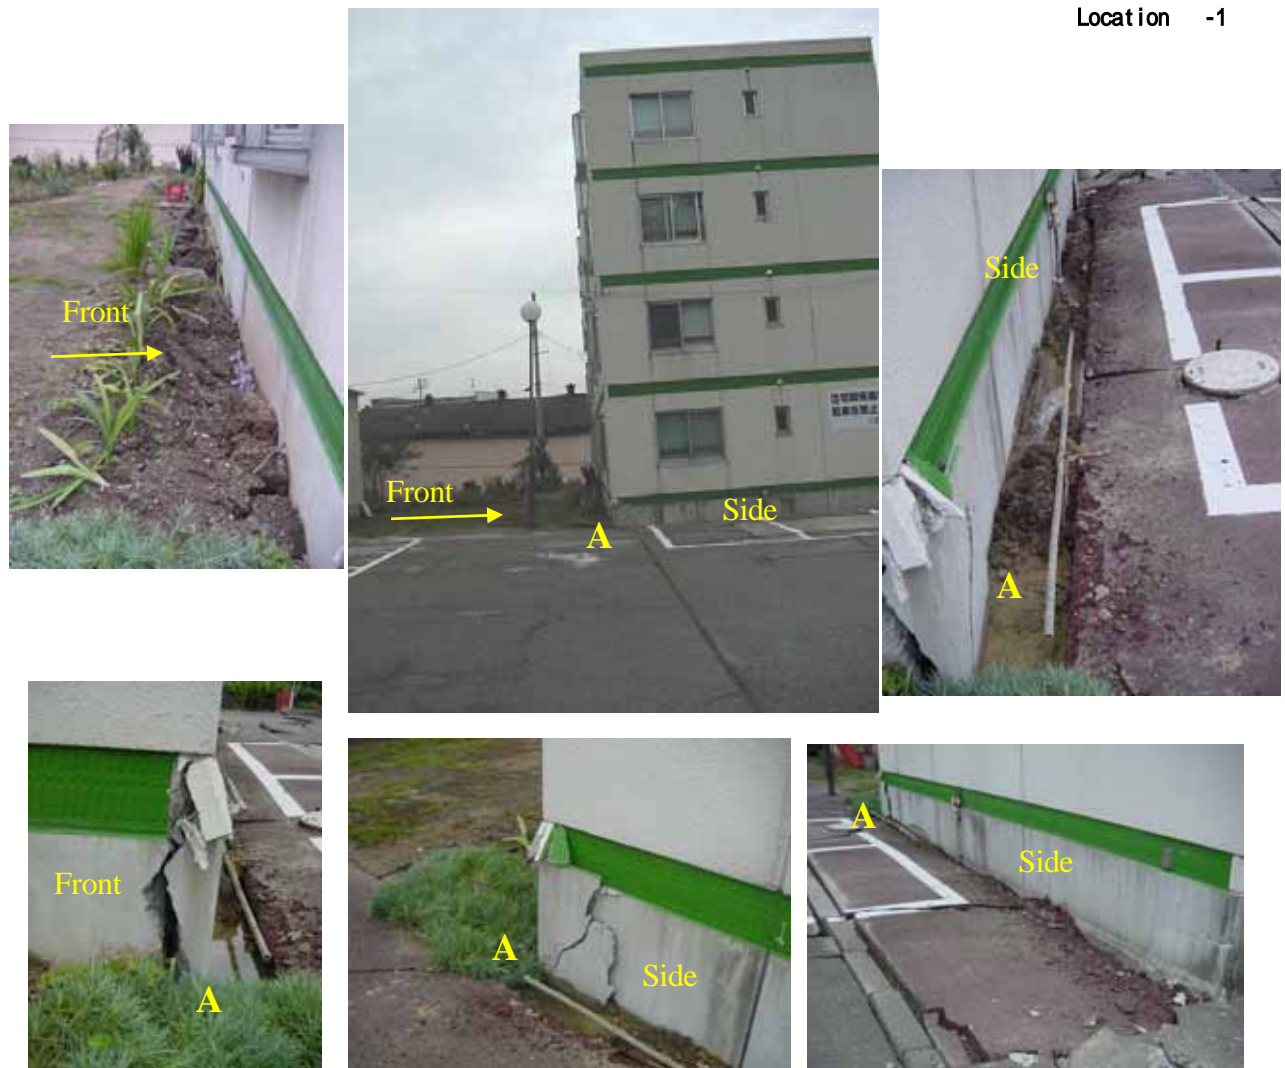
(1) Two apartment buildings (4 story bldgs.), located about 50 meters from Echigo-Kawaguchi station, moved laterally and subsided about 15-20 cm. One of the buildings tilted about 1°.

Bldg. 1 shown in the photos above tilted about 1°.

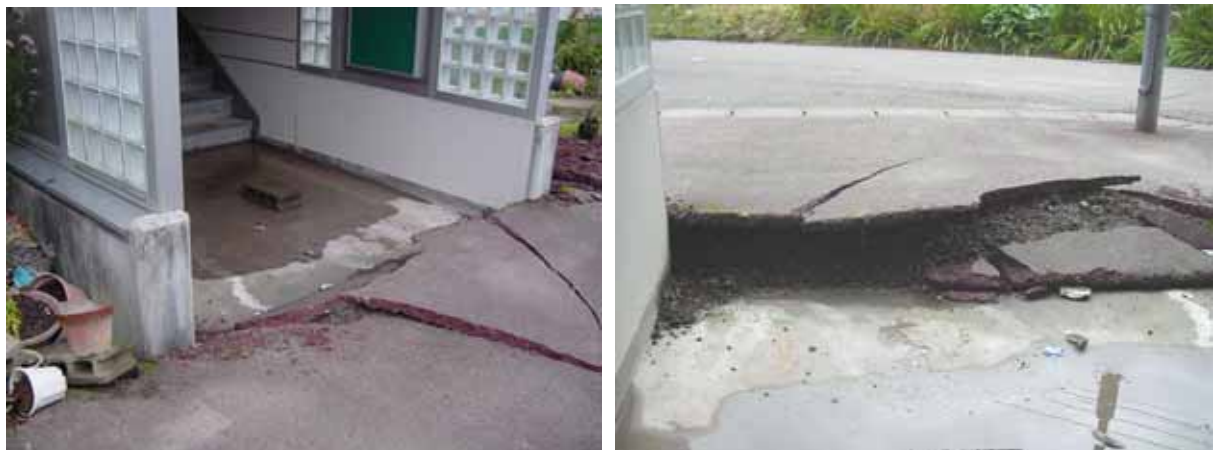
Differential settlement observed at the entrance of Bldg. 2

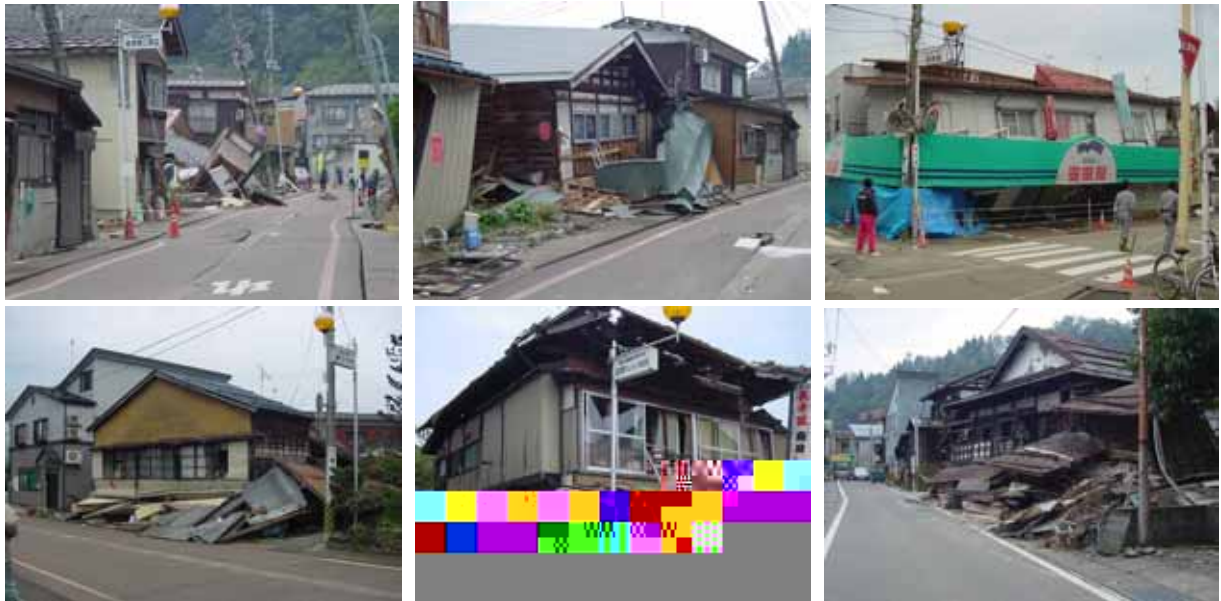
(2) Damage to wooden houses (mostly old and weak structures) was the largest at Ojiya and particularly in the residential area around Echigo-Kawaguchi Station. **Location -1**

Heavily damaged and collapsed wooden houses near Echigo-Kawaguchi Station.

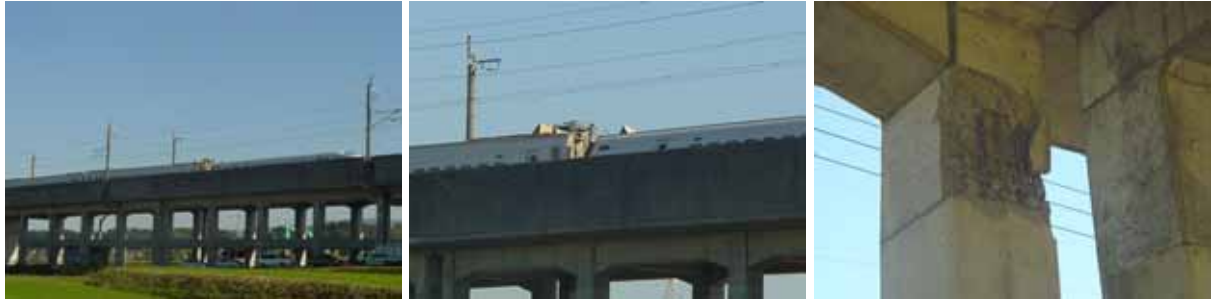
- (1) The earthquake caused derailment of Shinkansen (the first one in 40 years of operation of bullet trains in Japan). **Location** -1

The derailment is evident in the dislocation of the connection between the two cars (mid photo). About 100 m south of the derailment site, damage of the top part of the columns supporting the elevated structure was observed.

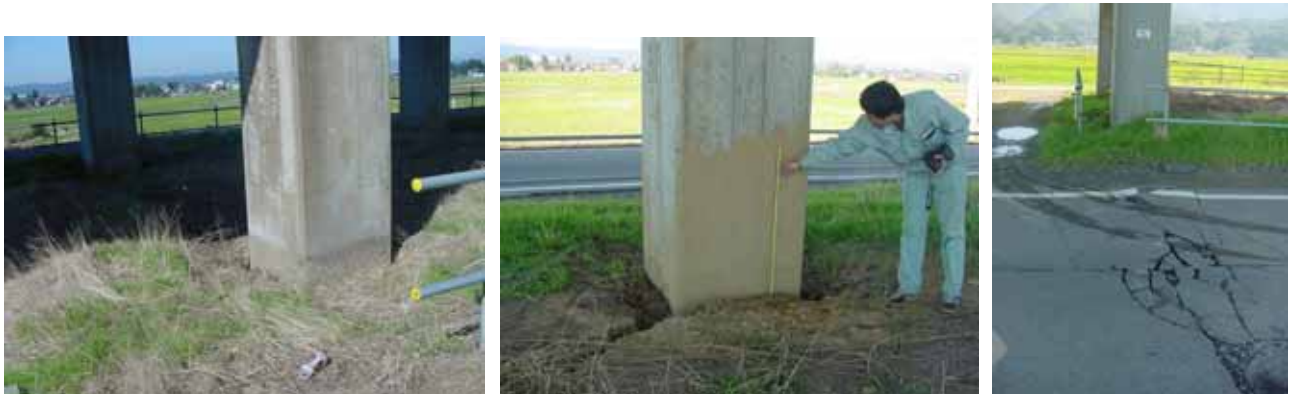
Cracks and settlement (15-20cm) of the ground were observed in the foundation soils. Mud traces (about 1m high) were found on the column

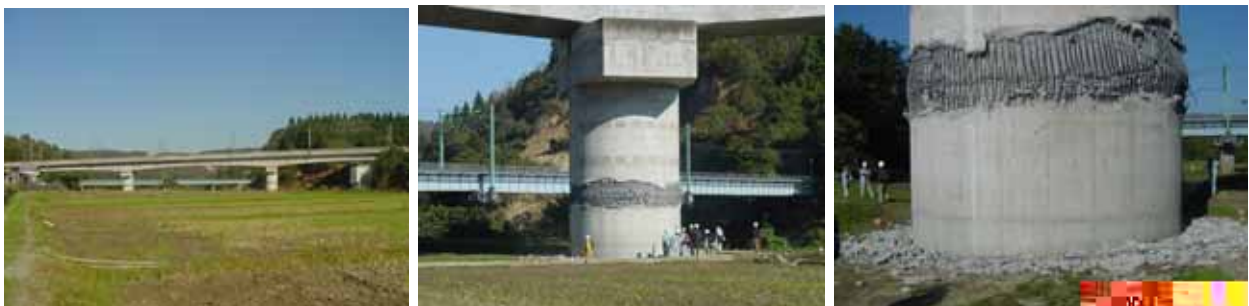
- (2) Damage to piers of elevated section of Shinkansen **Location** -2

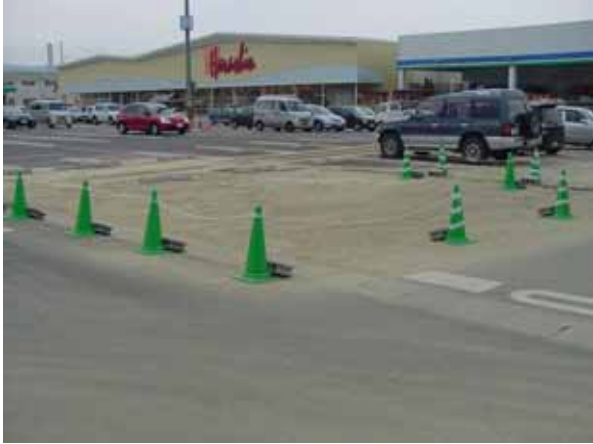
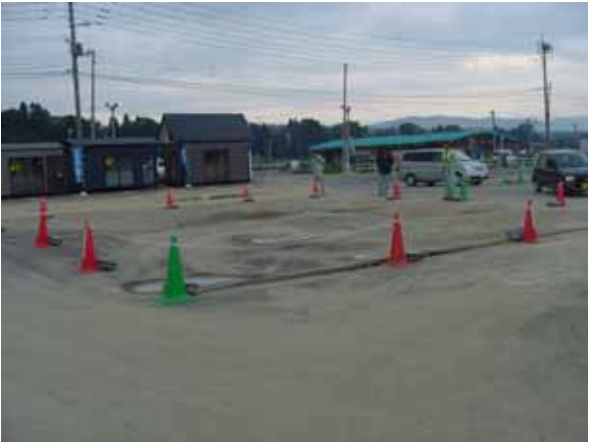
Sand boils and uneven settlement due to liquefaction observed at a parking lot.
