## PRELIMINARY RECONNAISSANCE REPORT ON THE 2003 TOKACHI-OKI EARTHQUAKE

### INVESTIGATION DETAILS

- Date: September 27 and 28, 2003
- Team members: S. Yasuda (Tokyo Denki University), I. Morimoto, K. Tsubota, M. Hashimoto and M. Cubrinovski (Kiso-Jiban Consultants), S. Goto (Yamanashi University)
- Route: Obihiro Airport - Hiroo (Tokachi Port) - Toyokoro - Urakoro - Kushiro - Onbetsu – Moiwa - Ootsu - Kushiro Airport

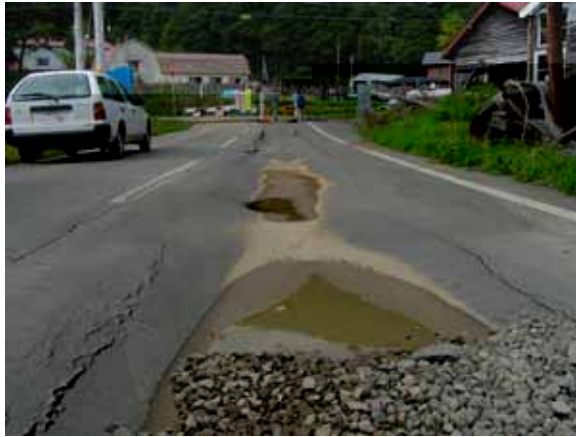
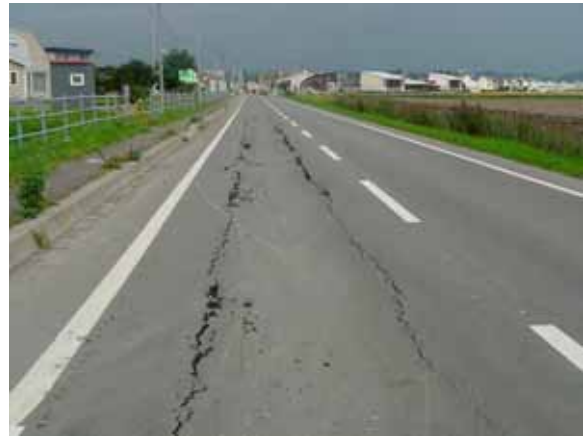
Moiwa: Cracks on asphalt surface and settlement of the road along buried pipelines (D-2)

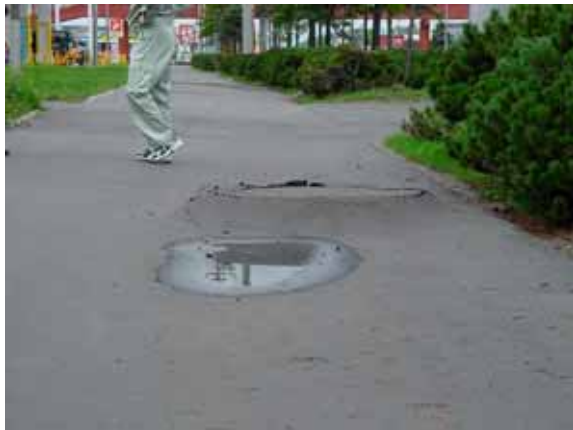
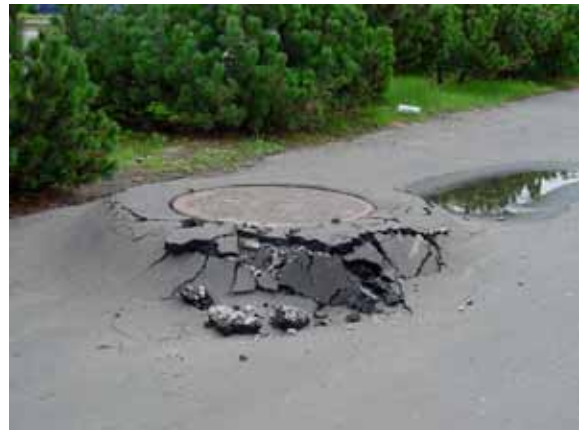
Kushiro: Differential vertical displacement of man-holes on the order of 10-20 cm; part of the movement can be attributed to uplift of the man-hole whereas part is due to settlement of the surrounding ground; the same man-holes were uplifted during the 1993 Kushiro earthquake (A-3)

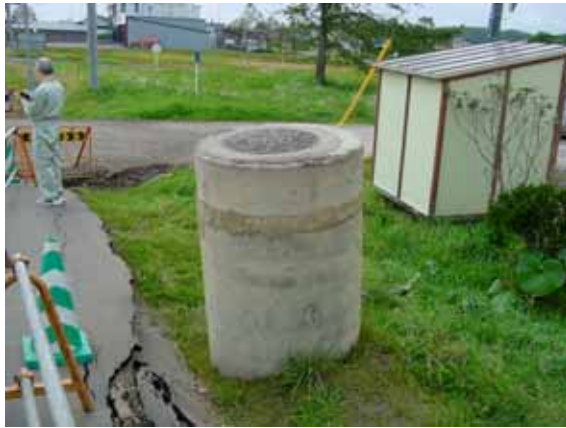
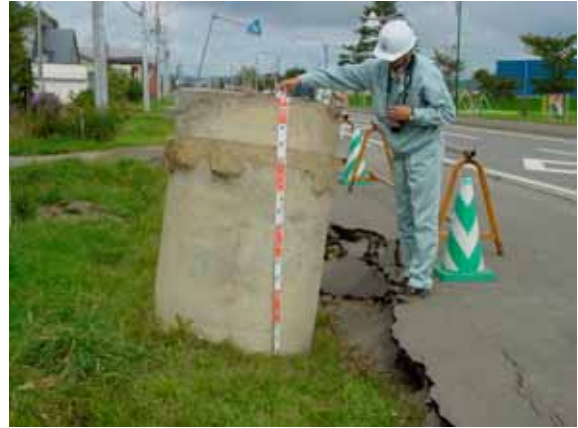
Onbetsu: Huge uplift of a man-hole at Onbetsu, Kawahigashi Danchi; the top of the man-hole was approximately 170 cm above the ground surface; (B-1)

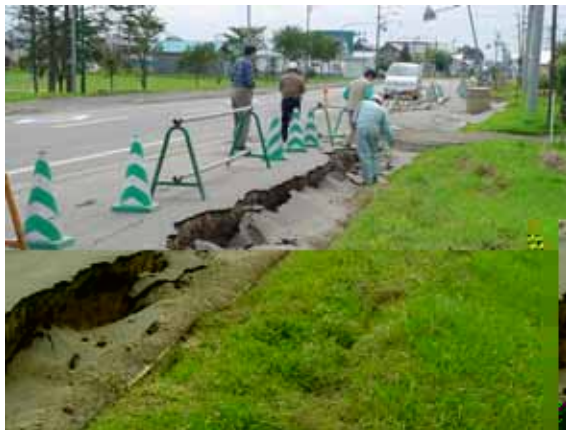
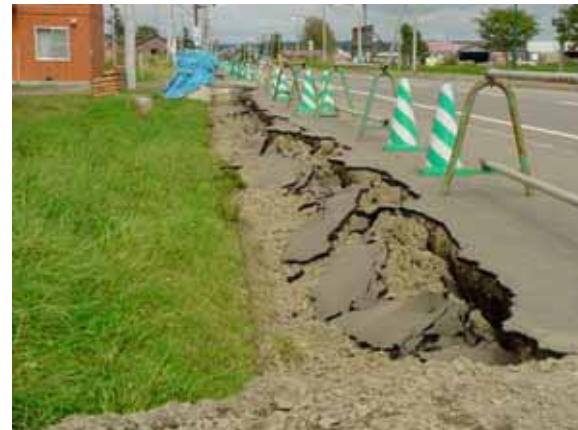
Onbetsu: Collapse of the pavement and subsidence of 30-50 cm was observed along a length of 200-300 m of the pipeline route; the collapsed portion has a width of about 1-1.2 m; (B-1)

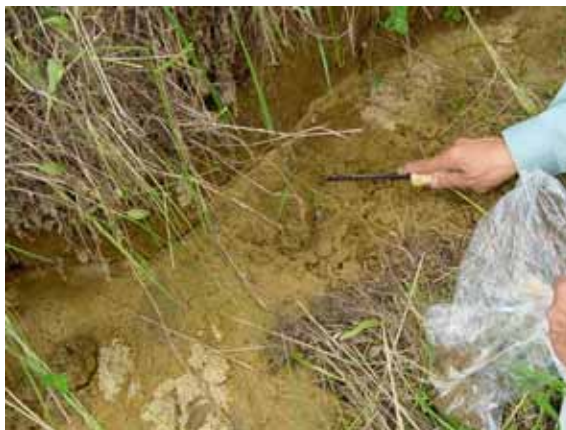
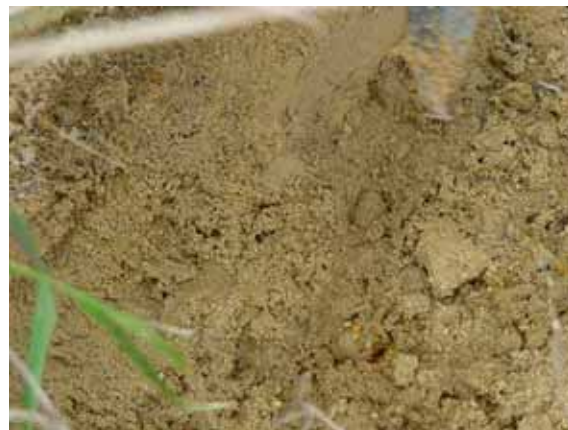
Onbetsu: The fill soils are sandy soils; liquefaction of the relatively loose fills is considered to be the cause of the observed damage as above; (B-1)

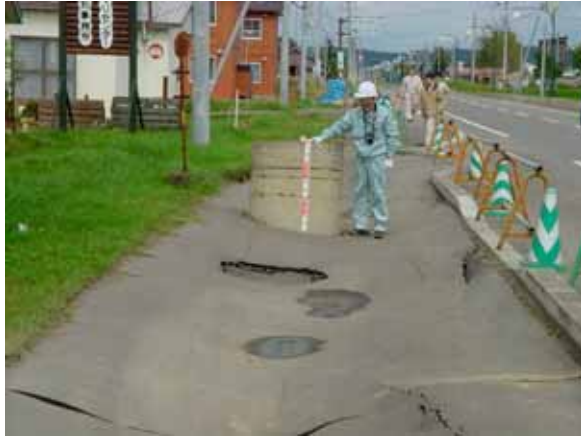
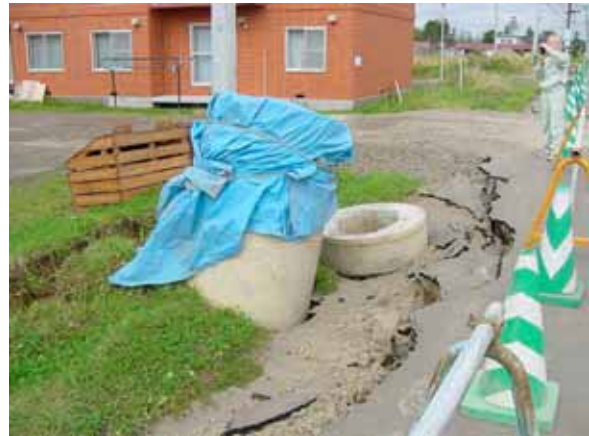
Onbetsu: Additional two man-holes were uplifted as much as 1 m and 1.7 m above the ground level; (B-1)

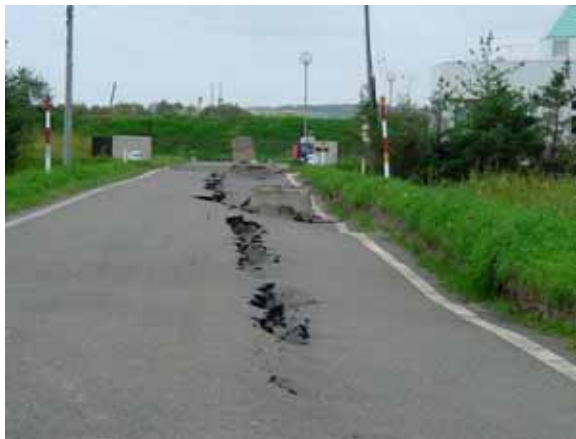
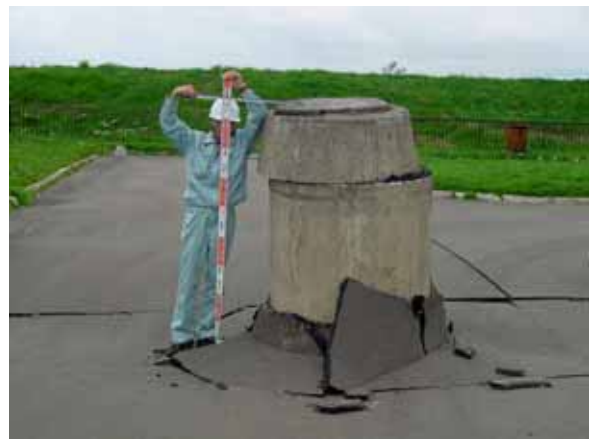
Ootsu: Subsidence of road surface above buried pipelines and uplift of man-holes; the top of the man-hole shown on the right was about 180 cm above the ground level; (B-1)

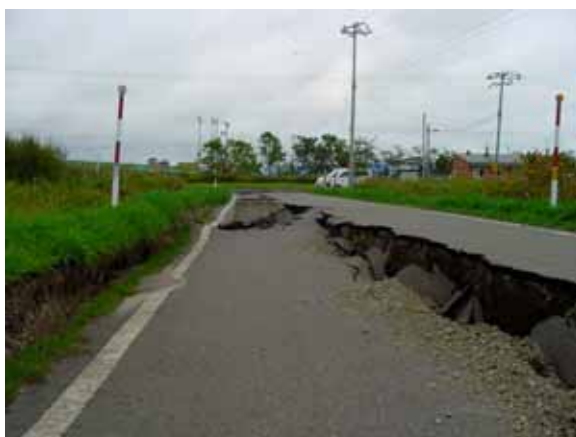
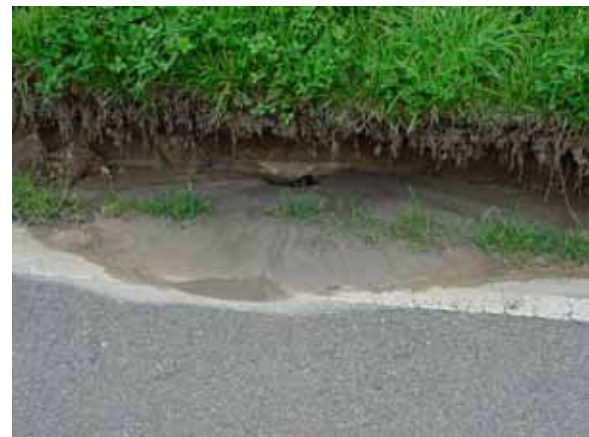
Ootsu: The maximum subsidence was about 40-50 cm; sand boils were seen at the contact zone of the asphalt and ground clearly indicating that the fill soils liquefied; (B-1)

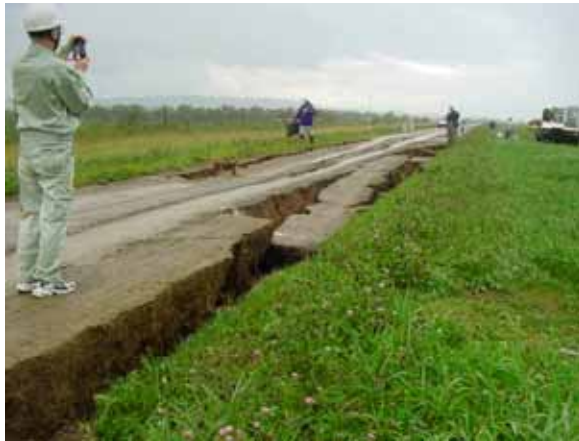
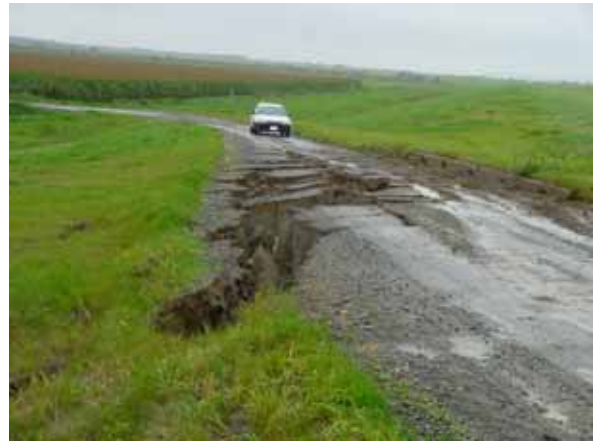
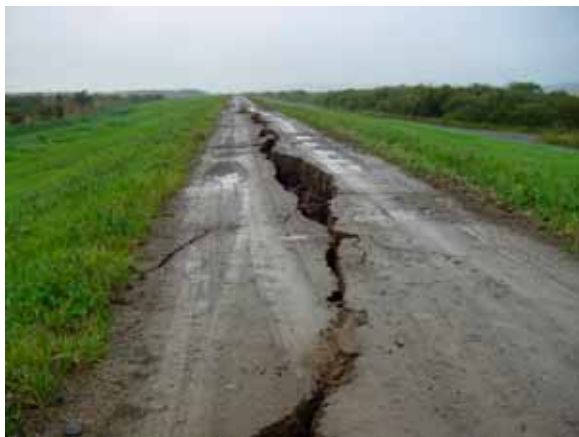
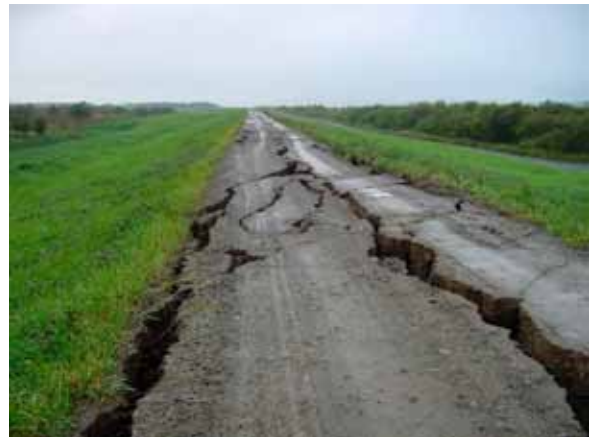
Tokachi River: The embankments along Tokachi River, from Toyokoro to Ootsu are about 20 km long; large longitudinal fissures along the crest and slopes were observed at numerous locations; (C-1)

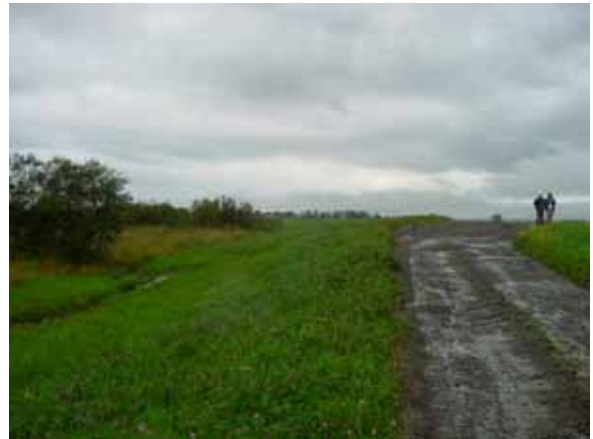
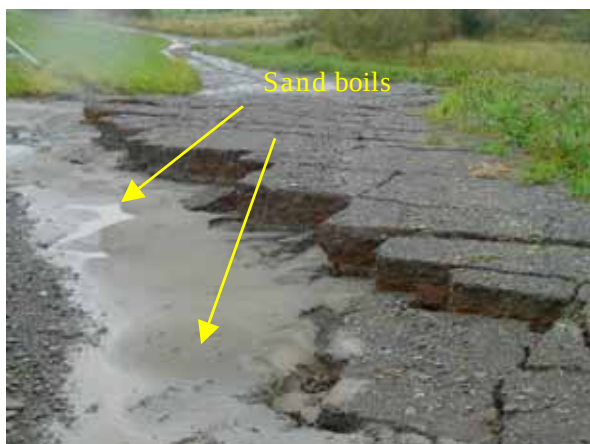
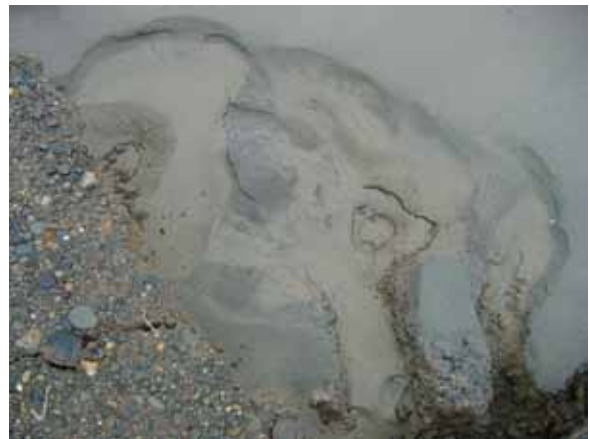
Tokachi River: At this location, massive sand boils were found at the top of the embankment; the approach road shown in the upper-right picture moved laterally; the fissures created by the large lateral movement are seen in-filled with sand-boils and water in the lower images; (C-1)

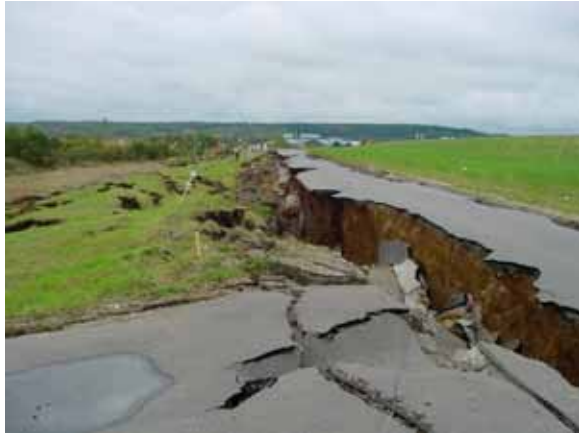
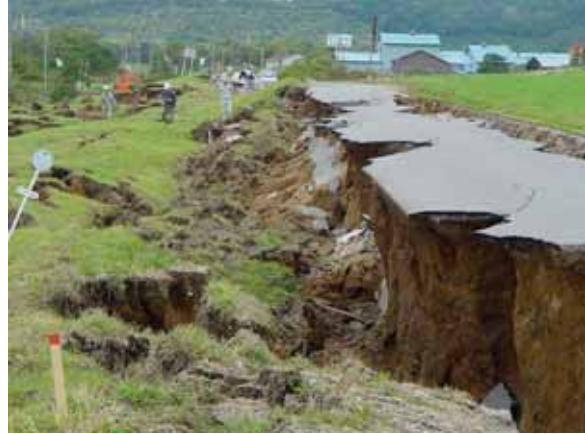
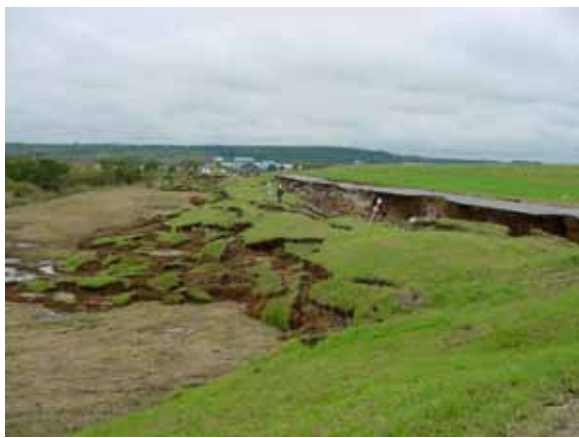
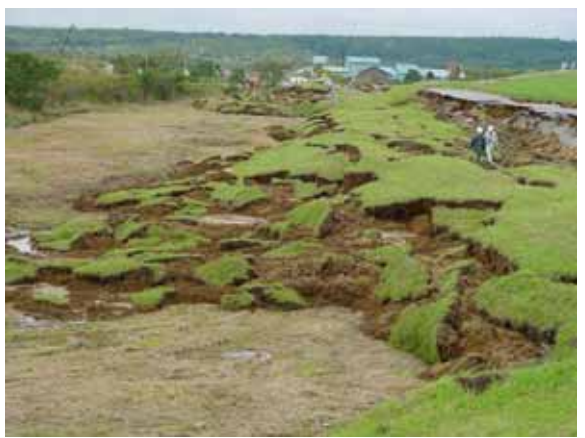
Tokachi River: The largest damage of the embankment occurred near the Ootsu Sewerage Treatment Facility; along two sections with approximate lengths of 150-250 m, the lower body of the embankment completely collapsed; the foundation soil beneath the embankment seen on the left side in the lower images was extremely soft and soaked in water; these images show the first of the two collapsed sections; (C-4)

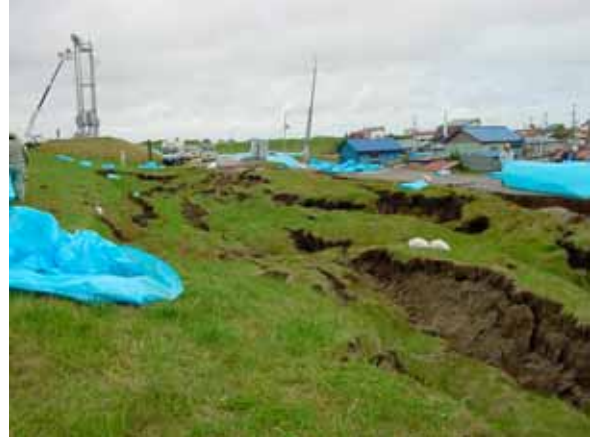
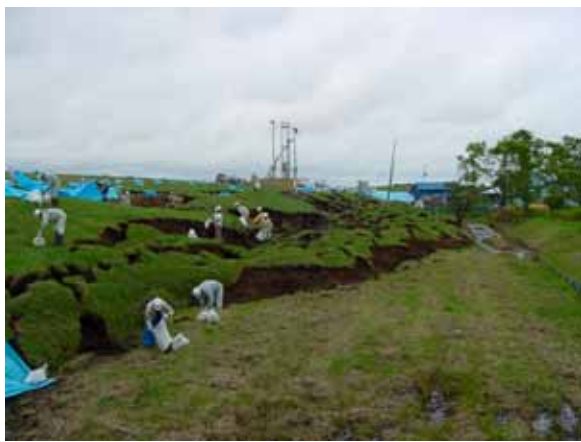
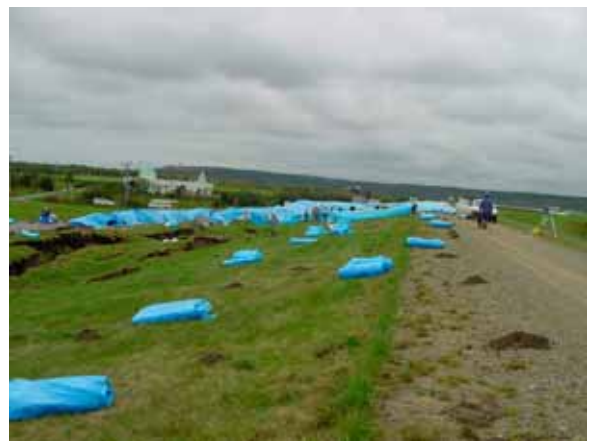
Tokachi River: The second section of the collapsed lower embankment is located just in front of the Ootsu Sewerage Treatment Facility; most of the ground surface was covered with protective sheets and therefore the features of ground distortion were not fully visible; excessive lateral movement of large masses of soil and collapse of the lower body of the embankment were evident; (C-4)

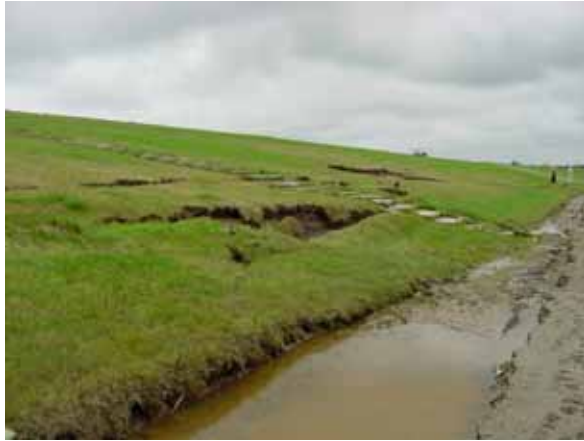
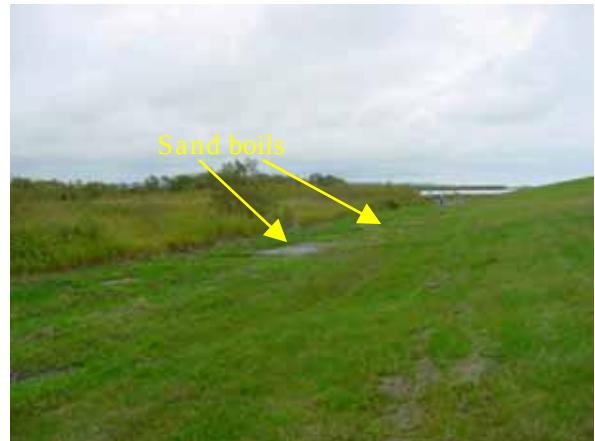
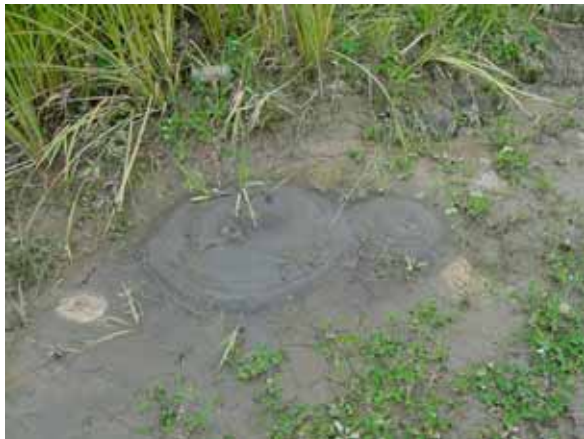
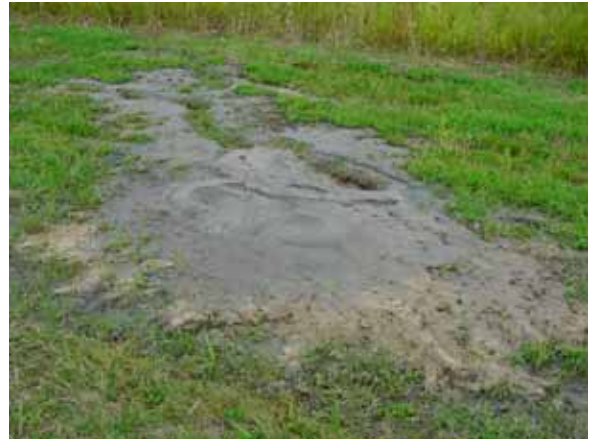
Tokachi River: These pictures show the other slope of the embankment (the one toward the banks of Tokachi River) at the Ootsu Sewerage Treatment Facility; longitudinal cracks and fissures in the lower body of the embankment were observed; these type of cracks and fissures were found in the foot of the embankment and also in the original soil deposit to a distance of about 20-30 m from the embankment; there were clear signs of liquefaction in the soil deposit at the foot of the embankment; (C-4)

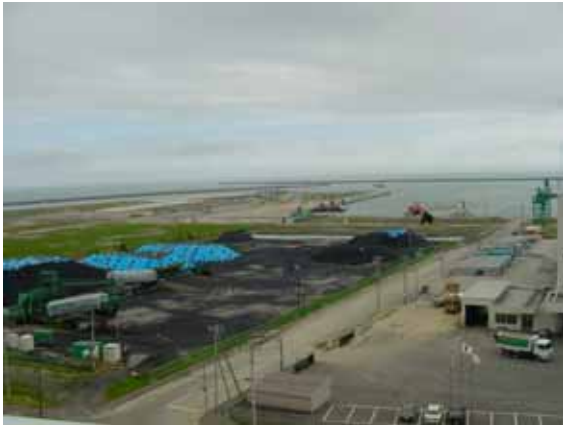
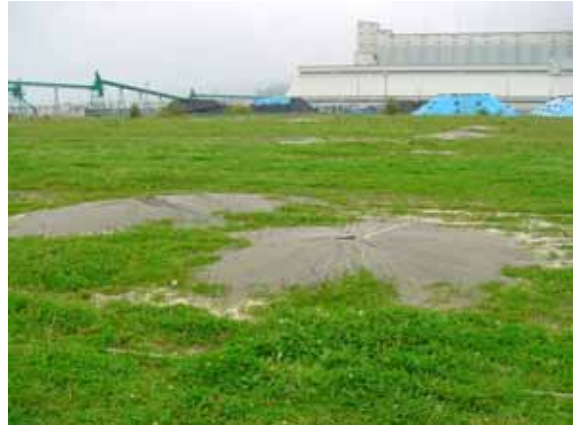
Tokachi Port: Massive sand boils were observed in reclaimed fills; (G-1)

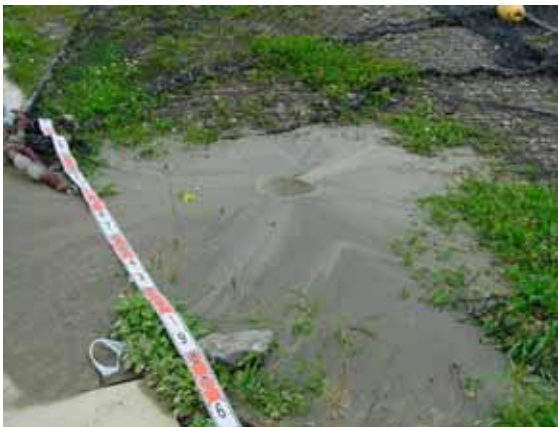
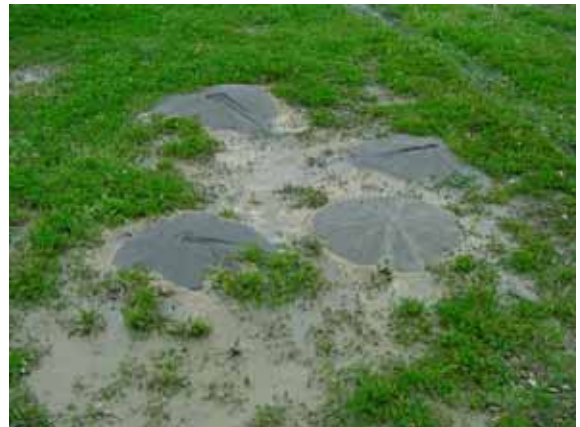
Tokachi Port: Sand boils; (G-1)

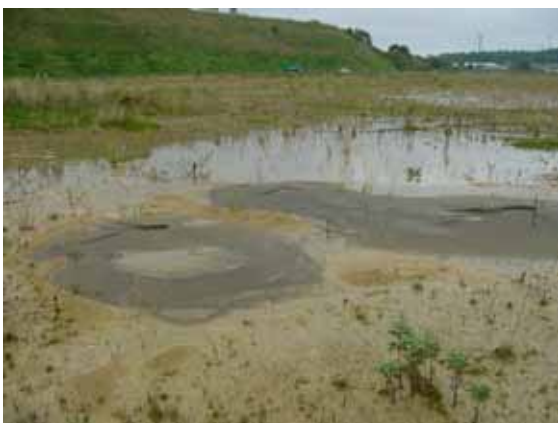
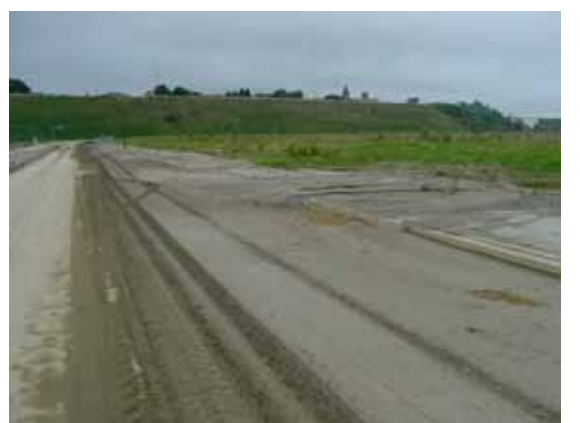
Tokachi Port: Massive sand boils and sand littered on the road surface; (G-1)

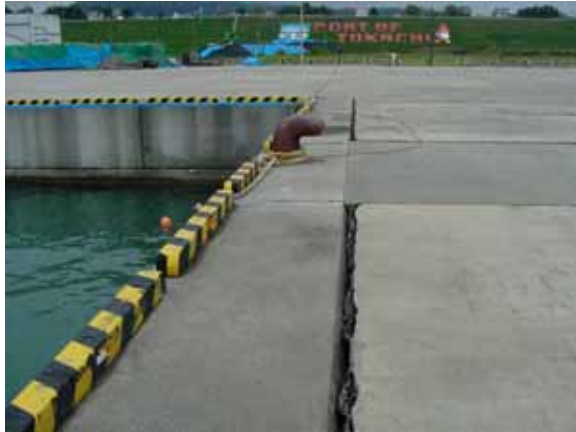
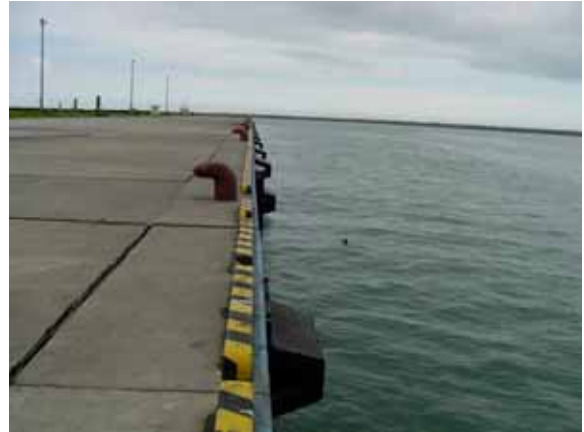
Tokachi Port: According to the observed gaps between the concrete blocks, it is estimated that the quay walls moved seaward about 10 cm; small settlement was observed behind the quay walls in accordance with the lateral seaward movement of the walls; (G-1)

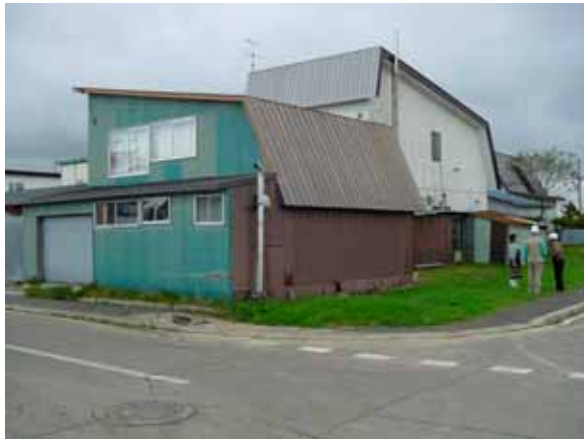
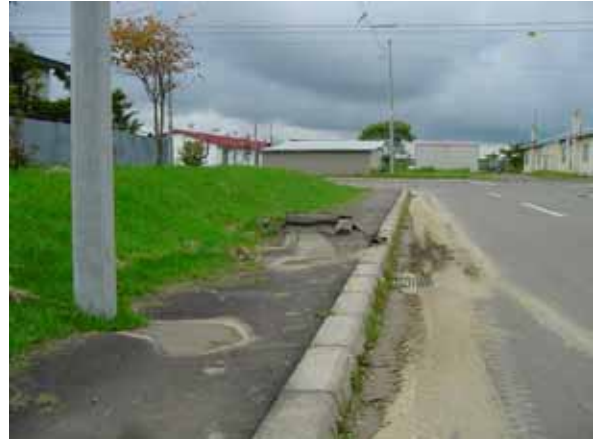
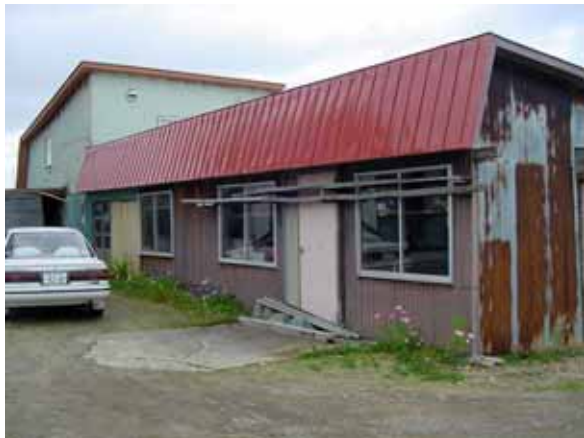
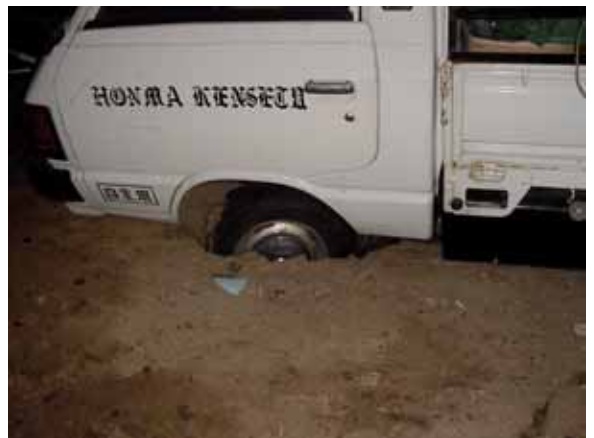
Ootsu: Liquefaction of foundation soils in the residential area occurred; there were clear signs of liquefaction including sand boils and uplift of a man-hole of about 15 cm just in front of the affected house; inside the garage shown in the lower-left picture, the parked truck sunk into the liquefied ground; (south of C-4)

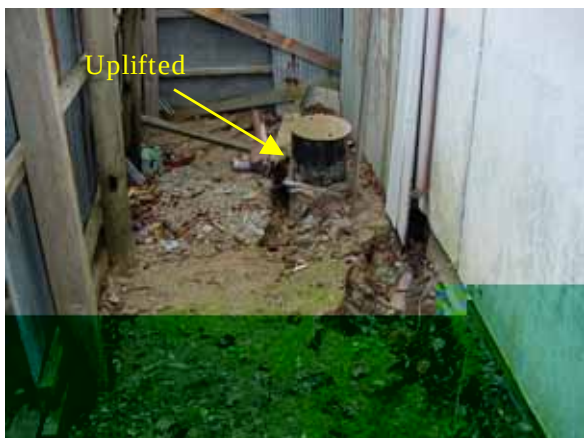
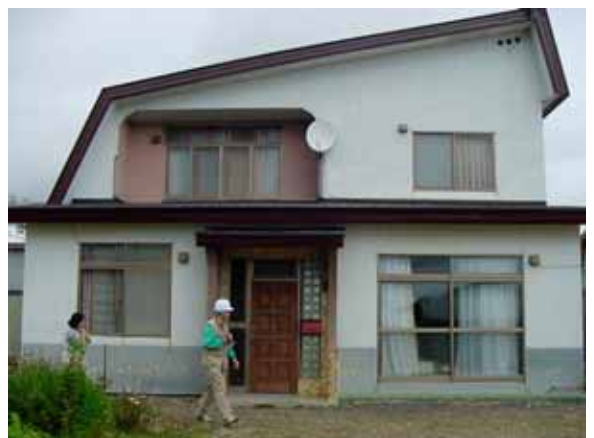
Ootsu: Fissuring of the ground around the foundation of the nearby house and uplift of a pipe about 30-40 cm above the ground were observed; (south of C-4)

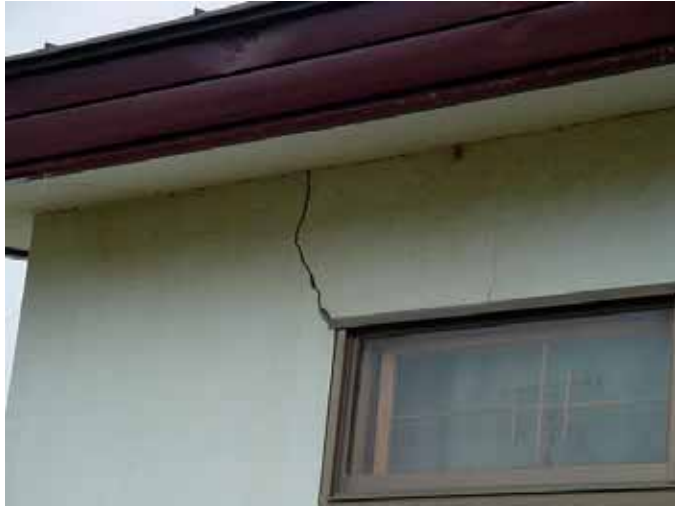
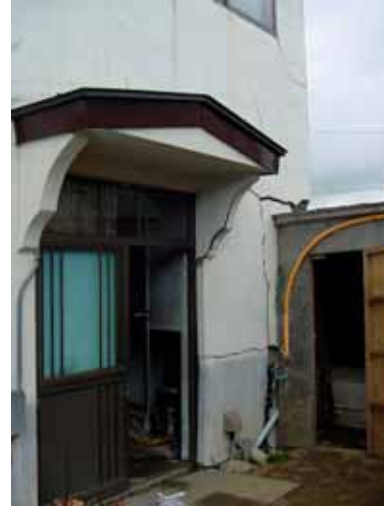
Ootsu: Cracks in the walls and damage due to non-uniform settlements; (south of C-4)

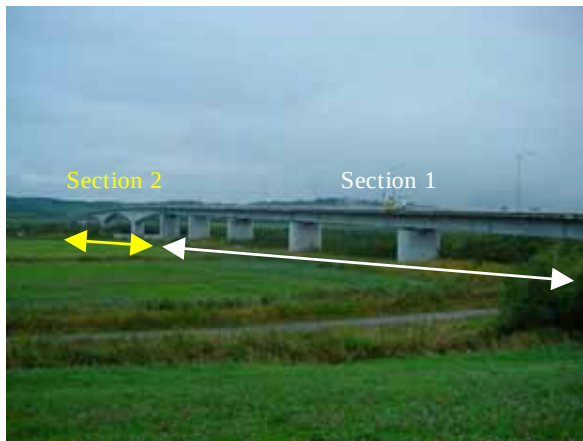
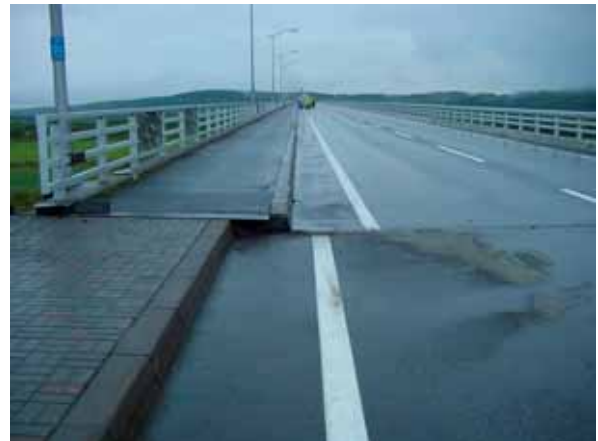
Tokachigawa Bridge: The bridge has two structural systems (Section 1 and Section 2); The upper deck of Section 1 moved laterally towards the right in the picture (NW), about 60 cm, as seen in the image on the left: view from the abutment; (C-2)

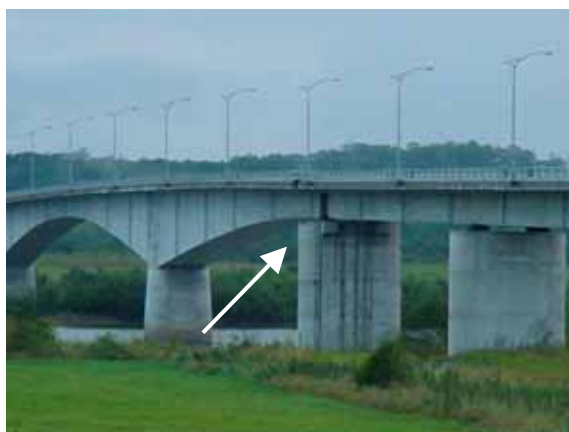
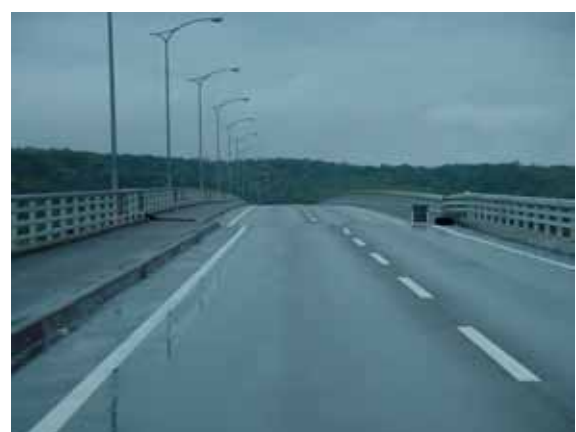
Tokachigawa Bridge: At the connection of two bridge sections: pier at the connection of Sections 1 and 2; View from Section 1 towards Section 2; Section 1 is seen displaced laterally about 60 cm; (C-2)

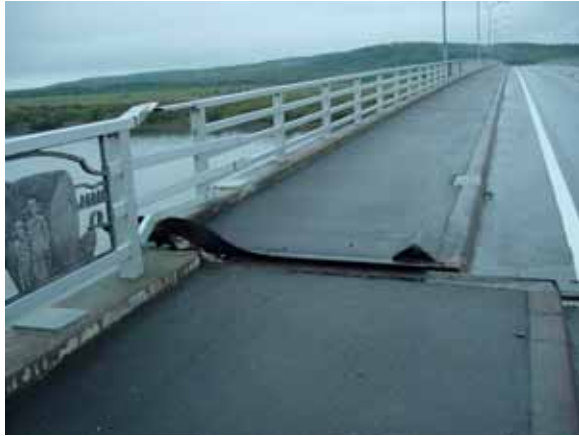
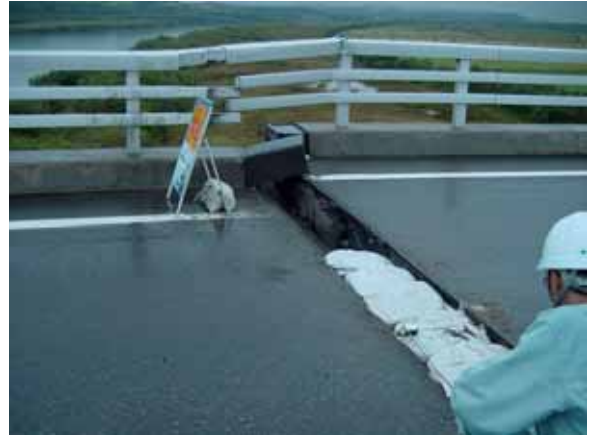
Tokachigawa Bridge: Damage details at the connection of Sections 1 and 2; (C-2)

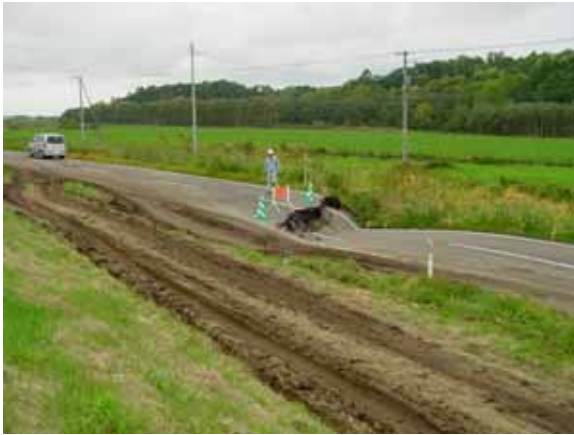
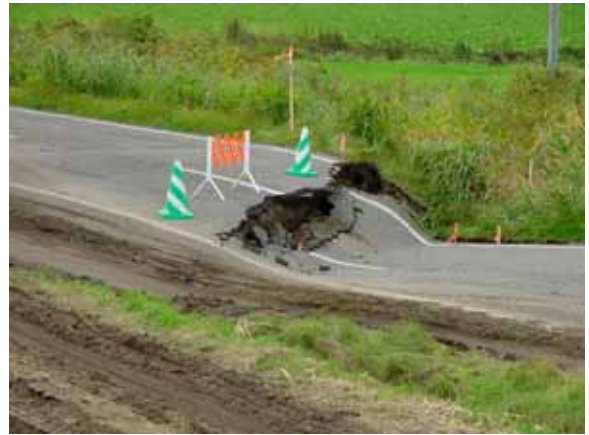
Tabikorai: The road running along the embankment from Moiwa to Ootsu was heavily damaged or collapsed at numerous locations; (C-3)

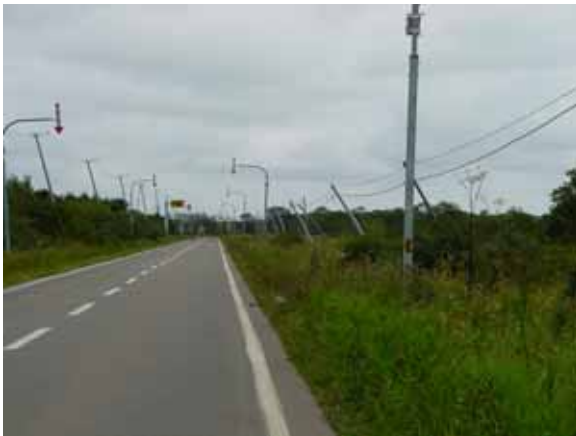
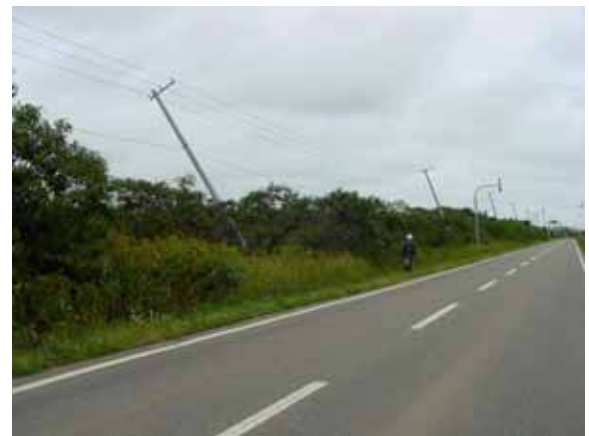
Between Tabikorai and Ootsu: Tilting of distribution poles of electric power lines; sinusoidal wave pattern of tilting was observed with the poles on both sides of the road showing similar pattern of movement; there was no such horizontal wave-pattern in the deformation of the road, which was without damage at this section; (C-3)

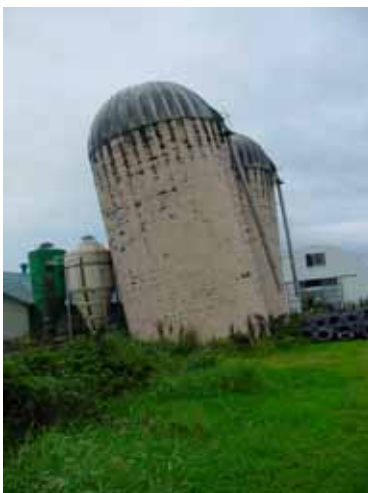
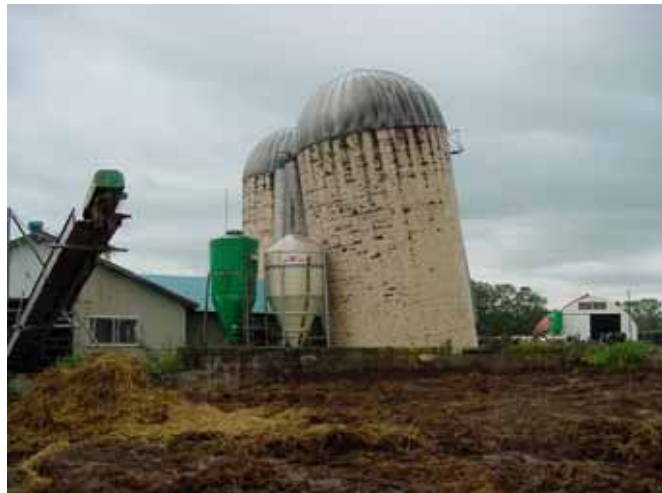
Shinyoshino: Differential settlement and tilting of silo; (C-1)
