LIQUEFACTION OF THE GROUND DURING THE 1978 MIYAGIKEN-OKI EARTHQUAKE

Ikuo Tohno* and Susumu Yasuda**

ABSTRACT

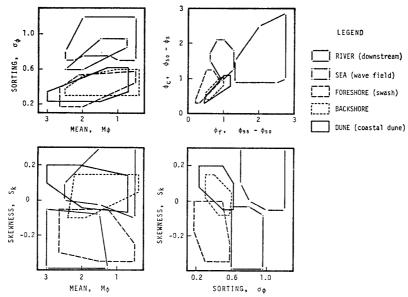
Fig. 12. Characteristic textural parameters of the present sand from Aomori Prefecture to Kagoshima Prefecture by Tohno (1979)

where d is grain size in mm and ϕ_x is the grain size, at x% coarser by weight. Correlation between the textural parameters from samples of the Japanese present sand is shown in Fig. 12. Here the encircled areas indicate the characteristics area of present sand for each sedimentary environment from Aomori Prefecture to Kagoshima Prefecture summarized by Tohno (1979).

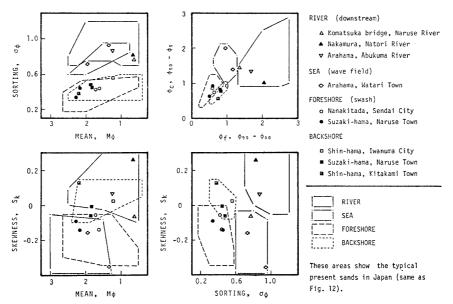
Fig. 13. Textural parameters of present sands in Miyagi Prefecture

Fig. 13 shows the grain size frequency distributions of the present sands in Miyagi Prefecture. This figure shows that the test results of all the samples in Miyagi Prefecture lie within their indicated encircled areas for each sedimentary environment (as shown

in Fig. 12). Therefore, the sedimentary environment can be inferred from these grain size frequency distributions.

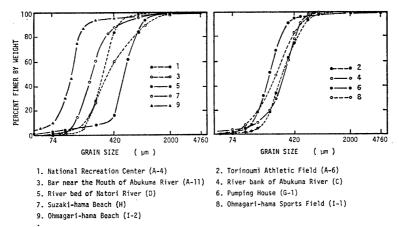
Fig. 14. Grain size distribution curves of liquefied sands by the 1978 Miyagiken-Oki earthquake

At the mouth of Abukuma River (Sites A and C), all the sand is fine-grained with a mean particle size, D_{50} , of approximately 0.3 mm (see Fig. 14). It can be judged that the liquefied sand at Torinoumi athletic field (Site A-6) is a marine sand, the one at National Recreation Center (Site A-4) is a beach sand, the one at a river dike (Site A-11) is a marine sand of wave field, and the one at a river dike (Site C) is a river sand of downstream by Table 3. It is considered that the liquefied sands at Site A-4 and Site A-6 are hydraulic fill consisting of marine and beach sands, as these sites are located within a reclaimed area (see Fig. 6).

As shown in Fig. 14, the liquefied sand at the Yuriage-Ohashi Bridge was a poorly graded coarse sand with a mean particle size, D_{50} , of 0.5 mm. This liquefied sand is judged to be a river sand by Table 3. Therefore, the depositional environment of the liquefied sand is the same as that for a surface deposit which lies on the river bed. Comparing the grain size distribution of the liquefied sand with those of the in-situ soils based on the sieve analysis by Iwasaki et al. in 1980, it can be concluded that the liquefied sand is similar to the sandy deposits encountered at depths ranging from 1.8 m to 3.0 m.

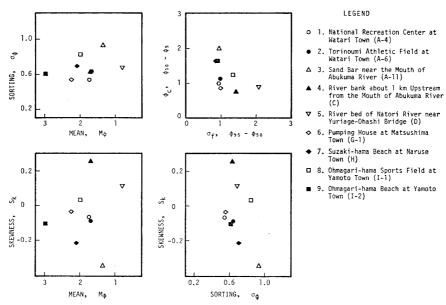
Fig. 15. Textural parameters of liquefied sands by the 1978 Miyagiken-Oki eathquake

It is attempted to infer the sedimentary environment of the liquefied sands from these grain size frequency distribution. The grain size distribution curves of liquefied sands by the 1978 Miyagiken-Oki earthquake are shown in Fig. 14. Textural parameters of liquefied sands were derived from Fig. 14 and are shown in Fig. 15. The sedimentary environment of the liquefied sands was deduced based on the characteristics patterns shown in Fig. 15 by Tohno's method (Tohno, 1979). One can estimate the environment of sedimentation of a

soil by superimposing Fig. 12 over Fig. 15. For example, all the open square symbols in Fig. 15 fall into the area enclosed by dashed lines, indicating that the soil is a river sand. The soil samples that can be identified in this manner are so indicated by circles in Table 3.
