2010年Chile, Maule地震

2010年
2月27日
Mw=8.8

現地調査を行った
のは2010年3月28
日~4月4日

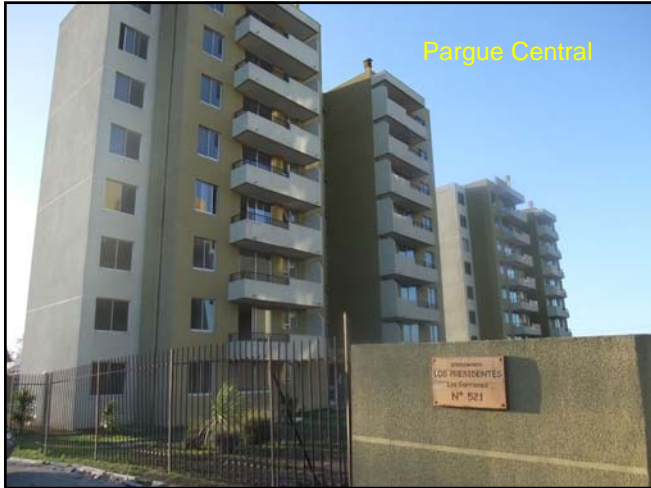
Parque Central

Damage due to liquefaction:
 Tilting of 8 story apartment building (Parque Central)
 One out of four apartment building was tilted by, possibly, liquefaction of backfill.
 The area was **swampy**.

For construction of foundation;
 •Native soft soil was excavated 4 m deep.
 •Well point method was used to lower the GW depth for compaction.
 •Backfill was compacted every 35 cm

•Splashed sands on the wall indicate occurrence of liquefaction
 •No glasses were broken
 •Buildings are not heavily tilted (0.77 deg) = Liquefaction was minor.

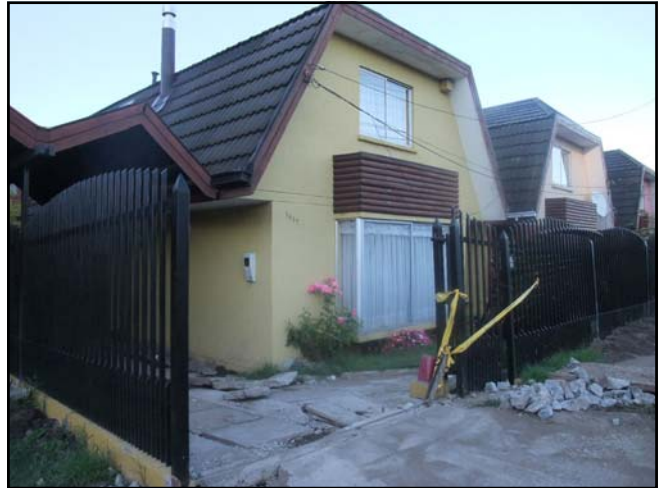
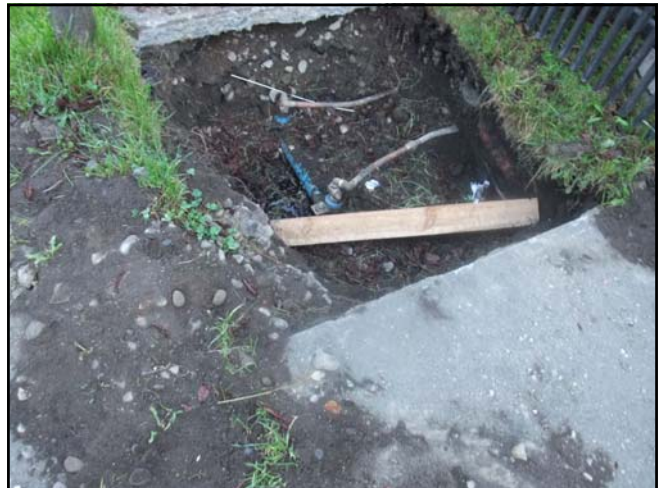
Uplift of sewage facility due to liquefaction of backfilled sand (San Pedro del Valle in Concepcion)

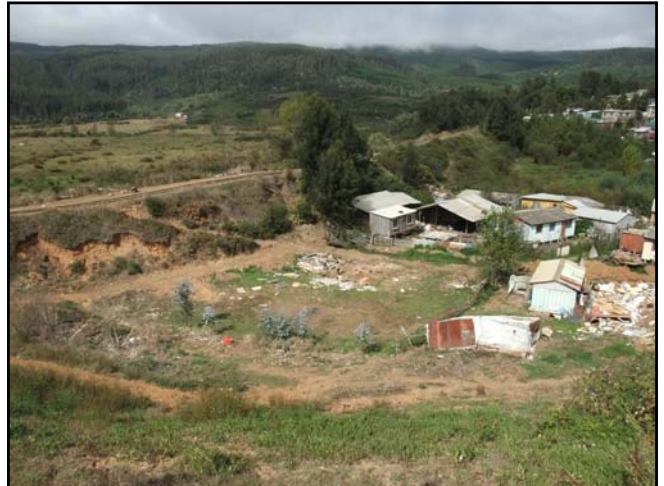
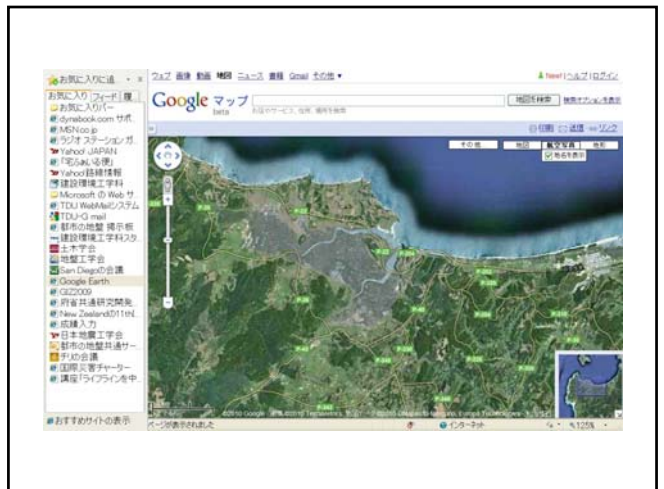
Damage to road embankments and bridges on soft clayey grounds

Summary of soil condition of failed road embankments

- (1) Filled on swampy ground
- (2) Surface soil is soft and clayey
- (3) Water table is shallow
- (4) Embankment material is clean sand in Lota Norte

RECOMMENDATION
 In design of road embankments

- (1) Improve the ground by cementation etc.
- (2) Appropriate slope angle
- (3) Selection of appropriate banking material

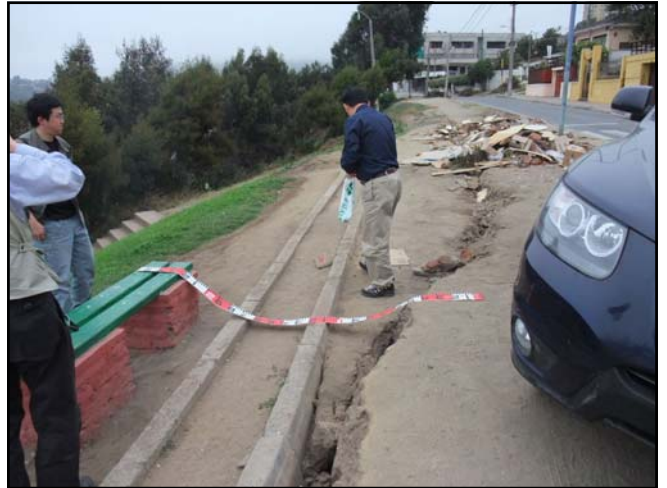
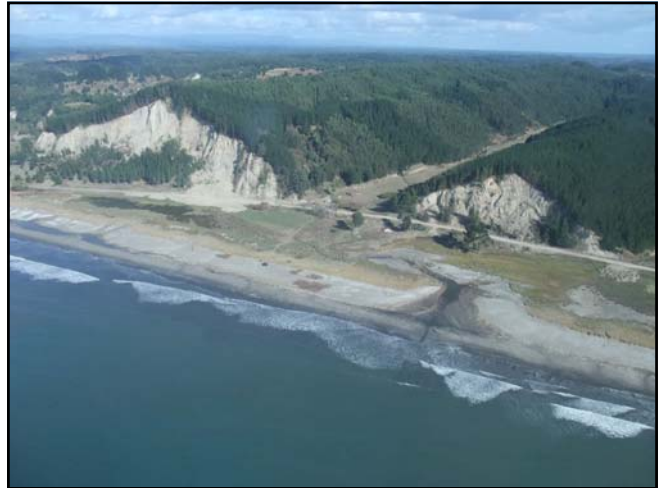
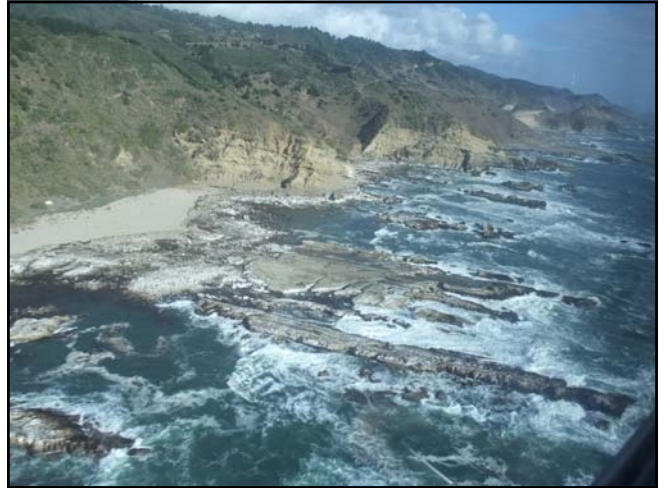
San Antonio
海岸段丘斜面の崩壊

Arauco
海岸の斜面の崩壊
