GEOTECHNICAL ASPECTS OF DAMAGE IN ADAPAZARI CITY DURING 1999 KOCAELI, TURKEY EARTHQUAKE

ABSTRACT

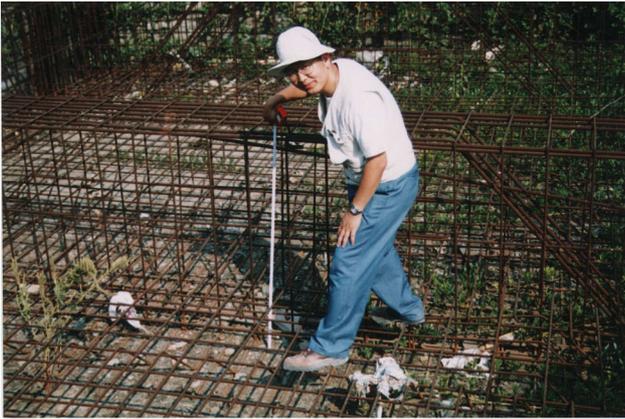
Almost all (more than 95%) of the RC buildings with 3 to 6 stories are spread foundation penetrating between 0.5 and 1.2 m under the ground. Photograph 2 shows an example of the arrangement of the reinforcing bars for the foundation beam. Two buildings are known to be a pile foundation and survived the earthquake damage. They are PTT Building (piles are 80 cm in diameter and 25 m in length; see Fig. 5(b) for location), and 2-story Parking Lot (locations not known). Agricultural Bank Building (shown as Ziaar Bank in Fig. 5(b)), has an underground floor, and therefore the spread foundation is about 4.5 m deep; it was not damaged. The relationship between the damage and foundation type is not known at present.

Photo. 2. Bar arrangement of foundation beam at Site A

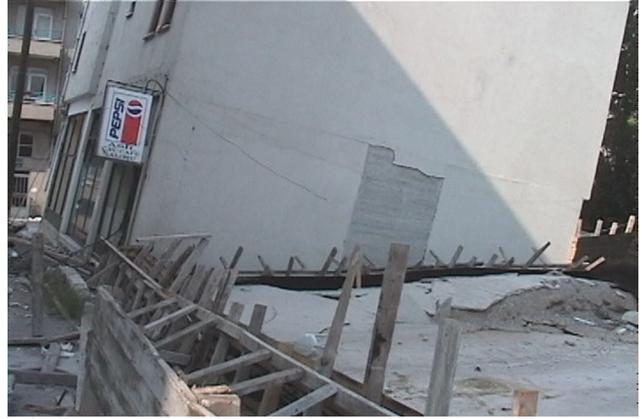
served around and between sunk or tilted building; examples are shown in Photos. 5, 6 (site C), 7 (site D) and 8 (site E). Thick deposited sand boils were observed between two buildings or between the crack of wall and heaved-up floor in some places; examples are shown in Photo. 9 for Site F. Sand boil was not frequently observed apart from at these and some other sites, although settlement and tilt were frequently observed. This damage seems to have been caused by soil liquefaction, but the reason why sand boil was rare is not clear, mainly because there is no borehole data. The term liquefaction will be used hereafter, however, although there is no clear evidence in the whole area.

Photo. 5. Heaving caused by settlement at Site C

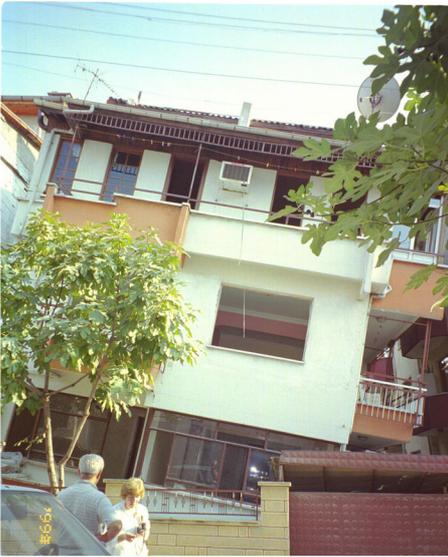
Settlement and tilt of buildings were frequently seen, as shown in Photos. 3 and 4, for example. Heaving, subsidence of the ground, and damage to pavement were ob-

Photo. 3. Tilted building at Site B

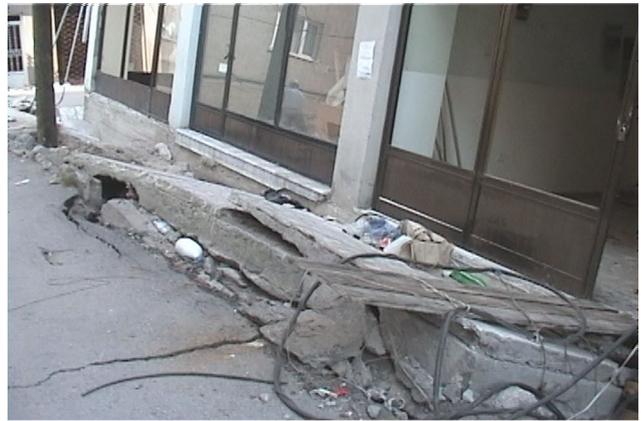
Photo. 6. Ground distress at Site C

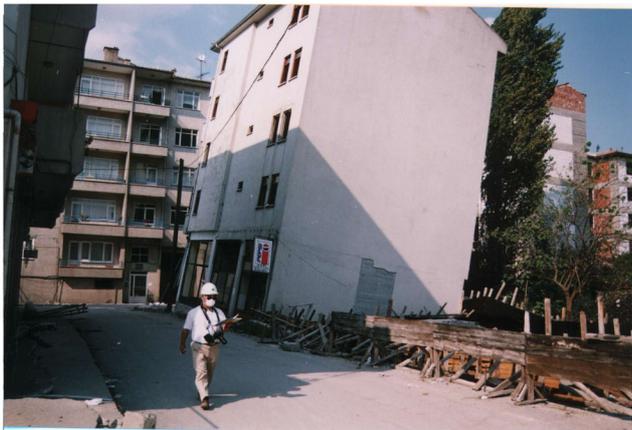
Photo. 4. Tilted building at Site C

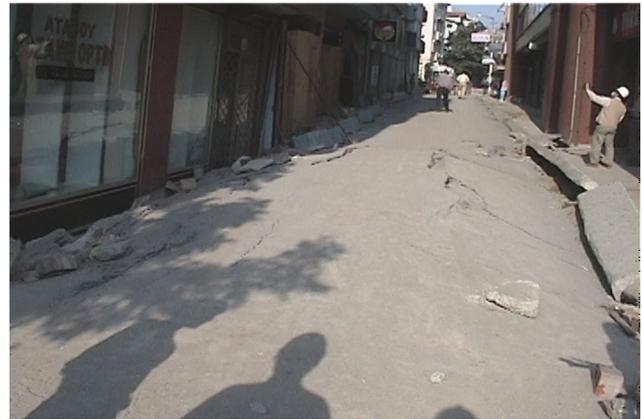
Photo. 7. Ground heaving at Site D

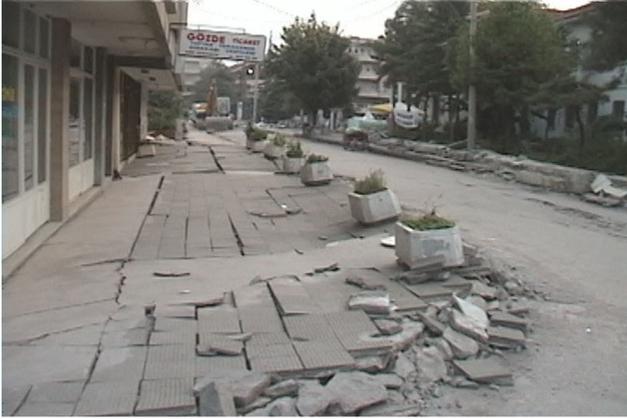
Photo. 8. Damage to pavement at Site E

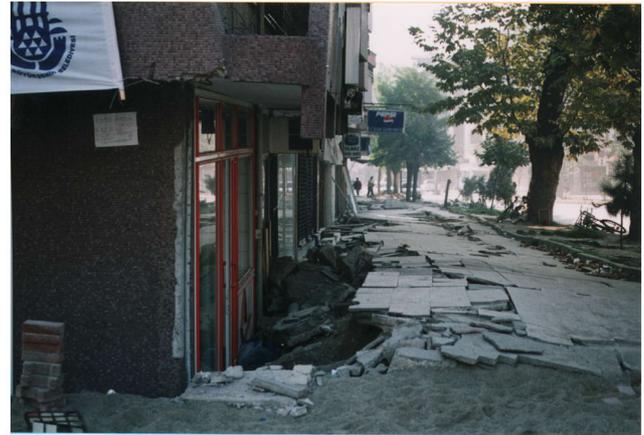
Photo. 11. Damage to building and pavement on the east side of Sakarya Cad. (Site H)

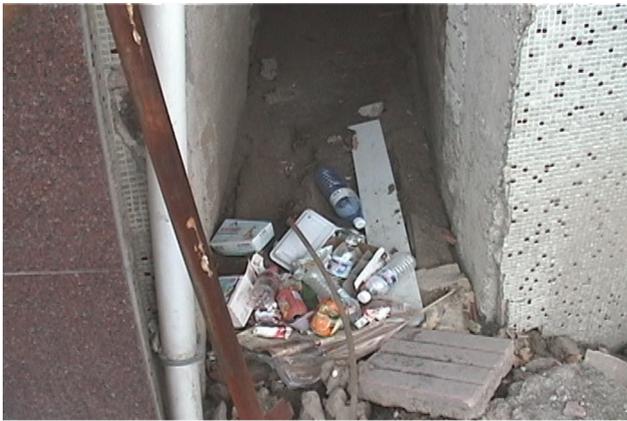
Photo. 9. Boiled sand between buildings at Site F

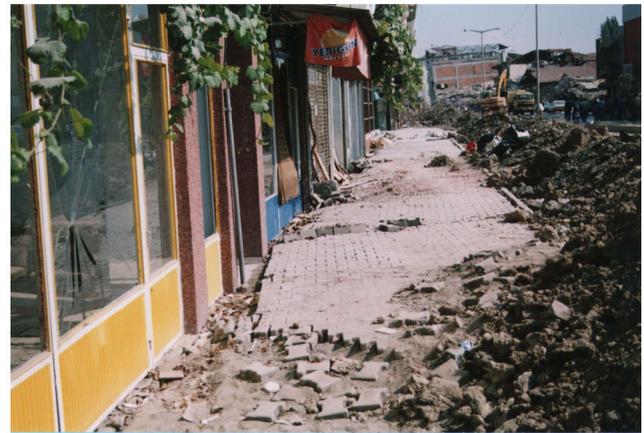
shown in Photo. 12 (site I). These areas are supposed to be old swamp or riverbed of the Sakarya River.

Photo. 12. Damage at Site I in Izmit Cad.

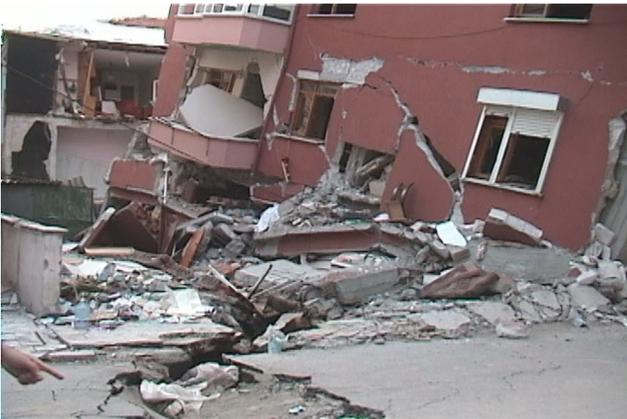
Several fissures run from southwest to northeast to the north of the Cark Cadesi (site G in Photo. 10), and the ground spreads laterally towards the southwest. Significant ground deformation was observed to the east of the Sakarya Cadesi, at Site B (Photo. 3) and Site H (Photo. 11). Settlement of the building and damage to pavement and road were significant along the Izmit Cadesi as

Photo. 10. Damaged by lateral spreading at Site G

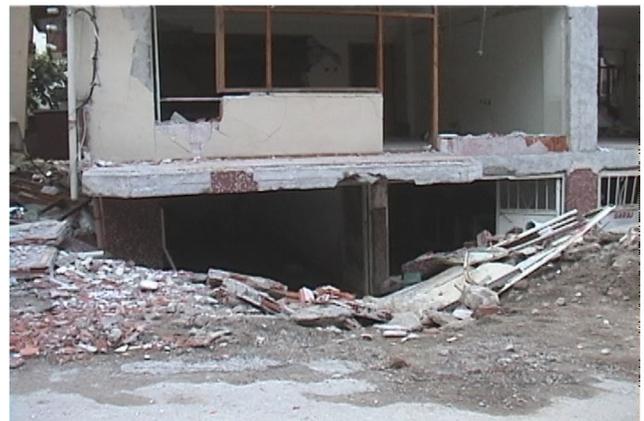
Photo. 13. Settlement of building at Site J

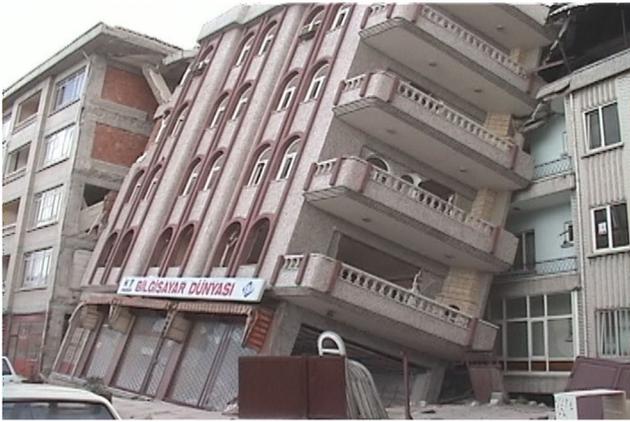
Buildings in the liquefied area may have tilted or sunk, but superstructure was seldom damaged. Buildings that tilt more than 2 degrees were frequently observed in the areas northwest of the fissures shown in Photo. 10, and east of the Sakarya Cadesi as shown in Photos. 3 to 4, and Photo. 13 (Site J). Damage to buildings due to leaning of the adjoining building was sometimes observed as shown in Photo. 14 (Site K).

Photo. 14. Damage to adjoining building by tilted building at Site K

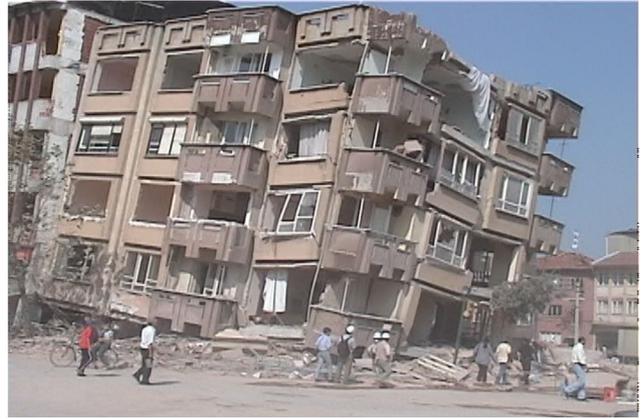
Photo. 17. Damage due to soft first story at Site N

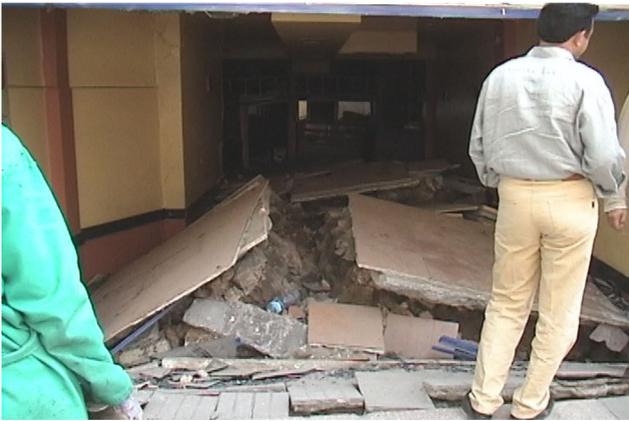
Settlement of buildings is relatively small in areas other than the above-mentioned area. A dense configuration of buildings, which may have a relatively larger foundation width in total, a thin liquefied layer, and large fines contents may be the reason. It is also worth mentioning that damage to the superstructure was small in buildings that sank and tilted, but floor slabs lifted and were damaged when no reinforcing bar was installed or when stiffness was low, as shown in Photo. 15 (Site L).

Photo. 15. Damage to floor slab by settlement of foundation at Site L

structures. Settlement was generally between 5 to 10 cm with several exceptions of SOG3S, SOG9S, and SOG10S whose settlements were more than 30 cm. Damage to the floor caused by lifted-up ground was significant, as shown in Photo. 15 for SOG9S and SOG10S. Both damage to superstructure and settlement and tilt of foundation were not observed for at least 100 m to the west from this point.

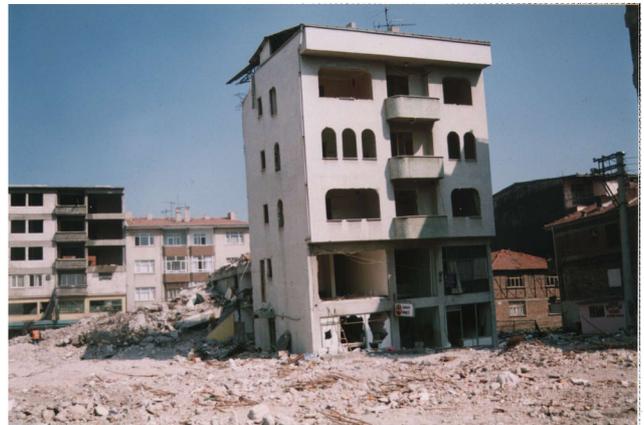
Photo. 18. Tilted building in demolished buildings at Site P

between the liquefied and nonliquefied areas and even inside the liquefied area, as shown in Photos. 14 (Site K) and 18 (Site O).

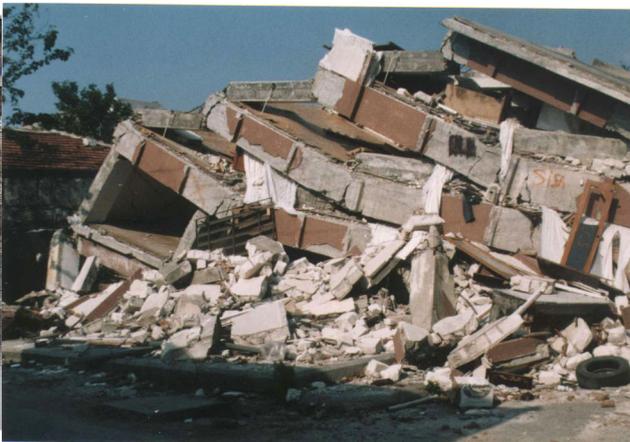
Photo. 16. Pancake crash of multi-stories at Site M

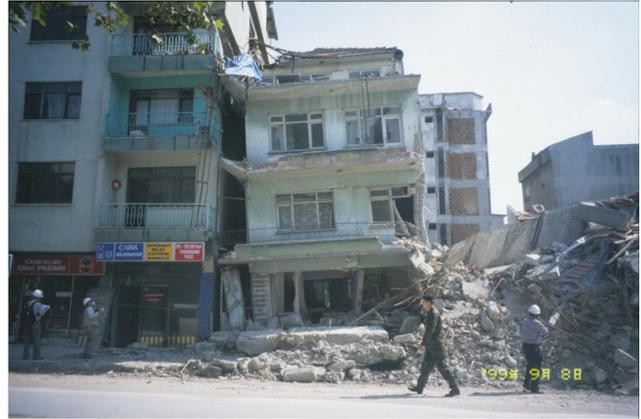
Photo. 21. Building leaning on adjacent building (KAM11)

ry buildings were completely collapsed. As shown in Fig. 9, buildings with less damage in structural members had a tendency to sink and tilt more. Buildings that were damaged because of the complete collapse of the neighboring building were also seen as shown in Photo. 21.

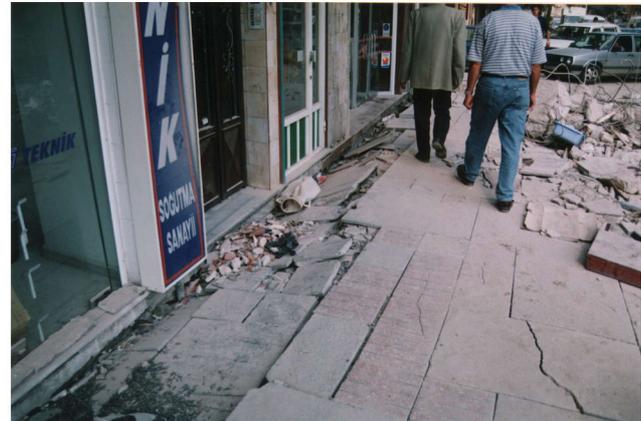
Photo. 22. Pavement around foundation on the north side of Cark Cad. (BOS5)

The damage pattern was quite different on both sides of the street from BOS4 to PAP9. Pavement was damaged in many places, as shown in Photo. 22, and many buildings sank about 10 cm, but damage to the su-

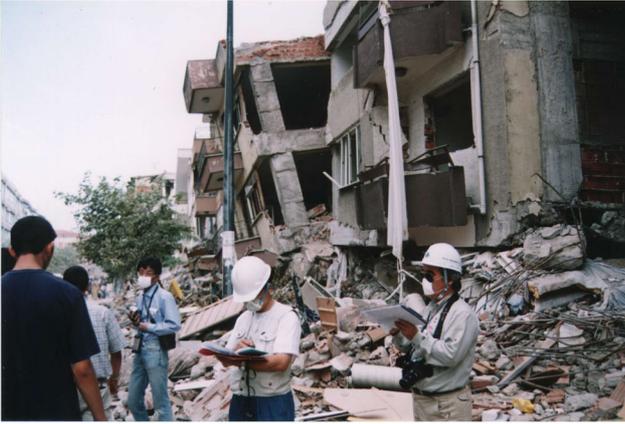
Photo. 23. Damage to buildings on the south of Cark Cad.

perstructure was hardly observed in the north side of the road. In contrast to this, buildings collapsed because of the first story failure, as shown in Photo. 23. Settlement was sometimes difficult to evaluate because the ground surface was covered with collapsed material, but it seemed not to have occurred. Collapse of this kind continued to the building in front of PAP9 along Line 1.

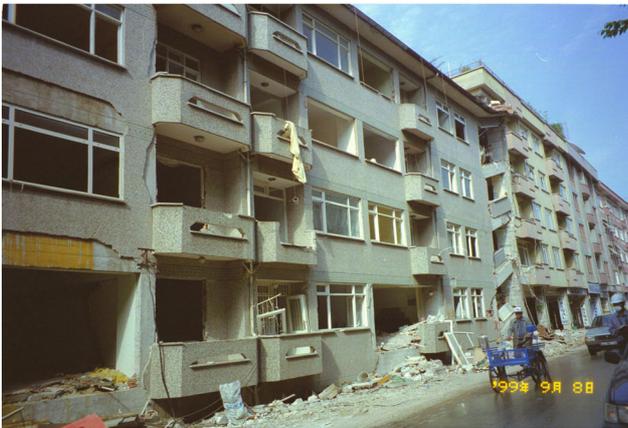
Photo. 24. Damage to building on the north side of Cark Cad. (KAN10)

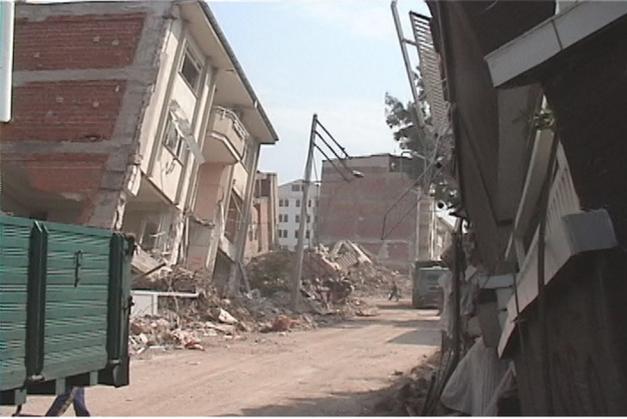
Buildings from MEL1 to BOS5 that were located along the western side on the Fabrika Cadesi were classified as grade 5 damage except for one wooden house. They completely collapsed (pancake crash) or collapsed due to failure of the first story that has wide openings. This area is one of the most significantly damaged areas and many buildings collapsed, as shown in Photos. 25 and 27.

Photo. 27. Damage to building on Fabrika Cad. (MEL6)

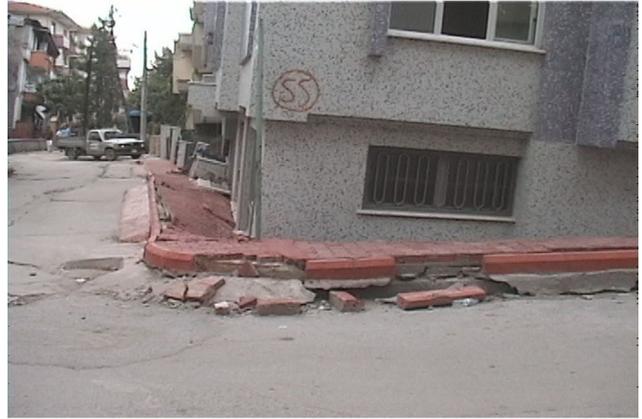
Photo. 29. Settlement of building (ATA12)

The damage pattern suddenly changed when entering the liquefied area after passing the Sakarya Cadesi. Buildings with 4 to 6 stories sank from several tens of centimeters to 1 meter, and tilted significantly, as shown in Photo. 29. Road and ground between the buildings lifted up and cracks appeared in many places. Photograph 30 shows the lift-up of ground between ATA11 and ATA12. A 4 story building (ATA13) that was located at the intersection between Line 2 and Line 3 tilted 60 degrees and sank up to 3 m, as shown in Photos. 31 and 32. Tilt of this building was 30 degrees in the morning of the day after the earthquake, and it took about 10 days to tilt another 30 degrees. Tilt stopped when it fell on the adjoining brick fence and building. Settlement and tilt became smaller east from this point.

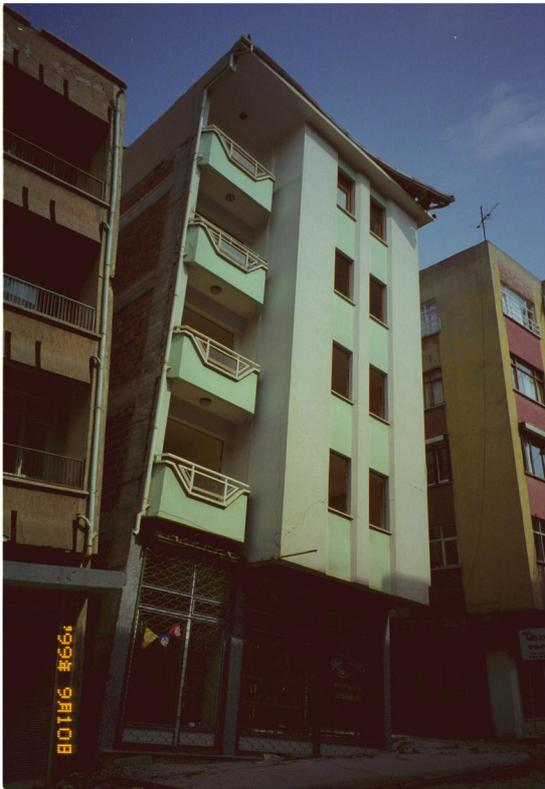
Photo. 28. Tilted building on Fabrika Cad. (BSN10)

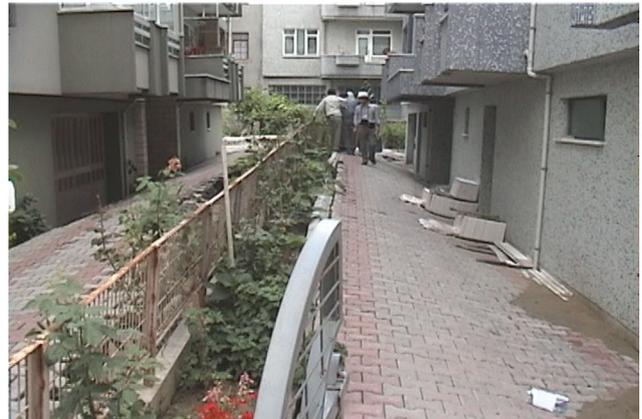
Photo. 30. Heaving between buildings (ATA11-12)

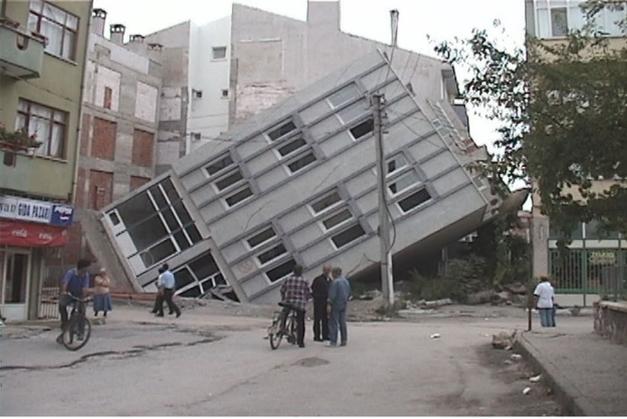
Photo. 31. Overturned building (ATA13)

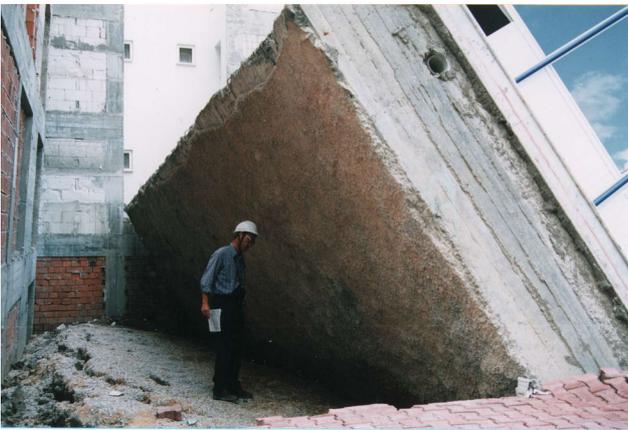
Photo. 32. Exposed foundation of ATA13

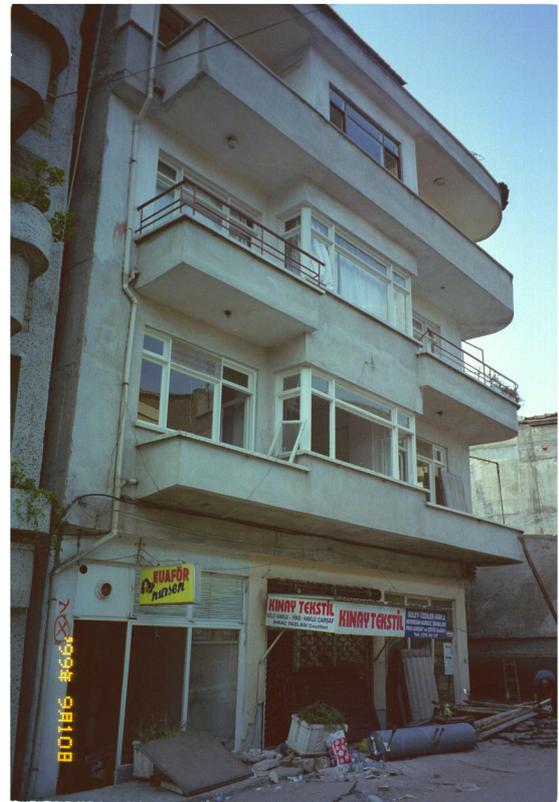
Photo. 35. Settlement of building (PEP2)

Eleven RC buildings from ELC1 to PEP7 sank 5 to 35 cm and tilted 0 to 2 degrees (Photo. 35), apart from two buildings. Damage to superstructure was not observed for the sunk building. Two exceptions were 2 story and 3 story wooden houses, among which a 3 story house was about to collapse, as shown in Photo. 36. Settlement was not observed in these wooden houses.

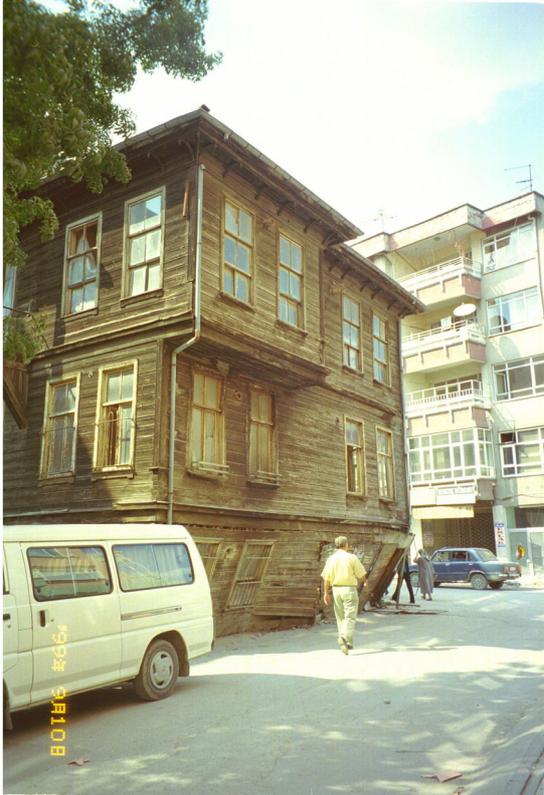
Photo. 36. Damage to wooded houses (PEP7)

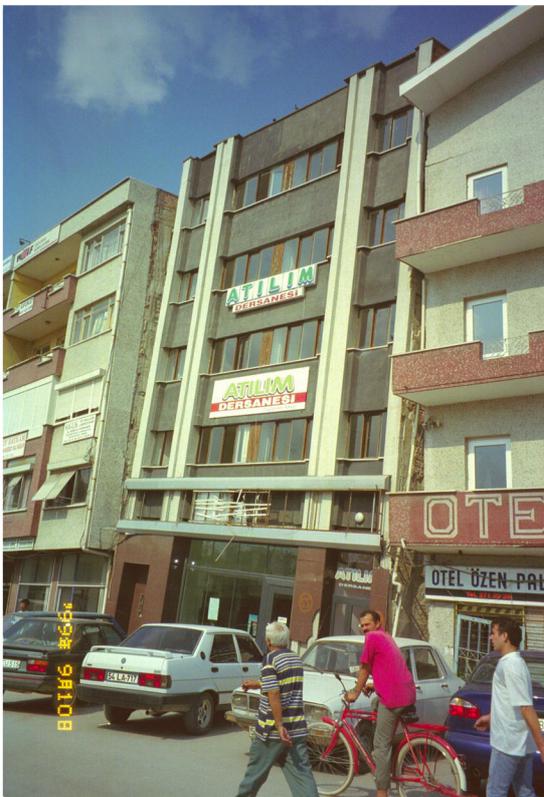
Among buildings from ECZ1E to ECZ11 along the Ankara Cadesi, 5 story RC buildings sank 5 to 60 cm and tilted 3 to 4 degrees at maximum, as shown in Photo. 37. Settlement was not observed, on the other hand, for light 1 story buildings and 3 story wooden buildings, although one 3 story wooden building was about to collapse. After crossing the Ankara Cadesi, buildings between ANK1E to ANK8E did not sink nor tilt, apart from one building. Instead of settlement and tilt, weak buildings that were damaged in the superstructure were frequently seen.

Photo. 37. Tilted buildings (ECZ9E)
