DAMAGES ON WATERFRONT GROUND DURING THE 1999 KOCAELI EARTHQUAKE IN TURKEY

ABSTRACT

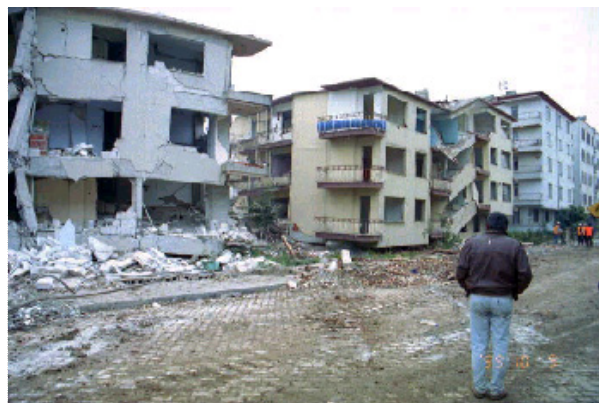
Photo. 1. Damaged summer houses in Yalova

quent figures, hollow arrow symbols are locations where photographs were taken and the number denotes the photograph number. Totally collapsed buildings were frequently seen in heavily damaged areas, a typical example is shown in Photo. 1. On the contrary, geotechnical damage was small even along the shorelines. The only exception was a differential settlement in the rockfill breakwater near the ferry terminal.

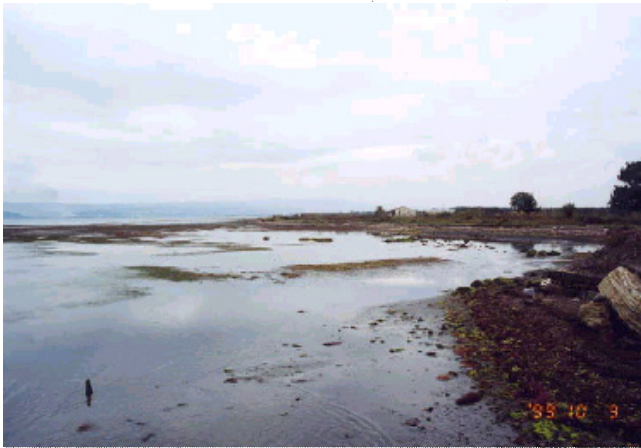
There was a lagoon in the east of the Helsek district, Altinova Peninsula, whose location is shown in Fig. 3. This lagoon waterlogged only in high tide before the earthquake, but became to waterlog all the time after the earthquake, as shown in Photo. 2. Subsidence occurred mainly in this lagoon. A maximum subsidence have been of the same order as the tidal range, i.e., several tens cm at maximum. Evidence of liquefaction such as a sand boil was not observed in this region. The reason of the subsidence is not clear at present.

Photo. 2. Subsided lagoon in Hersek

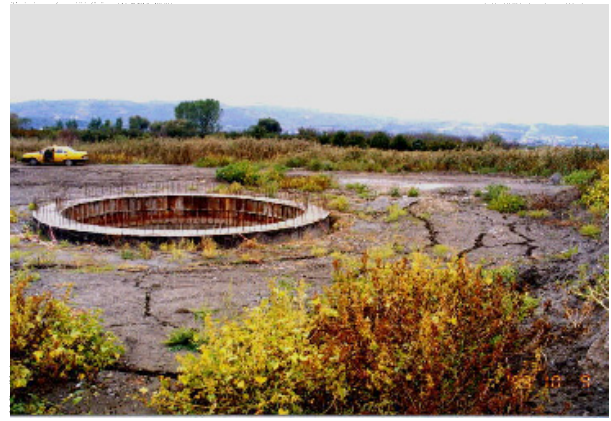
Photo. 3. Cracks near the circular diaphragm wall

parallel to the river were also seen as shown in Fig. 4 and Photo. 3, and blue colored sand boils were observed on the side opposite to the river. The pit seemed to move toward the river probably because the ground had become loosened by soil liquefaction.

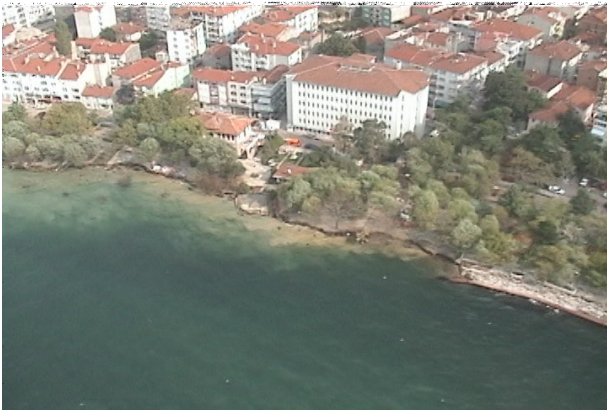
A fill area of about 200 m long and 25 m wide flowed out into the sea at the eastern end of this map. Details of this area are shown in Fig. 6 and Photo. 4. This fill was developed in 1968. Many cracks ran parallel to the shoreline on the rest of the fill and a little on the natural deposit. According to an interview with a resident, the seabed was about 100 m deep and the slope of the seabed was steep. The value of 100 m seems unlikely, so this report probably just indicates a deep and steep seabed. The section face of the remained part is shown in Photo. 5; the section is vertical. Considering the original deep and steep seabed and observation of damage, slope instability is supposed to have occurred here. Damage to buildings in the background was light.

Photo. 4. Aerial view of flowed-out shoreline at Karamursel

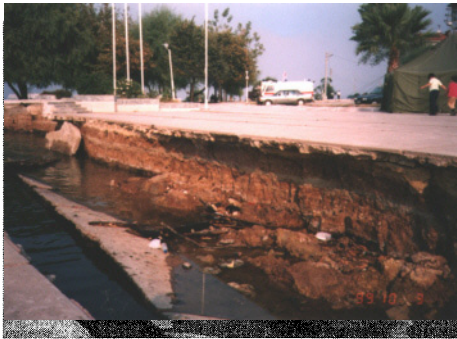
Photo. 5. Face of the rest of flowed-out ground

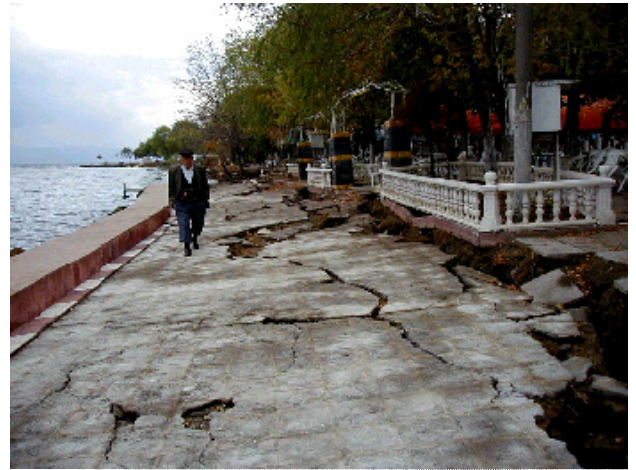
Cracks parallel to the shoreline were also observed at the park just west of the above flowed out area. Subsidence of the ground was also observed here, as shown in Photo. 6, which indicates that this area was just going to flow out. According to the residents, these cracks appeared at the mainshock. Then, they enlarged and the ground movement occurred at the maximum aftershock.

Photo. 6. Subsidence of the ground with cracks parallel to the shoreline

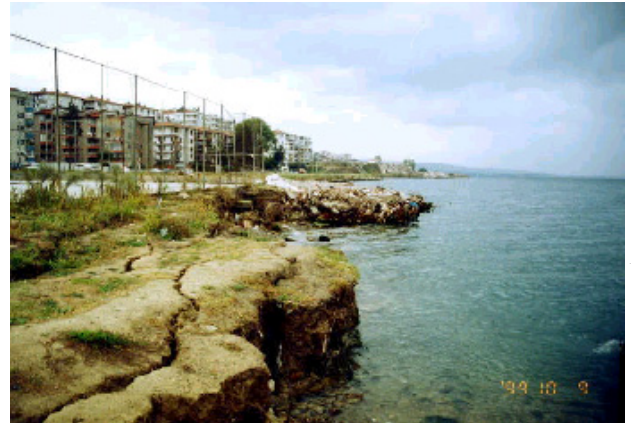
Flowed out ground was also observed in the western part of Fig. 5, as shown in Photo. 7. Reinforced concrete quay wall tore off at the boundary to the remained portion. In addition, cracks parallel to the old shoreline were frequent in the backfill ground. Sand boils were also observed. They did not, however, seem to be a cause of the flow in the fill. According to a interview of fishermen,

Photo. 7. Flowed-out area on the west of Karamusel

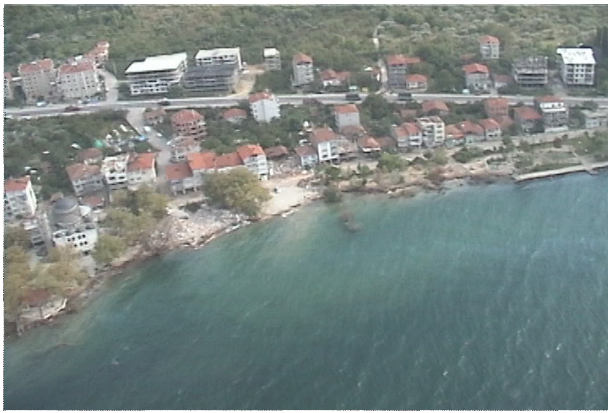
An area about 300 meters long and 40 m wide flowed out into the sea in the Ulasli city, as shown in Fig. 7 and Photo. 8. Most of the park was fill with the crashed rock taken from nearby mountains. The stone masonry quay wall was developed in 1986. Several cracks were observed in the backfill ground, which ran parallel to the shoreline. Evidence of liquefaction was not observed.

Photo. 8. Aerial view of flowed-out area in Ulasli

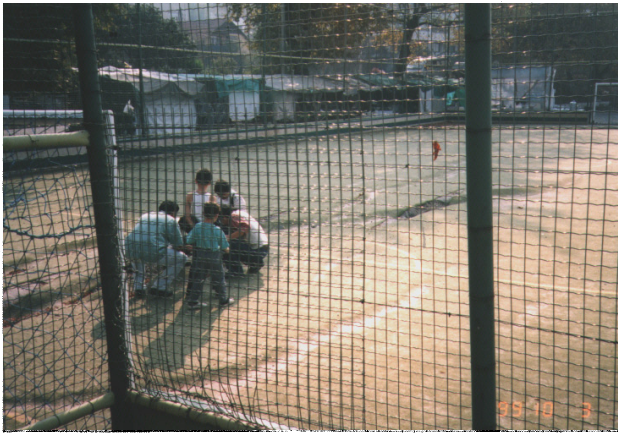
Photo. 9. Crack parallel to shoreline on the football field

area. Large cracks opened and ran parallel to the coastal line, as shown in Photo. 9, but water or sand spouts were not found on the ground surface. A sum total of crack widths reached 2.5 m; therefore, the quay wall moved toward the sea more than 2.5 m, although it did not seem to be seriously damaged.

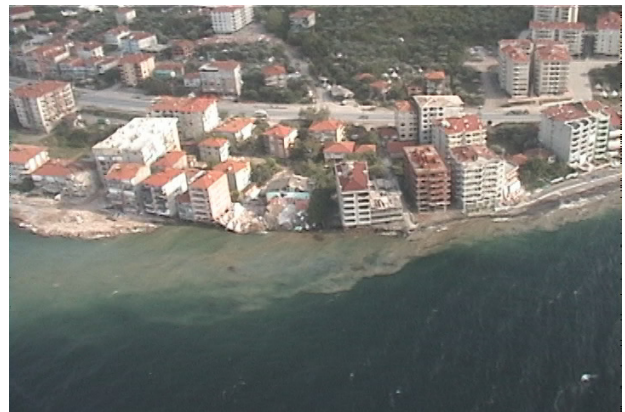
Photo. 10. Aerial view of flowed-out shoreline at Halidere district

A piece of the north region about 200 m long and 20 m wide disappeared into the sea in the Halidere city, as shown in Fig. 8 and Photo. 10. The road broke as shown in Photo. 11, in which photographs taken before and after the earthquake are compared. A stream ran on the west of the damaged area, and the slope of the river is fairly steep at 6.5 degrees. This region is again supposed to be a fan deposit.

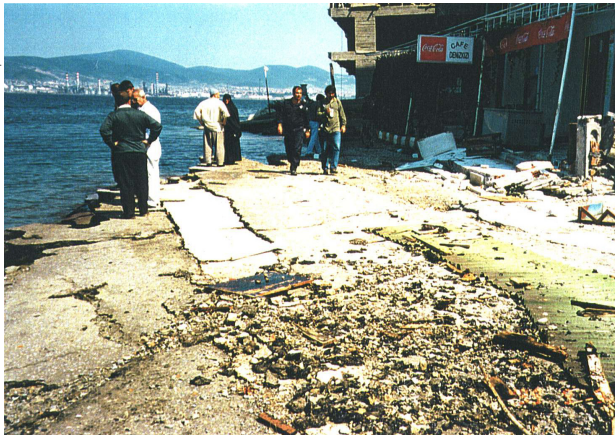
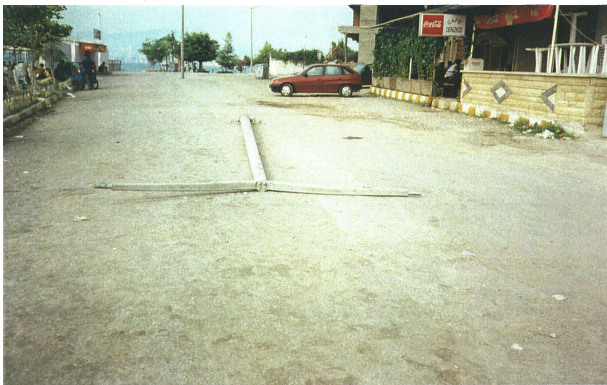
Photo. 11. Change of road before and after earthquake: (a) Before earthquake, (b) After earthquake

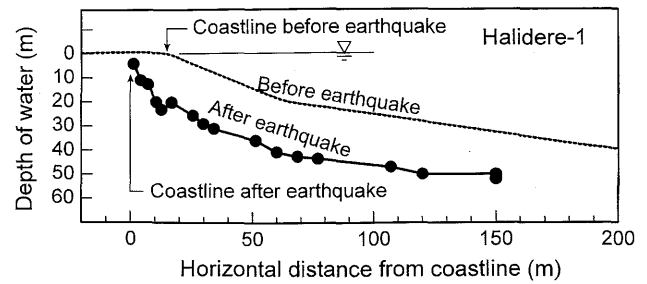
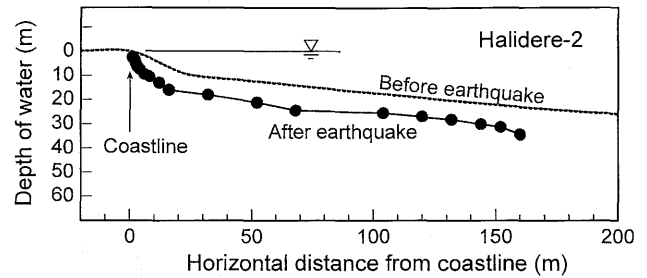
contour (Turkiye Marumara Denizi Izmit Limani, 1995), which was read off from the contour map of a seabed. Shapes of the seabed were changed drastically by the earthquake. A 20 m thickness of surface soil was lost along the line Halidere-1. It is also noted that the shape of the seabed is very steep, more than a 0.5 slope up to about 50 m from the shoreline. Surface soil was also lost by about 10 m thickness even along the line Halidere-2 where the ground was not lost. The slope is about 0.2 except close to the shore, which is also steep although it is

Fig. 10. Depth of seabed before and after earthquake in Halidere: (a) Halidere-1 line, (b) Halidere-2 line

a little gentler than the slope at the line Halidere-1. Change of seabed depth was also confirmed by an interviewing residents. A submarine landslide was supposed to have taken place in the wide area, and a huge mass of soil was taken away from the coastal region.

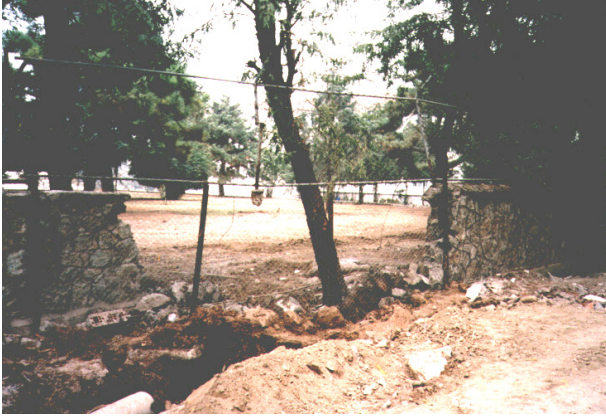
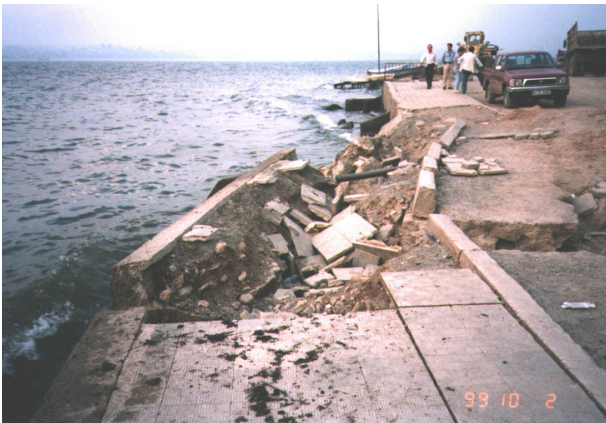
Photo. 12. Fault dislocation-induced damage in Degirmendere:
(a) Stone masonry fence, (b) Quay wall

cation with a relative horizontal displacement of 1.5 m in the east-west direction and 4.3 m in the north-south direction, as shown in Photo. 12(a), at the east end of the city, which is located at a boundary to the Golcuk Navy Base. This fault ran in the east-west direction and caused damage to buildings and houses along the line although the magnitude of the offset seemed smaller. A quay wall was damaged at the west end of the fault, as shown in Photo. 12(b). Then it vanishes into the Izmit Bay. This fault is supposed to be a main fault because its dislocation was in a right-lateral way, and it is on the line along the main fault in the Izmit city.

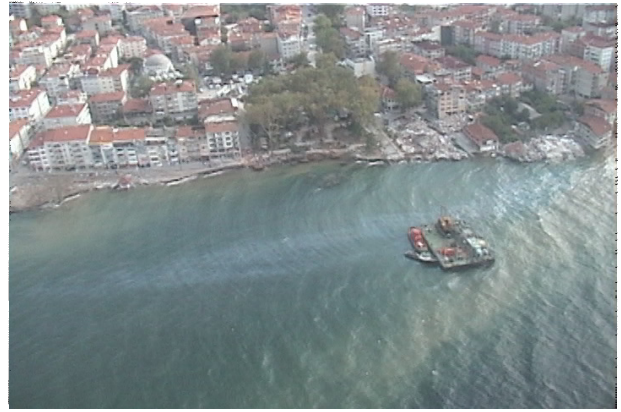
A coastal land about 100 m wide and 300 m long was lost into the sea in the west of the downtown, as shown in Fig. 11 and Photo. 13. There were a 4-story hotel and several buildings used for restaurants, etc. before the earthquake, but they flowed out into the sea with the land. Location of these buildings at present is still not known one year later, which suggests a huge mass movement into the sea. Buildings behind the lost area tilted

Photo. 13. Loss of coastal land in Degirmendere

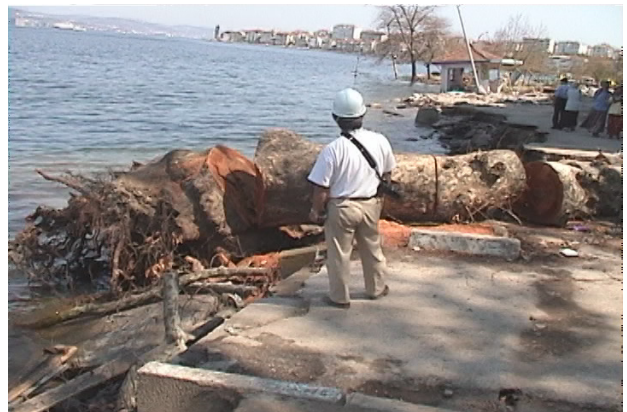
Photo. 14. View of flowed-out area. A thick-trunked tree indicates that this area is not a young fill; similar trees were frequently seen nearby.

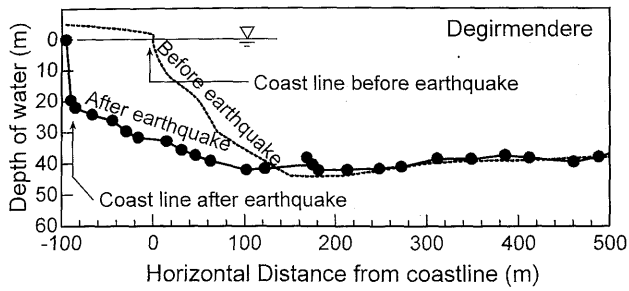
Sea depth was measured in the same way as Halidere in the direction shown in Fig. 11. The result was compared with the pre-earthquake seabed in Fig. 12. The original seabed was steep; the slope was about 0.16 in average up to 250 m from the original shoreline. The change of seabed depth reached about 20 m near the shore, and is about 10 m even 300 meters offshore from the current shore, which implies a huge submarine landslide in the sea. A simple extrapolation of the fault line at the east of the city suggests that the fault runs at 350 to 400 m off the coast. This distance is approximately the same as the distance where the seabed depth did not change after the earthquake. Fault dislocation, therefore, may affect the submarine landslide.

Fig. 12. Depth of seabed before and after the earthquake in Degirmendere

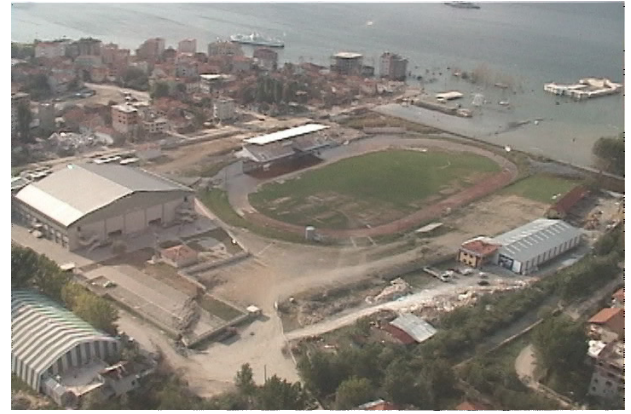
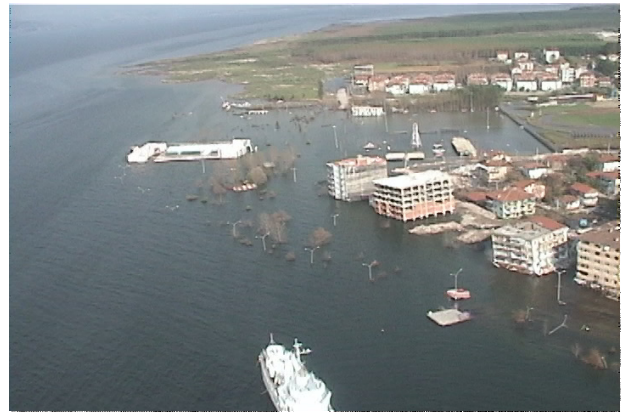
Area northeast of the fault subsided, as shown in Photo. 15, which may be related to the vertical offset of the fault. The original flat land tilted slightly toward north; daubed terrain in Fig. 13 is a submerged area at high tide. A swimming pool and a Ferris wheel were submerged all the time, whereas the Ataturk stadium, which was located closed to the fault, waterlogged only at high tide, as shown in Photo. 15(a). Walls, street lamp post, and woods, etc. stood almost vertical as shown in Photo. 15(b), which suggests that subsidence occurred slowly keeping the level ground.

Photo. 15. Aerial view of subsided area: (a) View to northwest direction, (b) View to northeast direction

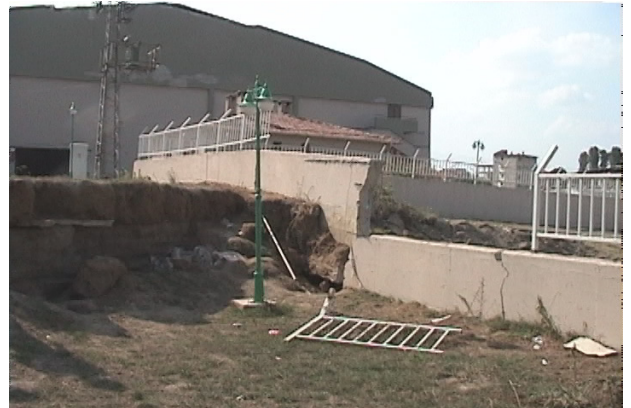
Photo. 16. Vertical dislocation of a branch fault

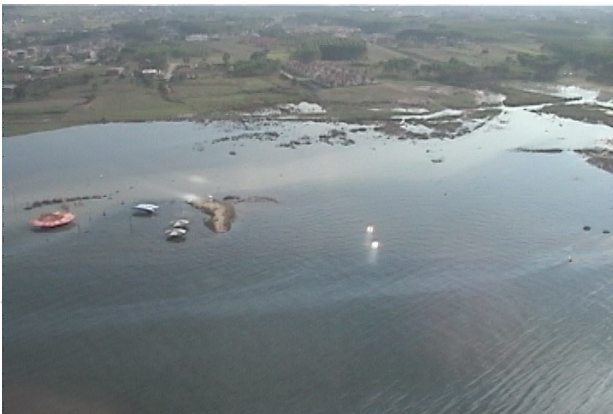
Photo. 17. Subsided ground on the east of Golcuk

Subsidence of the ground was continuously observed from Golcuk to the east along the shoreline for more than 10 km, as typically shown in Photo. 17.

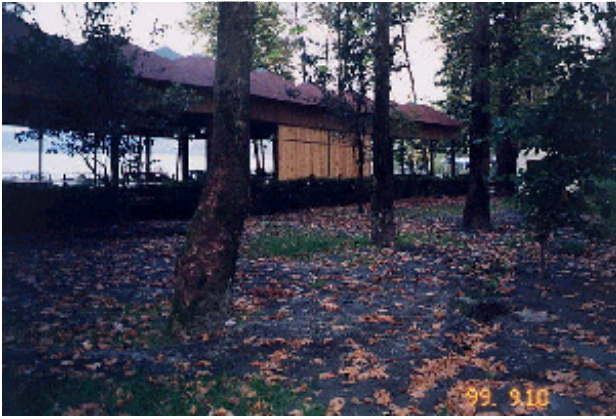
Traces associated with the liquefaction were widely found in the yard. There were many cracks running parallel to the lakeside and significant amount of sand boiled through Photo. 18 cracks. Photograph 17 shows the ground covered by boiled sand; almost all the ground is covered by boiled sand although it may be difficult to

Photo. 18. Sand boils in the yard of Sapanca Hotel

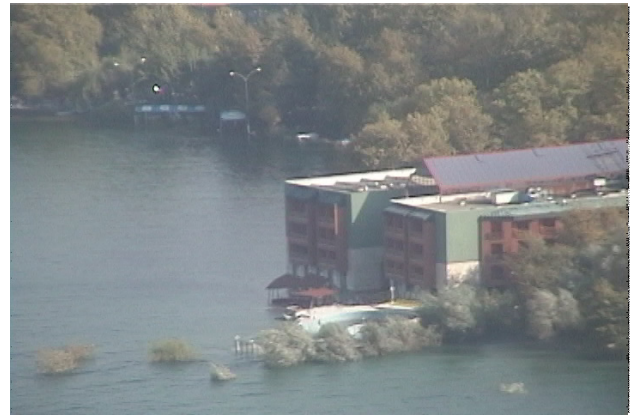
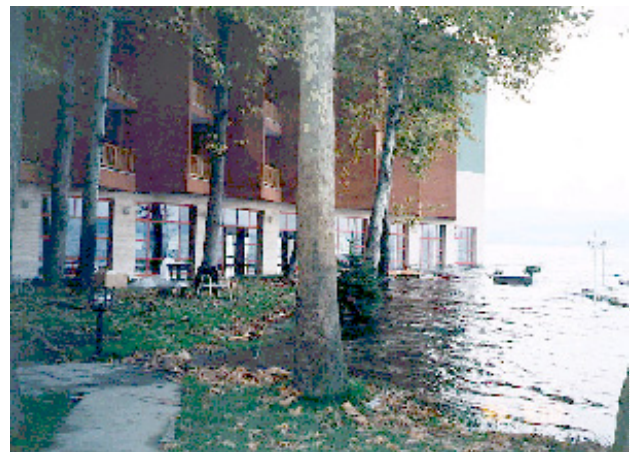
The Sapanca Hotel was set up in 1958 on the alluvial ground, which was the eastern wing of the current hotel. According to the hotel manager, the building settled during the earthquake of 1967 and was repaired after the earthquake. Then, a new building and an atrium, which connects two buildings, were built. The north of the hotel was filled for 20 m wide in 1983, which were also submerged, as shown in Photo. 19(a).

This building settled relative to the ground, and about a half of the hotel submerged, as shown in Photo. 19(b) and Fig. 15. Offset of about 20 to 30 cm was induced between each structural element, i.e., an old building, a new building, an atrium, and an entrance.

Photo. 19. Damage to Sapanca Hotel: (a) Aerial view. Settlement of the building and subsidence of fill and natural deposit occurrence, (b) Settlement of building

The total amount of the settlement of the building can be evaluated roughly 1.5 m. On the other hand, settlement of the building relative to the ground surface is several tens cm, as shown in Fig. 15, in which relative settlement at the corner of the building is written in parentheses. Therefore, the ground itself is supposed to have subsided for about 1 m, as easily seen in

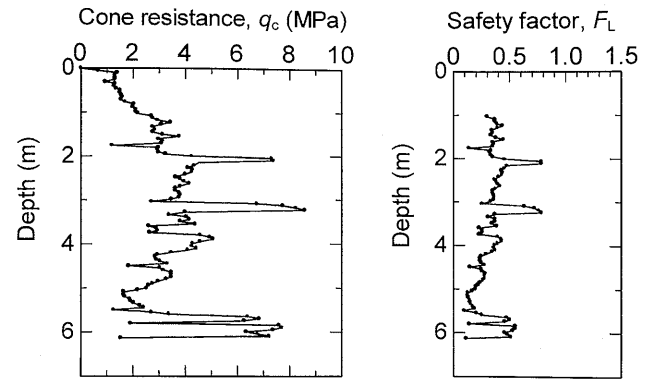
A soil test was carried out at point C in Fig. 15. A grain size distribution of the boiled sand in the yard is shown in Fig. 17. It is well-graded sand with fines contents less than 10% and a mean diameter of about 0.6 mm. Figure 18(a) shows the result of the cone penetration test. A thickness of the loose layer whose cone penetration resistance q_c is less than 4 MPa is about 6 m. A safety factor against soil liquefaction, F_L , is computed by a simplified method, i.e., to compute a ratio of liquefaction strength to the maximum shear strength during an earthquake. Liquefaction strength is evaluated based on Shibata et al. (1988), and a maximum shear stress caused by a ground shaking is evaluated by a method of Yoshimi and Tokimatsu (1983). The peak acceleration on the ground surface is assumed 400 cm/s^2 , referring the peak acceleration of the observed record near the site. The result is shown in Fig. 18(b). The F_L value is smaller than unity in all layers, and less than 0.5 for almost all depths. This indicates that significant liquefaction occurred at this site.

Fig. 18. CPT test result and evaluation of liquefaction potential: (a) CPT test result, (b) Safety factor against liquefaction
