Mr. Yuminamochi's photographs depicting ongoing liquefaction disaster
during the 1964 Niigata earthquake
1964 年新潟地震に際して液状化発生と震災直後の市内の状況を映像記録した
弓納持福夫氏の業績

Ikuro Towhata¹, Nozomu Yoshida²

ABSTRACT

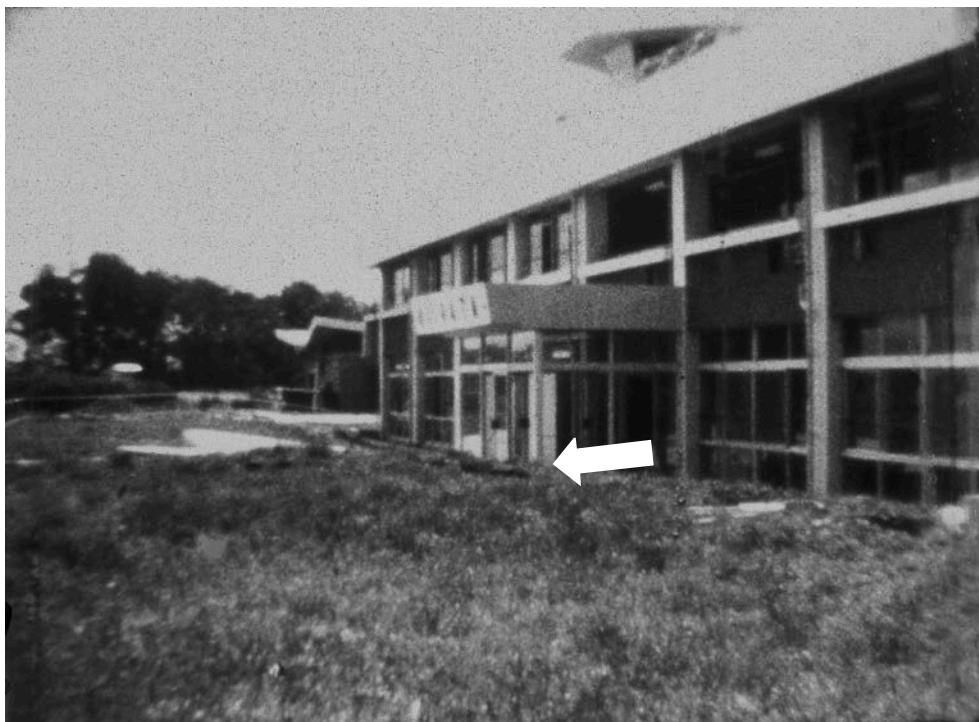
Fig. 6. First scene of Mr. Yuminamochi's motion picture in which sand ejection has not yet started with an arrow suggesting heaving of ground surface 液状化
動画の冒頭部、まだ噴砂は始まっていない、矢印は地表の膨張らしき状況を示す

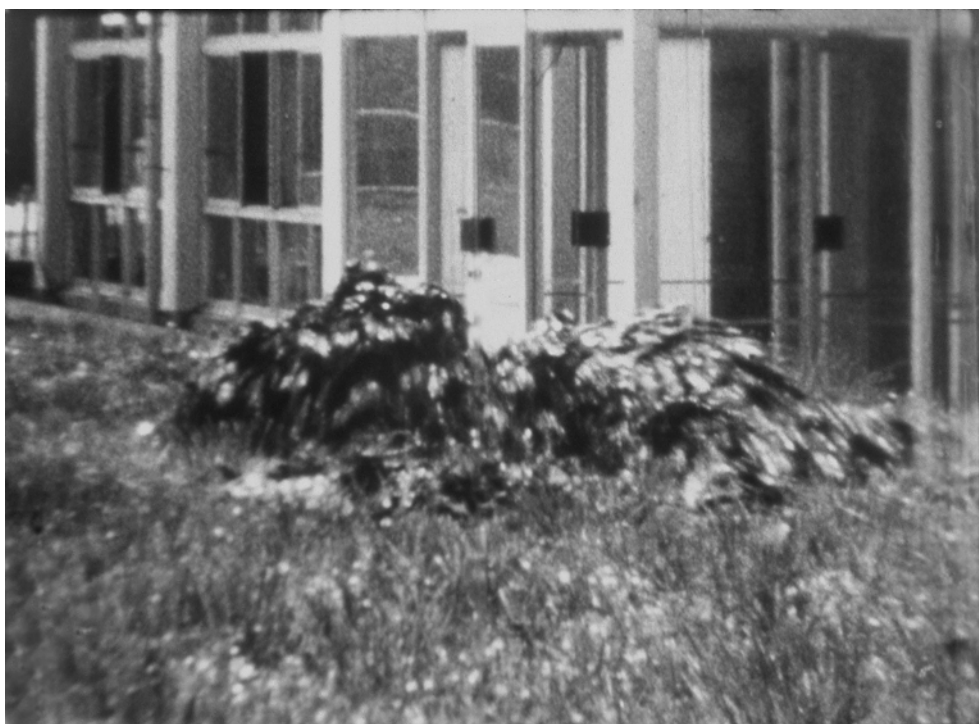
On the other hand, Mr. Yuminamochi was staying in front of the terminal building (Fig. 3) when the ground shaking started. He could not stand up under strong shaking and squatted on the ground. He felt that the shaking was slow and large as if staying on a floating island. He then realized that he had to record the disaster as a professional and prepared one of his still cameras (Fig. 4). Nothing was happening around the terminal building. Then, suddenly people rushed out of the building (Fig. 5), shouting that the building was sinking. Two still photographs were taken and Mr. Yuminamochi realized that taking still photos required film setting and many time-consuming procedures. To record more information within a short time, he decided to take a motion picture. This was the time when sand ejection started in front of him. Figs. 6 to 11 were captured from the motion picture. In Fig. 6, ejection is not yet visible but probably a part of black color shown by an arrow indicates the beginning of ejection. It became clear and impactful quickly in Fig. 7.

Fig. 7. Beginning of ejection of sand and water in front of the terminal building (captured from Mr. Yuminamochi's motion picture) 噴砂噴水の始まり

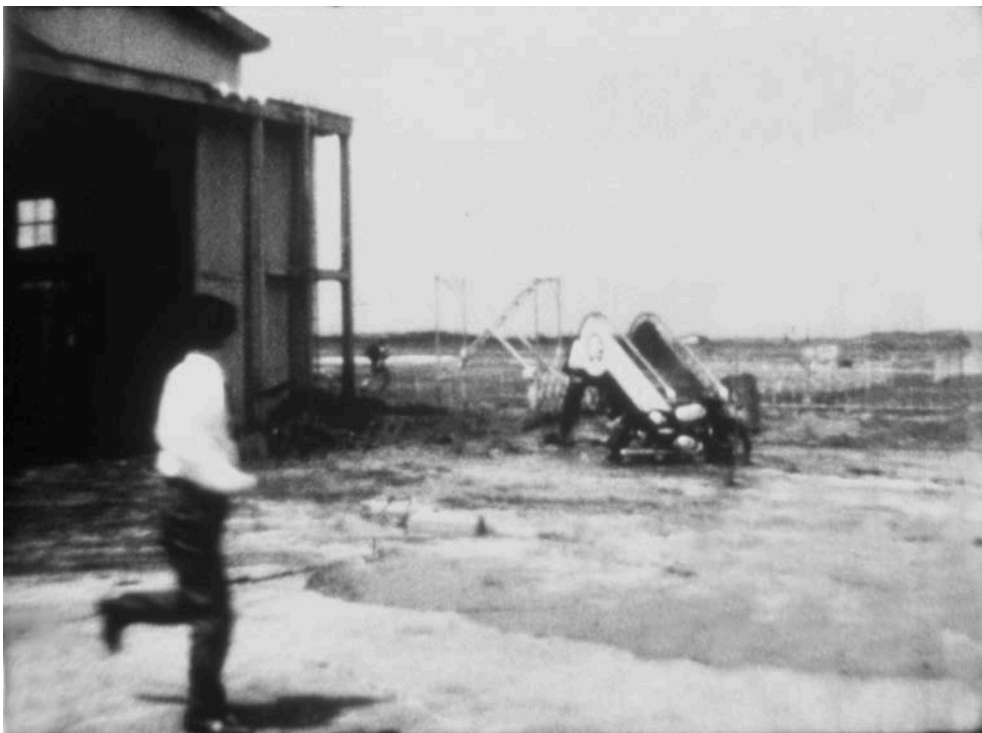
Fig. 9. Ejected water spreading into the airport apron (1) (captured from Mr. Yuminamochi's motion picture) エプロンに広がる噴出水(1)

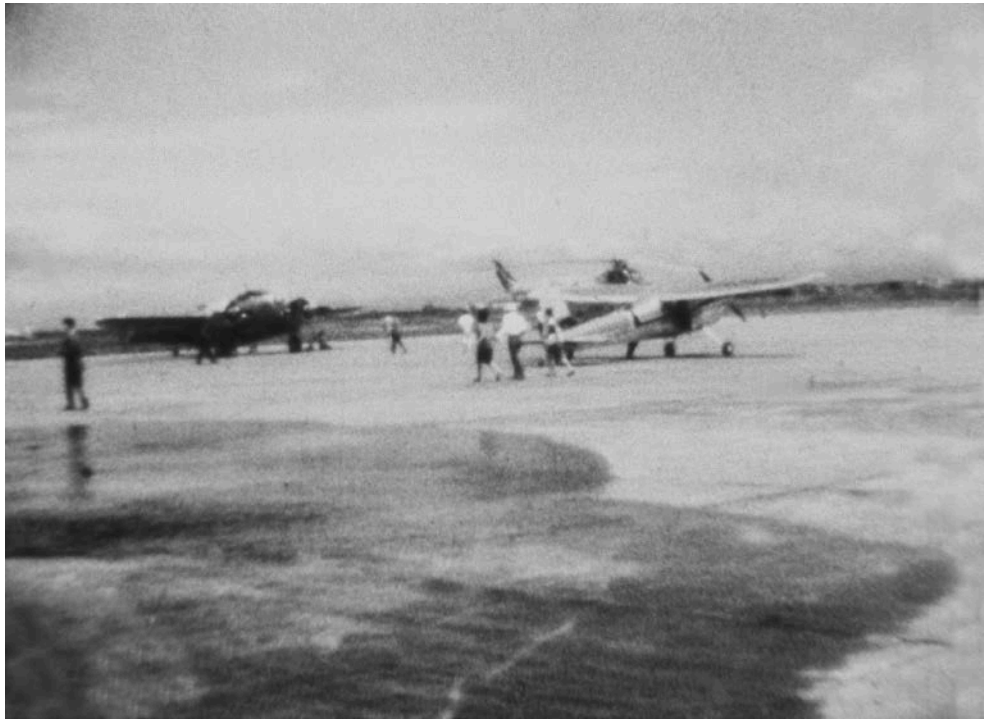
Fig. 10. Ejected water spreading into the airport apron (2) (captured from Mr. Yuminamochi's motion picture) エプロンに広がる噴出水(2)

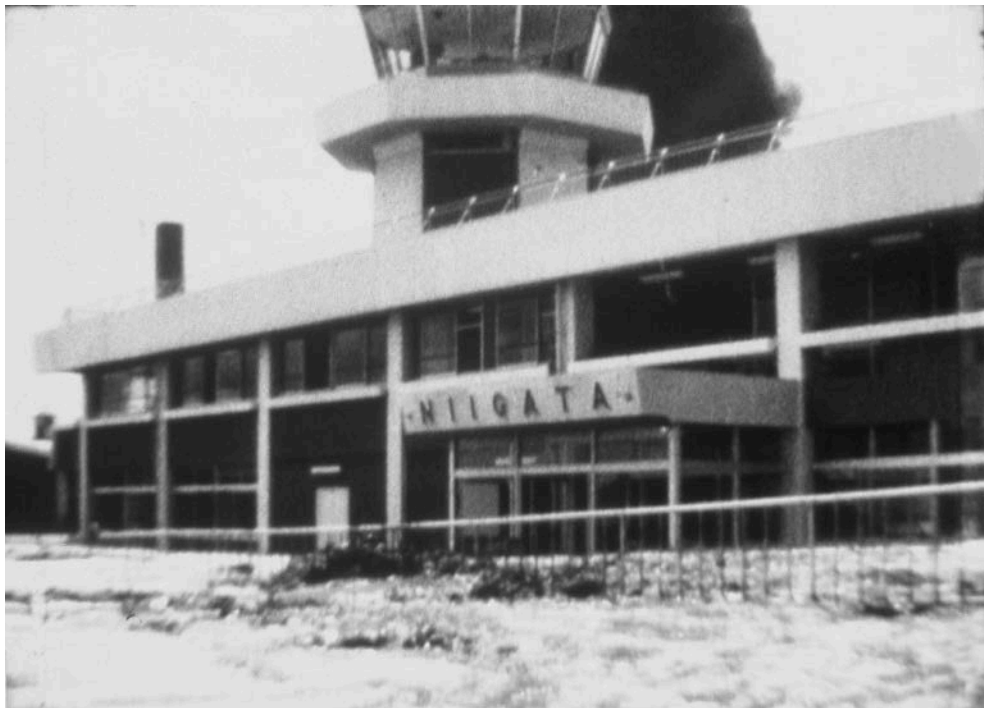
Fig.11. Terminal building inundated by deeper ejected water (captured from Mr. Yuminamochi's motion picture) 水没しつつある空港ビル

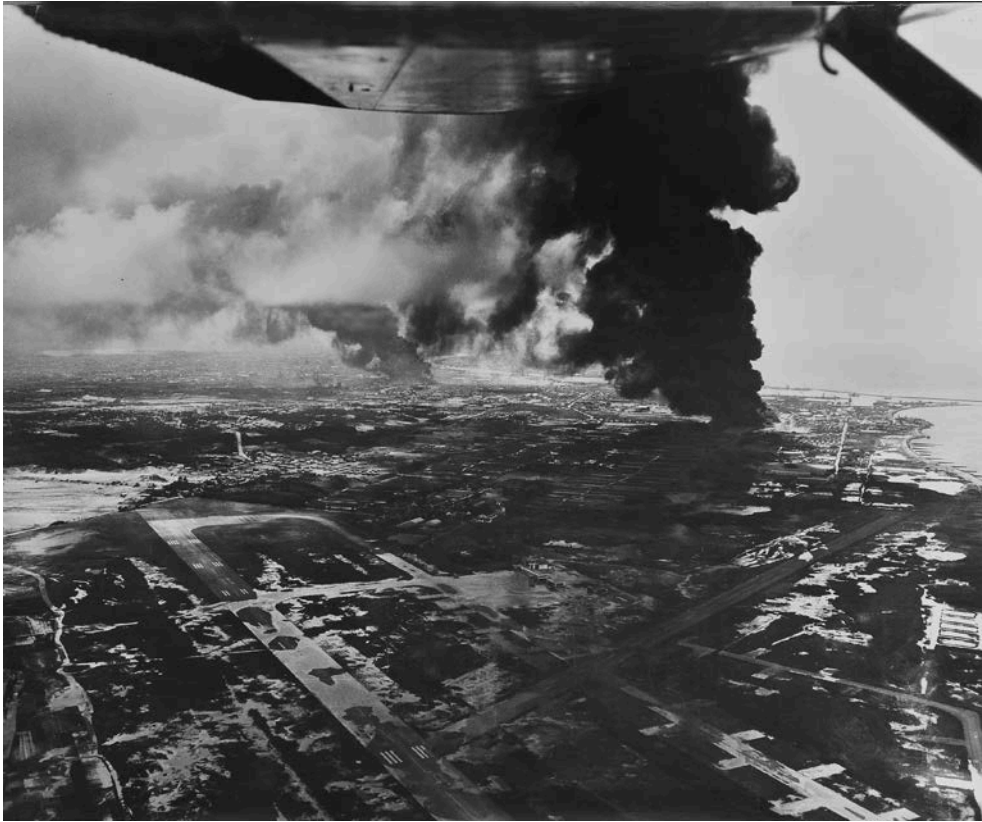
The still photographs are explained in what follows. Fig. 13 shows the fire in the oil refinery that is located between the airport and the Shinano River mouth (Fig. 12). Figs. 13 and 14 show that the surface of the airport was covered by liquefaction-ejected water. Note here that Mr. Yuminamochi got seated on the left side of the aircraft throughout his flight.

Fig. 13. Fire of oil refinery as seen from the airport area (still photo taken by Mr. Yuminamochi) 機内左側座席に着席した弓納持氏による製油所火災の情景

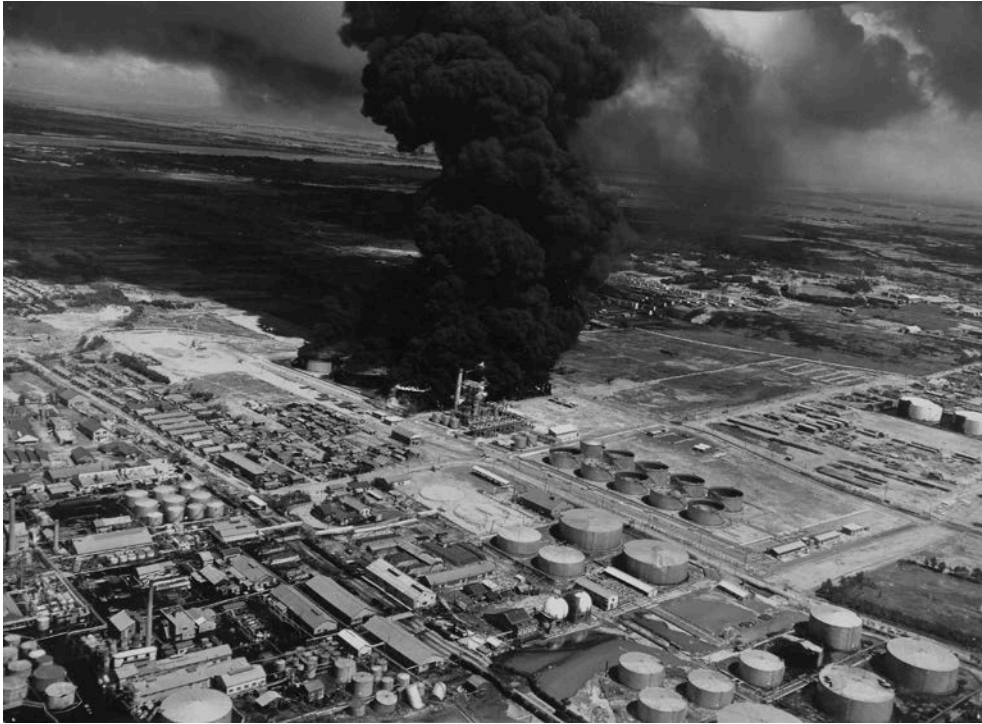
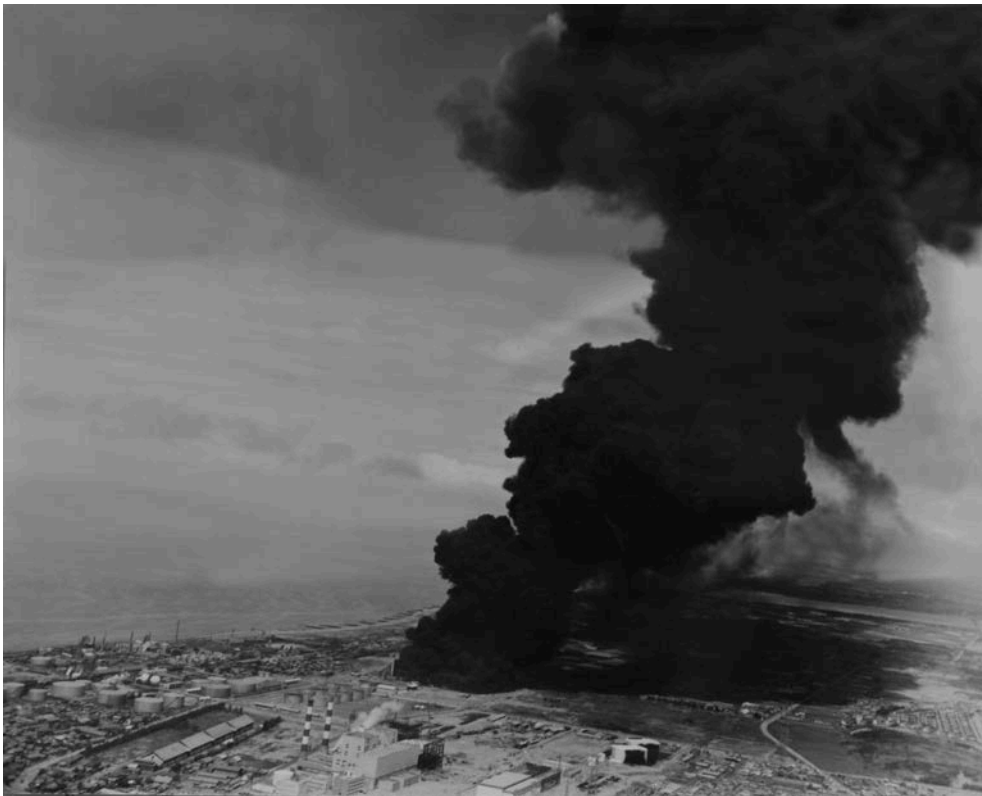
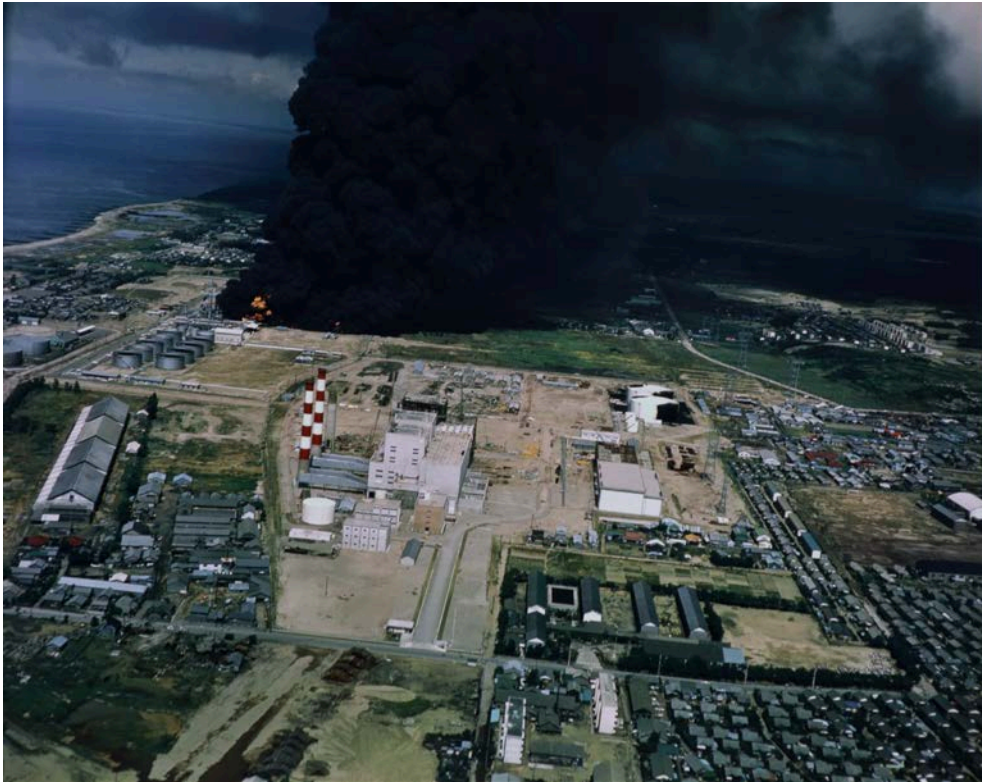
The oil refinery was affected by two fires^{7), 8)}. The first fire started at 1:02 PM, which was one minute after the onset of the earthquake. This fire was initiated by collision of metal members of the tank and affected 21 houses. This fire lasted for 15 days. Figs. 15 to 18

indicate the fire from shorter distances. Note herein that the fire occurred in the inland area, with no influence of tsunami inundation. The second fire near the sea area (Fig. 18) started later at 6 PM on the same day⁸⁾ and had not yet started when the photographs were taken. The second fire triggered explosions of many oil tanks. Until it was extinguished at around 5 PM on June 20th, 27 families lost their houses in addition to the abovementioned explosion of oil refinery facilities. The reason of the delayed occurrence of the second fire is unknown. Because the affected area was inundated by tsunami water, it is likely that the burning oil was transported into a bigger areas by the flow of water.

Fig. 15. Fire of oil refinery from short distance (1) (still photo taken by Mr. Yuminamochi) 製油所の火災

Fig. 16. Fire of oil refinery from short distance (2) (still photo taken by Mr. Yuminamochi) 製油所の火災

Fig. 17. Fire of oil refinery from short distance (3) (still photo taken by Mr. Yuminamochi) 近距離から撮影した製油所の火災

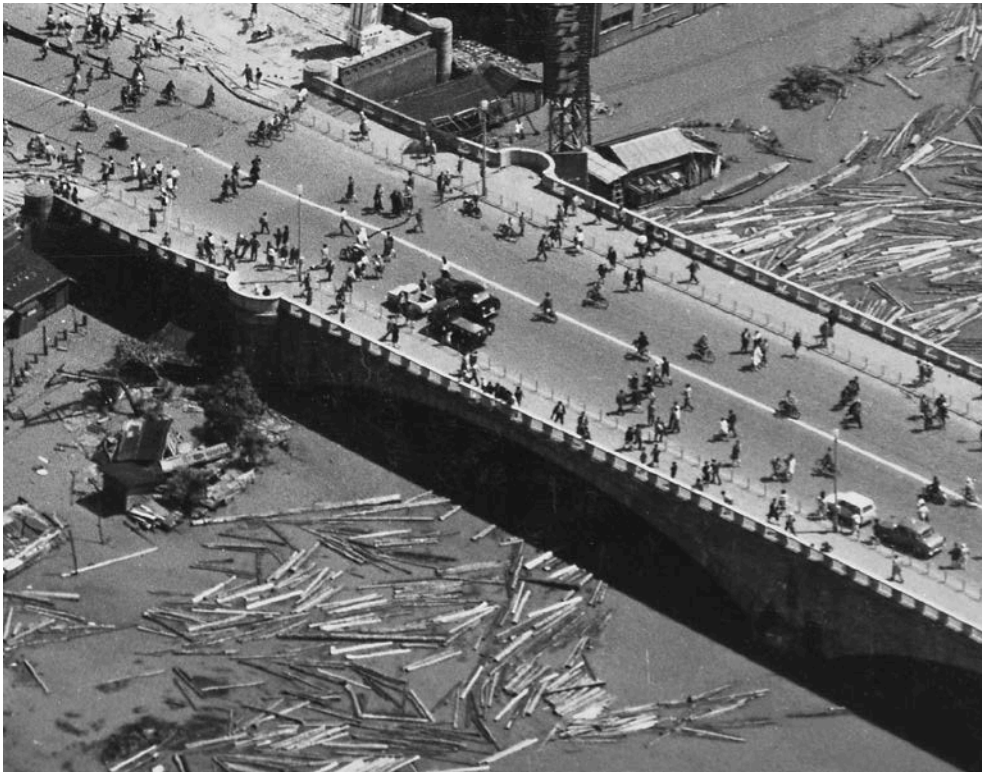
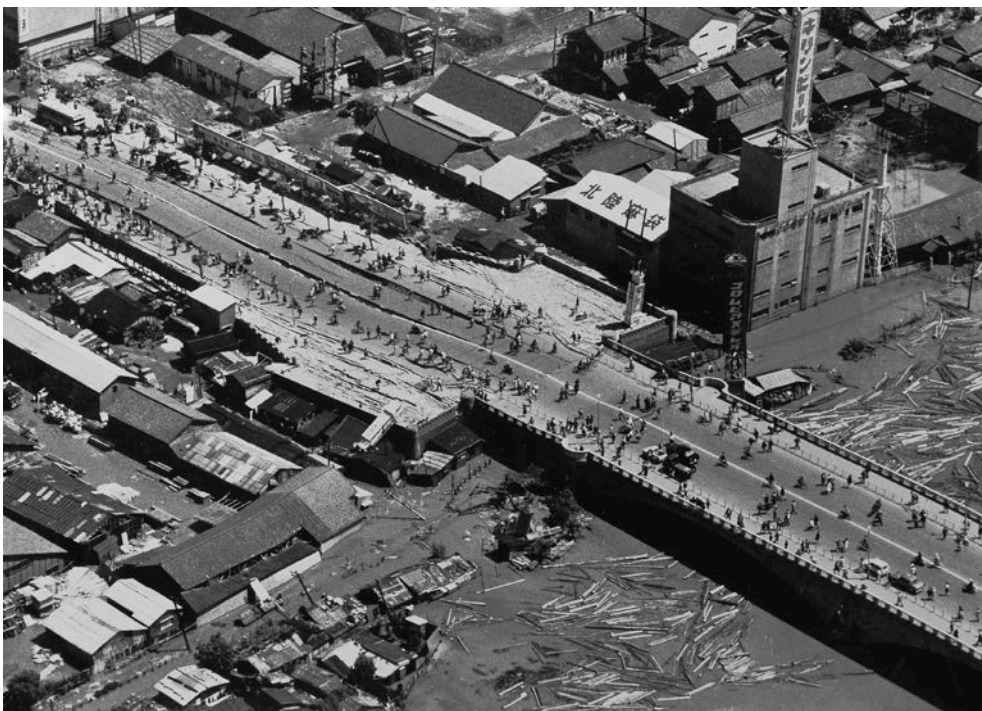
Figs. 24 and 25 show the Bandai Bridge of the second generation that was constructed in 1929 after the river width was reduced and is an RC arch bridge. This bridge survived the earthquake and served for evacuation of people during the aftermath. Nevertheless, the approach road suffered a big crack in the longitudinal direction (Fig. 25). The timbers in the water imply that they were transported by flow of tsunami water from the timberyard in the more downstream area and that these photos were taken after arrival of tsunami. Tsunami arrived at Niigata after 1:35 PM and reached Kawagishi-Cho 3-chome^{11), 12)}. Note that the revetment wall along the river totally fell down and induced lateral displacement of the backfill surface (Fig. 25). Consequently, the revetment wall around the northern end of the bridge distorted to be curved (Fig. 26) because the rigid Bandai Bridge prevented the lateral displacement of the wall in its vicinity only.

Fig. 24. Bandai Bridge (1) (still photo taken of the south bank of the river by Mr. Yuminamochi) 万代橋の地震後の状況(1)

Fig. 25. Bandai Bridge (2) (still photo taken of the south bank of the river by Mr. Yuminamochi) 万代橋の地震後の状況(2)

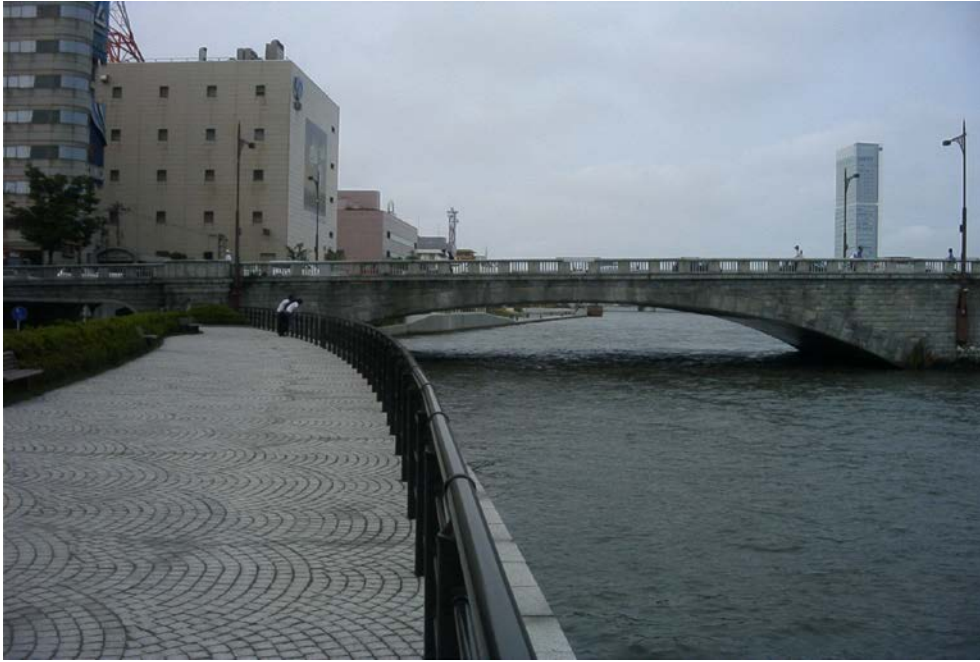
Fig. 26. Distorted shape of the revetment wall in 2003 at the northern side of the Bandai Bridge (IITT Imagery Bank) 万代橋北たもとの護岸の曲線型変状

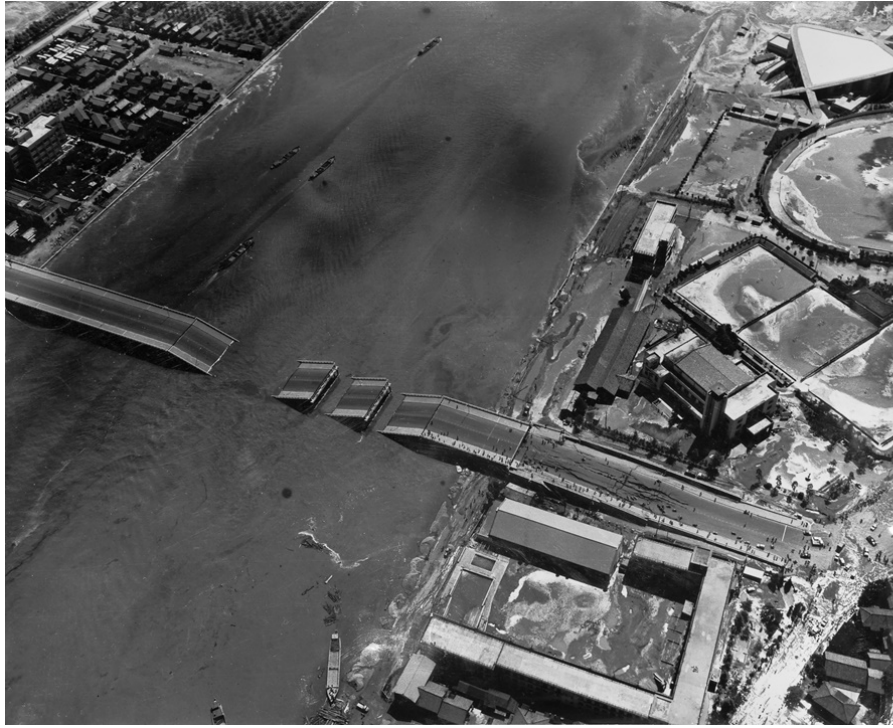
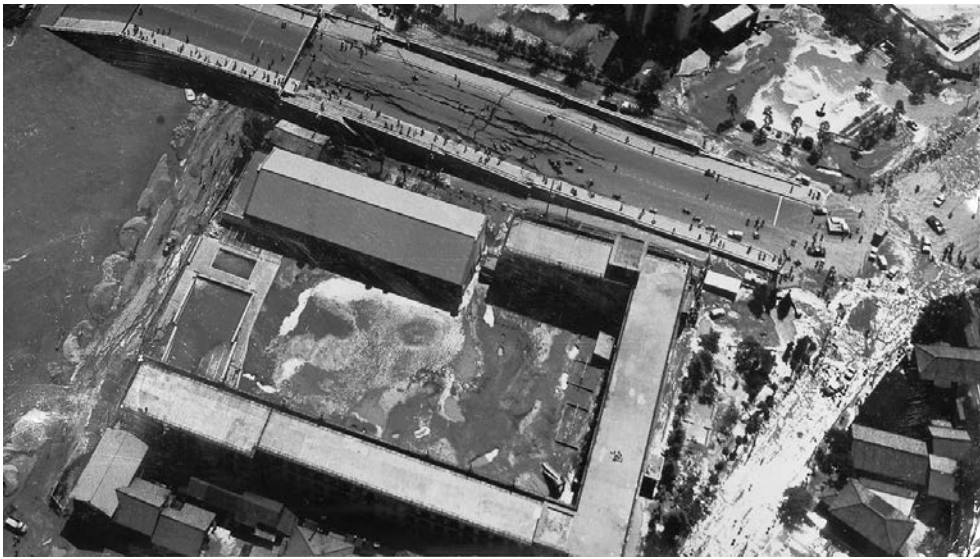
Figs. 27 and 28 show the collapse of the Showa Bridge that had been completed only a few weeks before the earthquake when the national sports festival took place in Niigata. The athletic stadium for this festival is seen as well at the top right corner of Fig. 27a. Five spans of the bridge fell down into the river. Moreover, the revetment wall along the Shinano River collapsed and triggered lateral displacement of liquefied ground behind the wall. Fig. 27b demonstrates the detailed situation in the Hakusan Elementary School in which the swimming pool near the river was sheared laterally, perpendicular to the river, and the surface of the school yard was covered by liquefaction ejecta. The road in front of the school (right-hand side) was covered by whitey liquefied sand. The access-road embankment of the Showa Bridge developed several longitudinal cracks as a consequence of its lateral extension (Fig. 27b).

(a) Arrow showing Hakusan Elementary School in which ejected ground water is visible as a patch on the surface 矢印は被災した白山小学校の位置を示す

(b) Details of liquefaction damage in the Hakusan Elementary School 白山小学校被災の詳細

Fig. 27. Fall of Showa Bridge and the substantial damage of the revetment wall along the river (1) (river flow towards the bottom of photo) (still photo taken by Mr. Yuminamochi) 昭和大橋周辺の状況

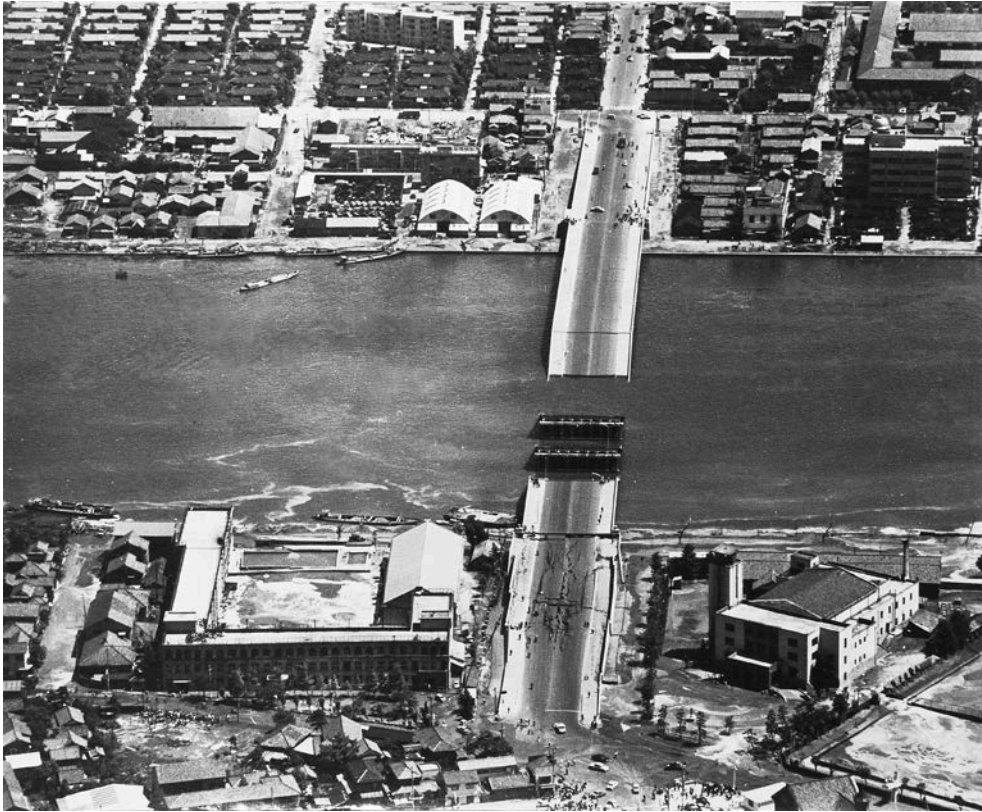
Fig. 28. Fall of Showa Bridge and the substantial damage of the revetment wall along the river (2) (downstream to the left) (still photo taken by Mr. Yuminamochi)
 昭和大橋近隣の護岸の被害

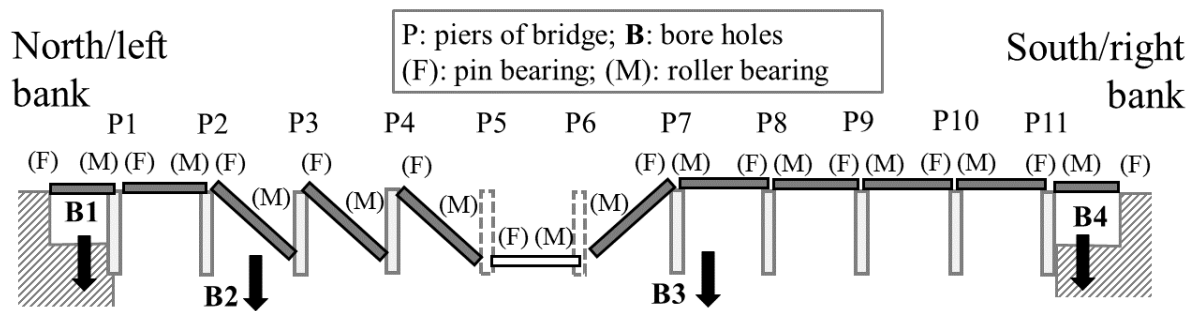
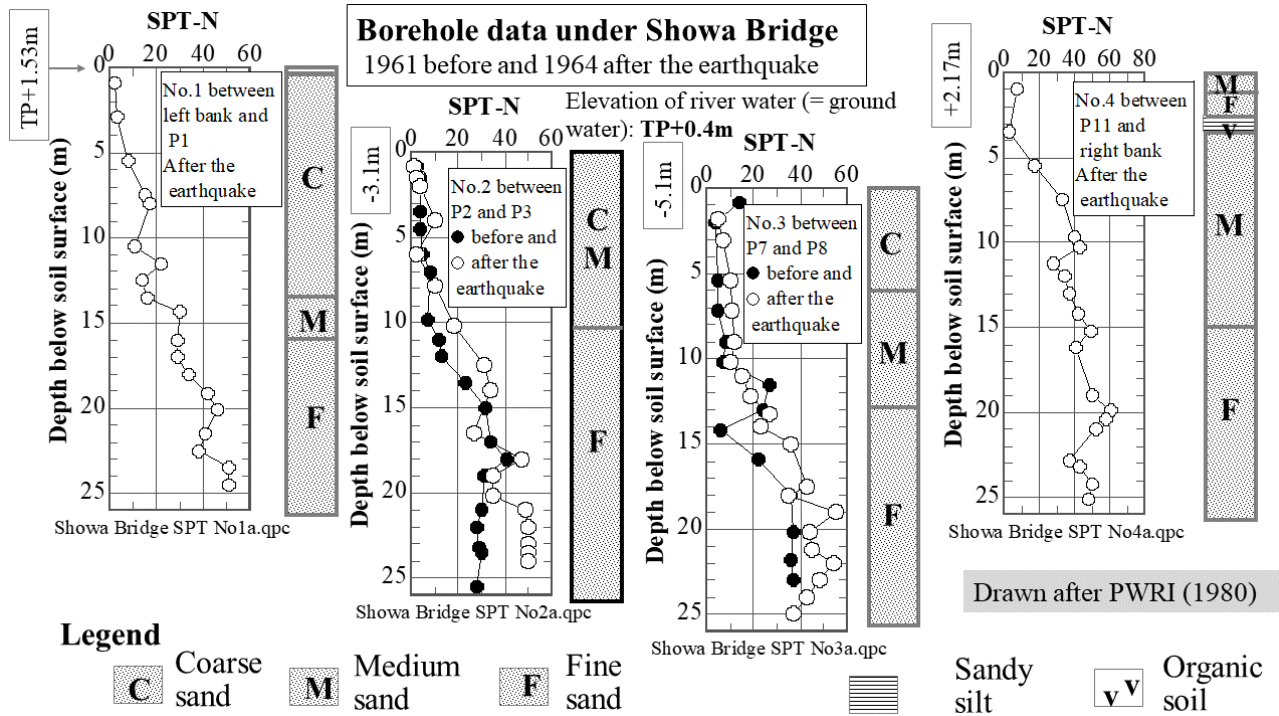
Fig. 31. SPT-N profiles along the Showa Bridge 昭和大橋のサイトにおける標準貫入試験結果

Fig. 31 exhibits the *SPT* (Standard Penetration Tests) cross sections under the Showa Bridge published in 1980¹⁴⁾. Two profiles were obtained before the earthquake (●), whereas four were after the earthquake (○). There were and are loose material down to approximately 10 meters below the river bed, which is shallower than the depth of the pier foundations. It seems that *SPT-N* increased to a certain extent after the earthquake. Further note that finer sand dominates at lower elevation, while coarser material prevails near the surface.

Interview with eyewitnesses strongly suggested that the bridge fell down after shaking^{15), 16)}, indicating that the earthquake-induced inertial effect was not the causative mechanism, whereas more important roles were played by the loss of rigidity and lateral flow of liquefied subsoil. It should be borne in mind that those eyewitness remarks addressed the end of ‘felt’ strong shaking and do not necessarily mean the end of weaker but prolonged displacement oscillation. It was also reported that black columns appeared at the river surface¹⁵⁾, which may imply substantial liquefaction in the river bed.

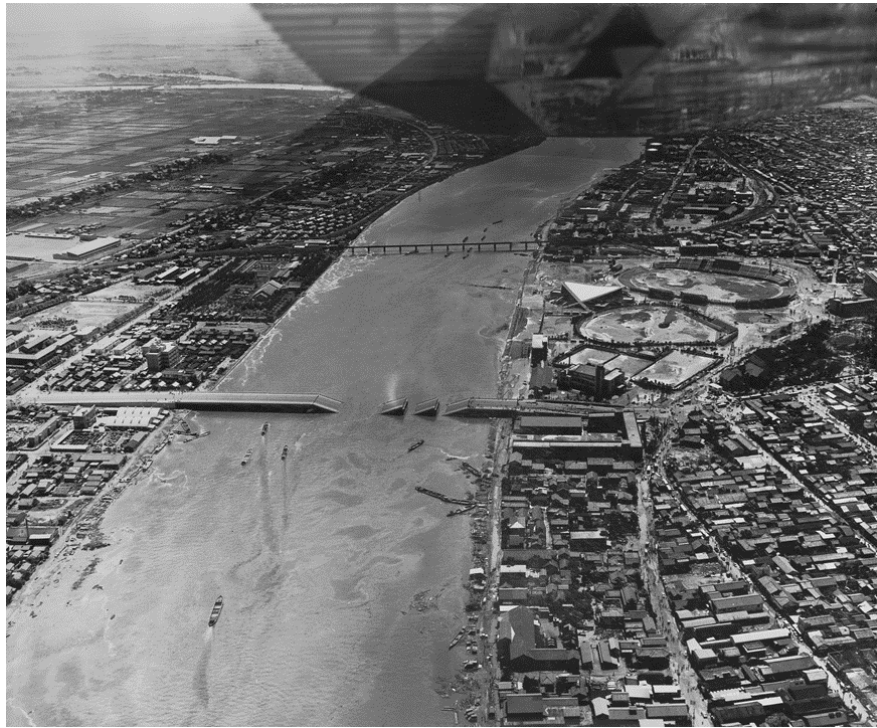
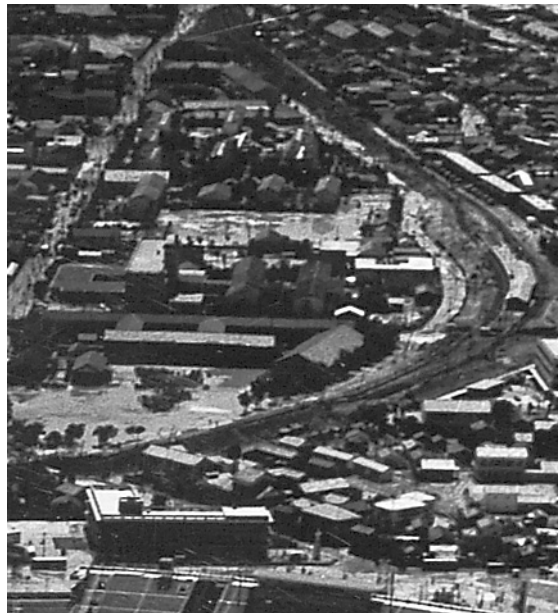
Fig. 32a presents the view of the upstream direction from the Showa Bridge. The sports facilities just beyond the bridge (northern bank, right-hand side in this photograph) are seen clearly. The railway bridge at a far distance appears less damaged than the Showa Bridge. As stated before (Fig. 14), Mr. Yuminamochi was seated on the left side of the aircraft. Since the route of the flight was counterclockwise in principle above the city (Fig. 12), he could not take photos of the upstream area except this photograph. Only Fig. 32 captured the famous tilting of the Kawagishi-Cho Apartment Buildings. The portion of the apartment buildings was extracted, therefore, and magnified in Fig. 32b. Taking this photograph, Mr. Yuminamochi did not recognize this famous tilting.

(b) Extraction of the part of the tilting Kawagishi-Cho apartment buildings (location indicated by arrows) 矢印は川岸町アパートの部分の拡大写真
Fig. 32. Aerial view of the upstream direction from the Showa Bridge area (still photo taken by Mr. Yuminamochi) 昭和大橋から信濃川上流方向を望む

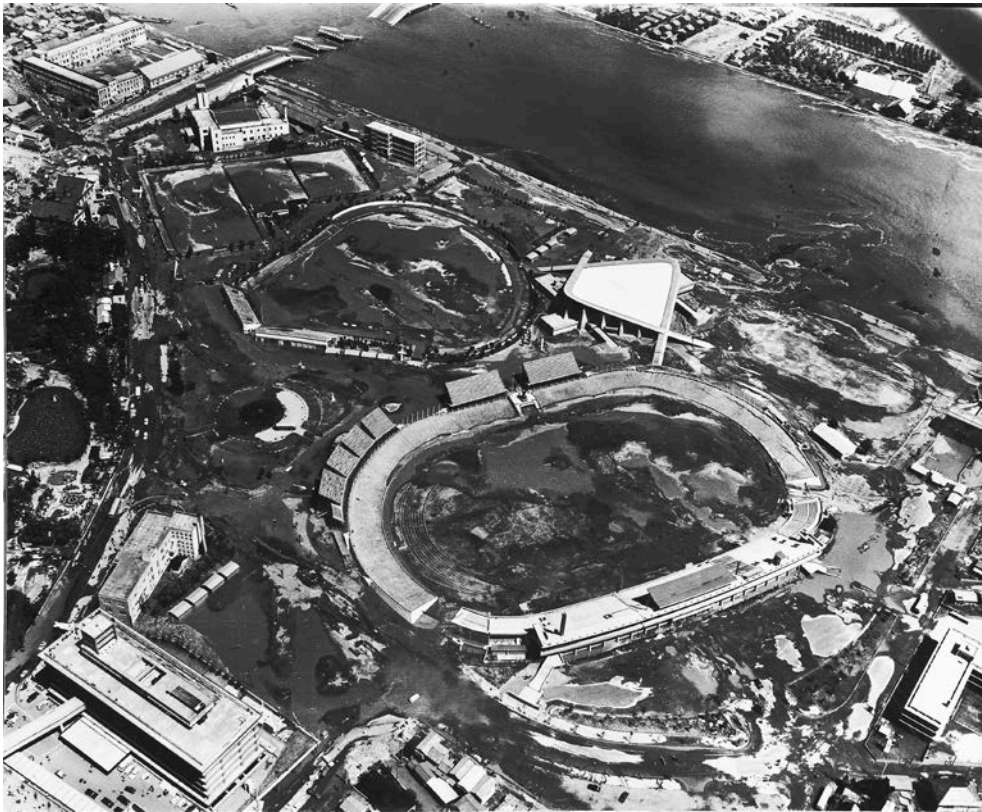
Niigata Prefecture hosted the national sports festival from June 6th to 11th of this year. For this big event, many sports facilities were constructed and the liquefaction-prone area along the Shinano River (Fig. 12) was the most important place of construction. Only five days after the closing ceremony of this event, the constructed facilities were affected by the earthquake. Fig. 33 indicates the view after liquefaction damage, while more details are shown in Figs. 34 and 35. It was fortunate that the athletic stadium in Fig. 35 avoided structural damage, as is the common case with structures resting on liquefied subsoil, and has been used since then.

Fig. 33. Liquefaction around the sports complex near the Showa Bridge (still photo taken by Mr. Yuminamochi) 競技場地区

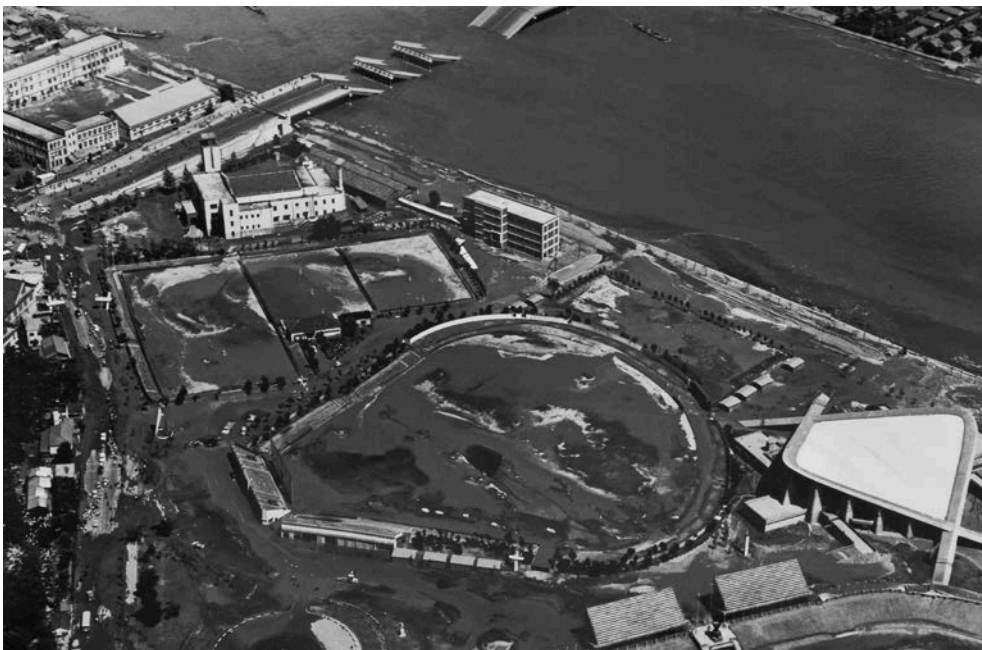
Fig. 34. Liquefaction in and around the baseball stadium (still photo taken by Mr. Yuminamochi) 野球場周辺の被害状況

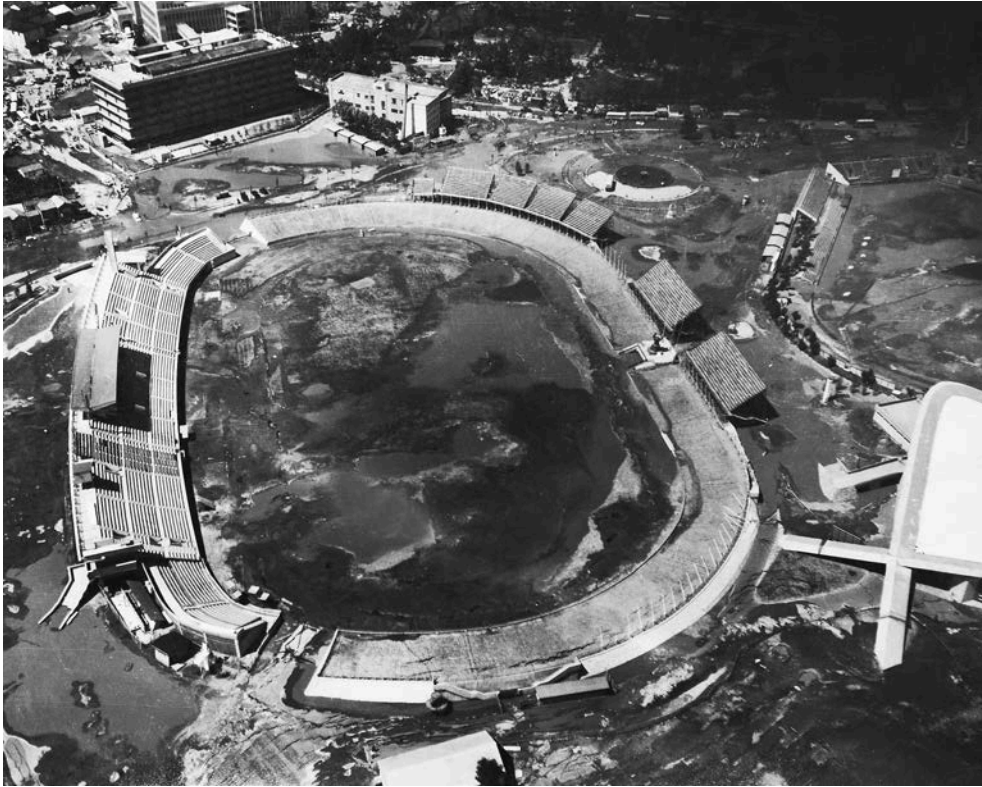
Fig. 35. Athletic stadium that was just completed for the national sports festival in June 1964 (still photo taken by Mr. Yuminamochi) 陸上競技場の被災状況

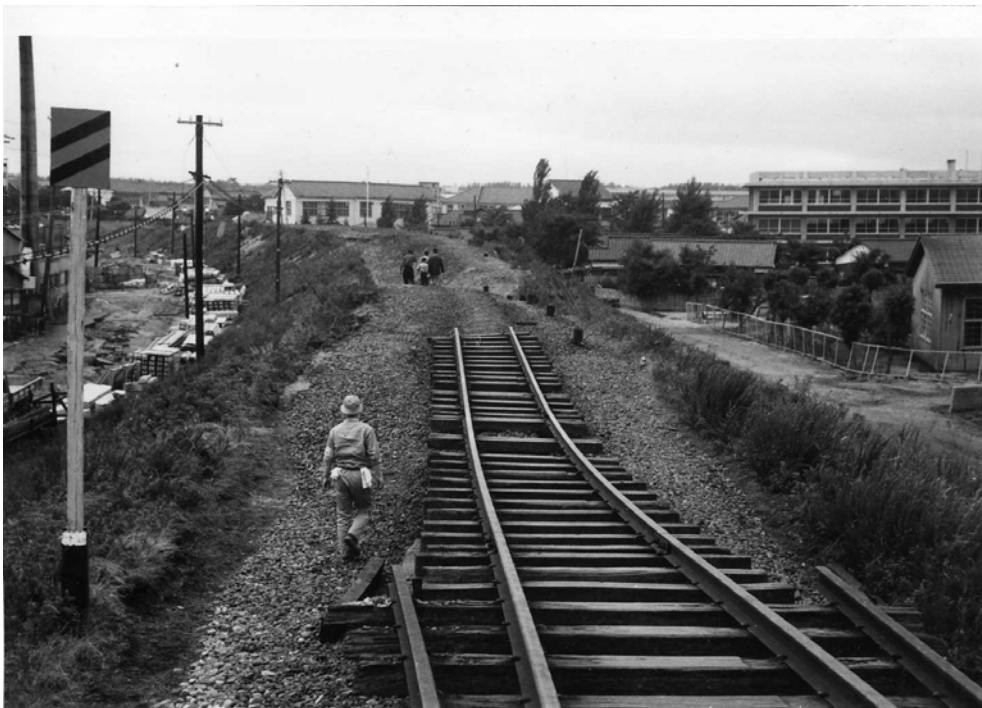
Fig. 38. Subsidence and lateral spread of the Echigo Line railway embankment (Shinano River and Kawagishi-Cho Apartment Buildings located to the left of this picture) (photograph by University of Tokyo) 越後線盛土の変状

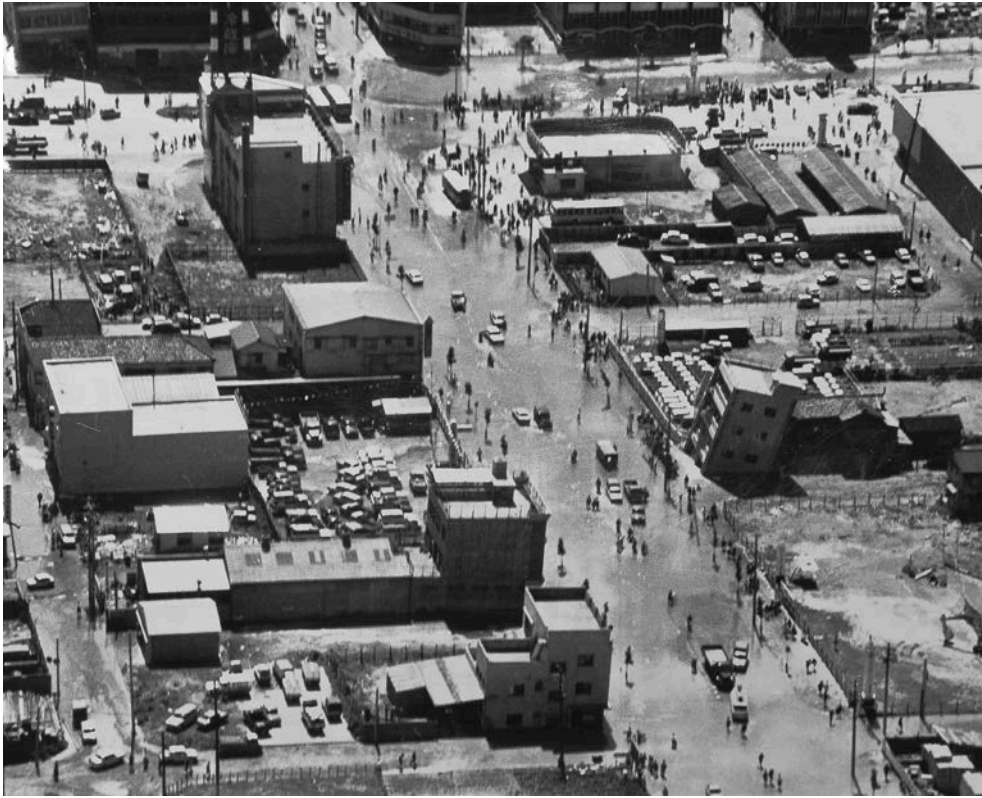
Fig. 40. Akashi Street near the Niigata Station in which the road surface is flooded by liquefaction ejecta 明石通りの液状化被害

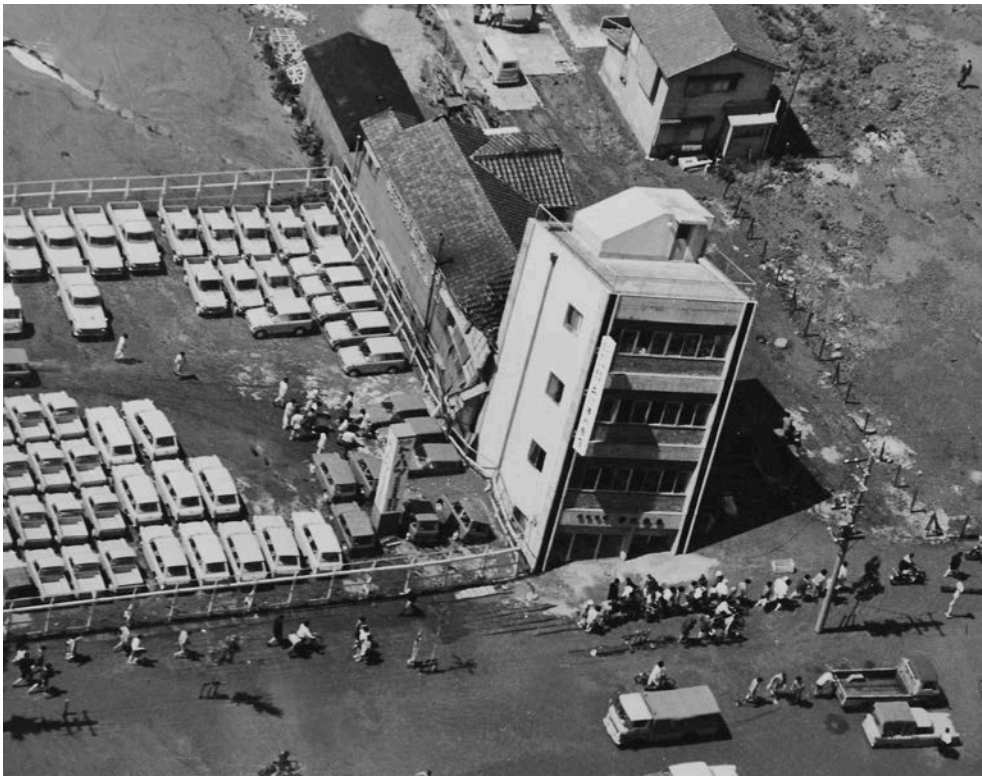
Fig. 41. Tilting of RC building in Akashi Street resting on liquefied subsoil (still photo taken by Mr. Yuminamochi) 傾斜したビルディング

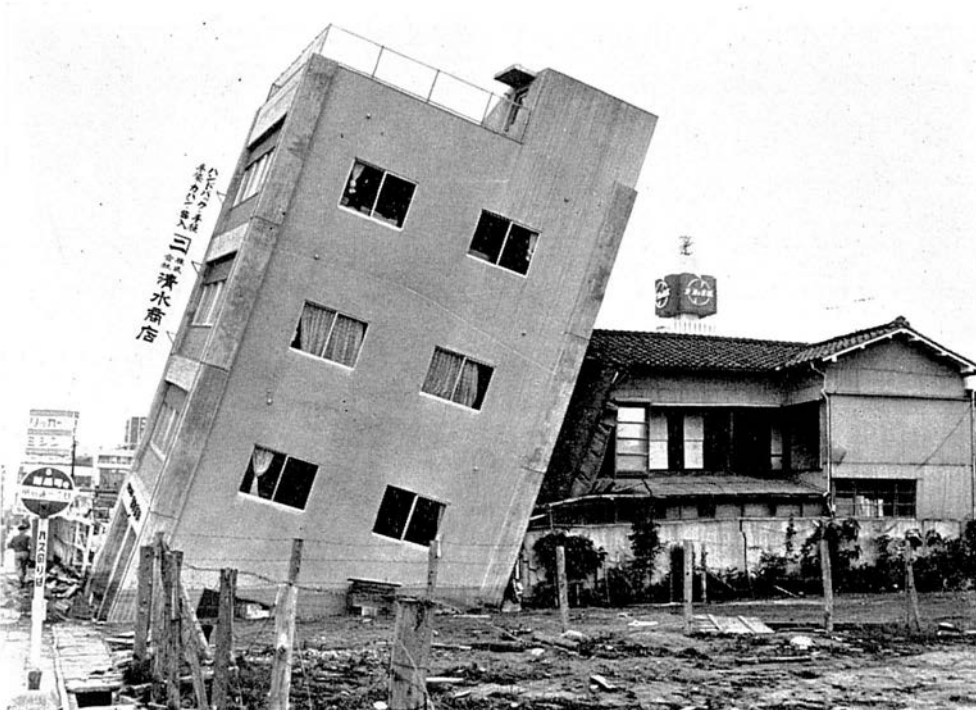
Fig. 42. Contrast in damage extents of heavier RC building and lighter wooden two-storey house¹⁷⁾ (this photograph can be used for academic/engineering purposes freely with reference to the literature 17; no request for permission needed) RC ビルの傾斜と木造家屋の無被害（軽微な変状か）との対比

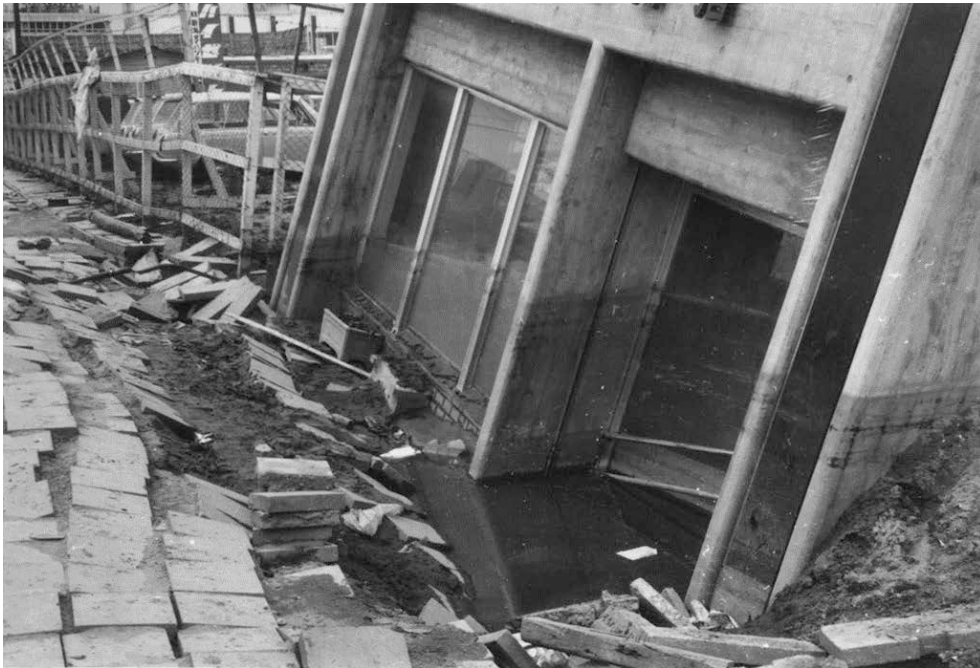
Fig. 43. Damage detail of the tilted building in Figs. 41 and 42 (Reconnaissance team of Civil Engineering Department, University of Tokyo) ビルディングの傾斜状況の詳細

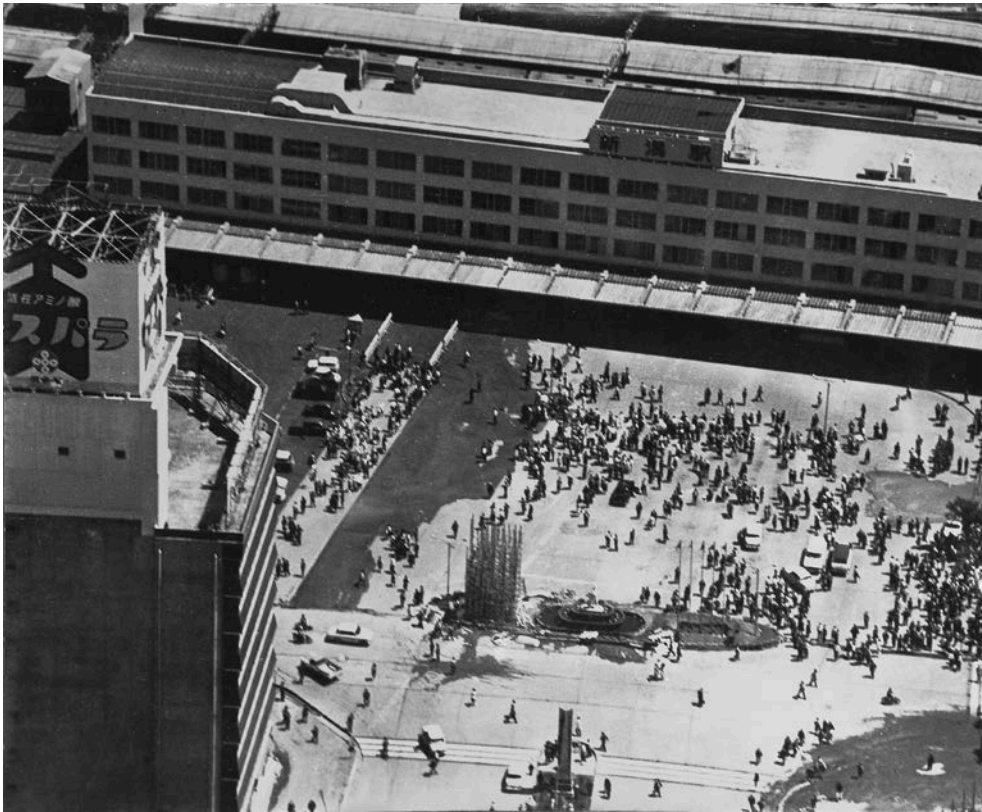
Fig. 44 indicates the northern side of the Niigata Central Railway Station. The dark color on the surface implies the ejected liquefied sand and water, but another possibility is the leakage from broken water pipelines. A more serious problem happened to the east of this station where an overpass bridge fell down onto a train (Figs. 45 to 49). Substantial distortion and probably buckling of rails are visible in these photos. It is also found in Fig. 45 that the ground surface in the station is covered by grayish materials that are most probably liquefaction sand ejecta. A similar material is also found in Fig. 46 to 49 on both sides of the railway track. Any relationship between liquefaction and the damage of the overpass is not known.

Fig. 44. Bandai Exit on the north side of the Niigata Station (still photo taken by Mr. Yuminamochi) 新潟駅北側万代口
