Mr. Yuminamochi's photographs depicting ongoing liquefaction disaster
during the 1964 Niigata earthquake
1964 年新潟地震に際して液状化発生と震災直後の市内の状況を映像記録した
弓納持福夫氏の業績

Ikuro Towhata¹, Nozomu Yoshida²

ABSTRACT

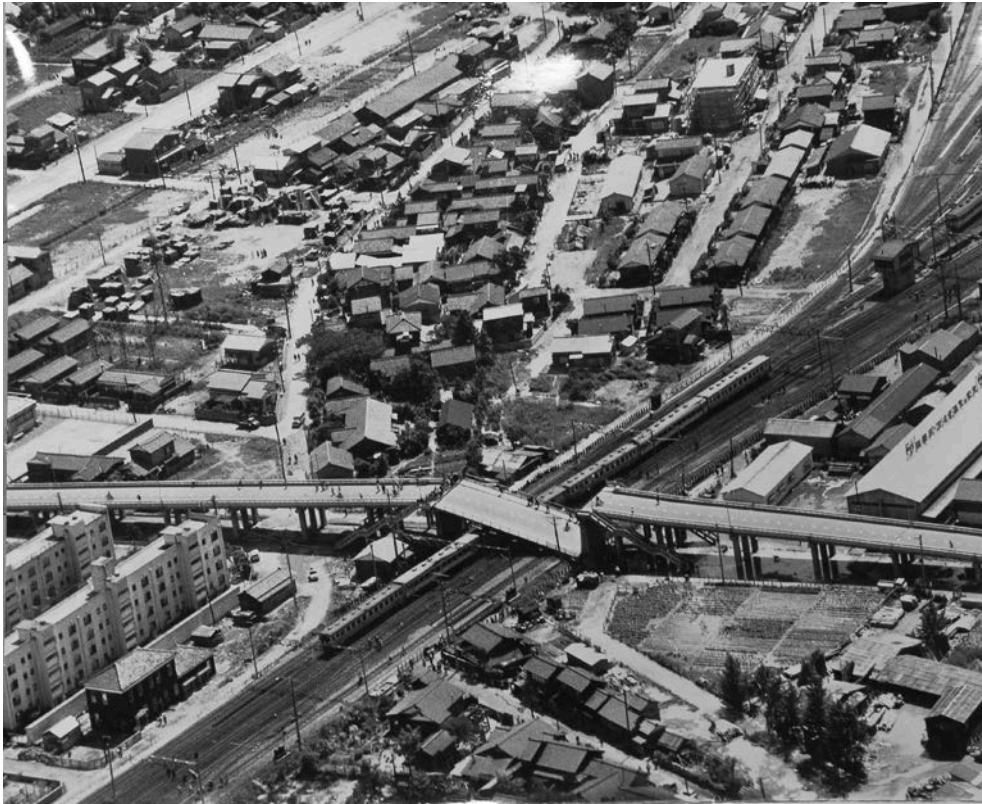
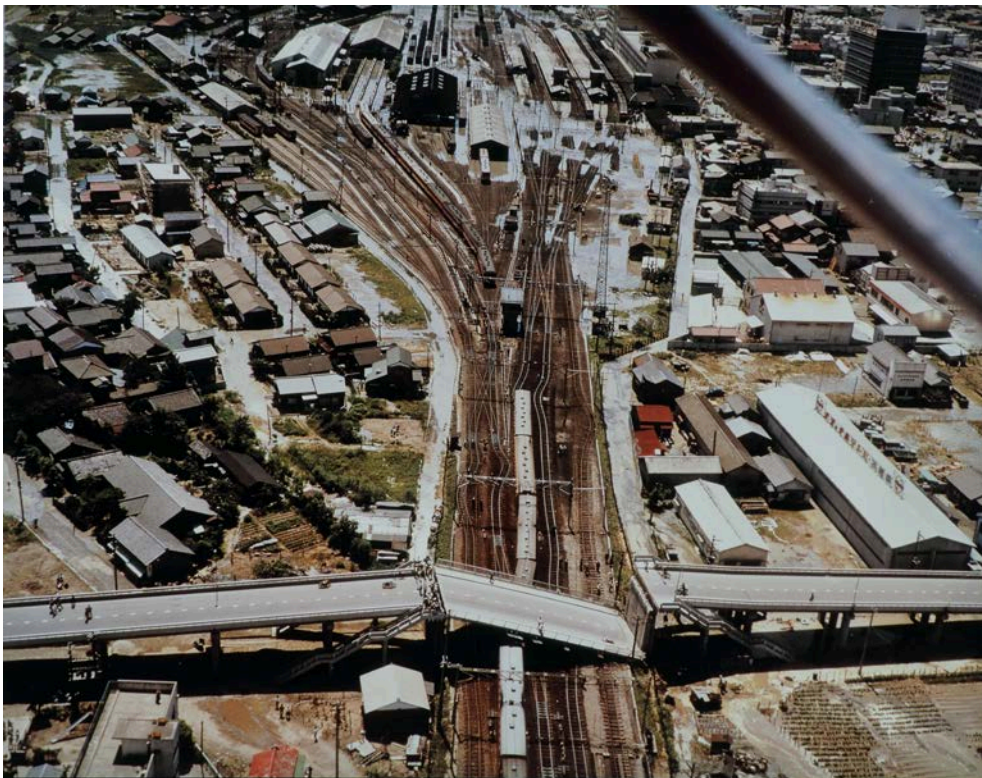
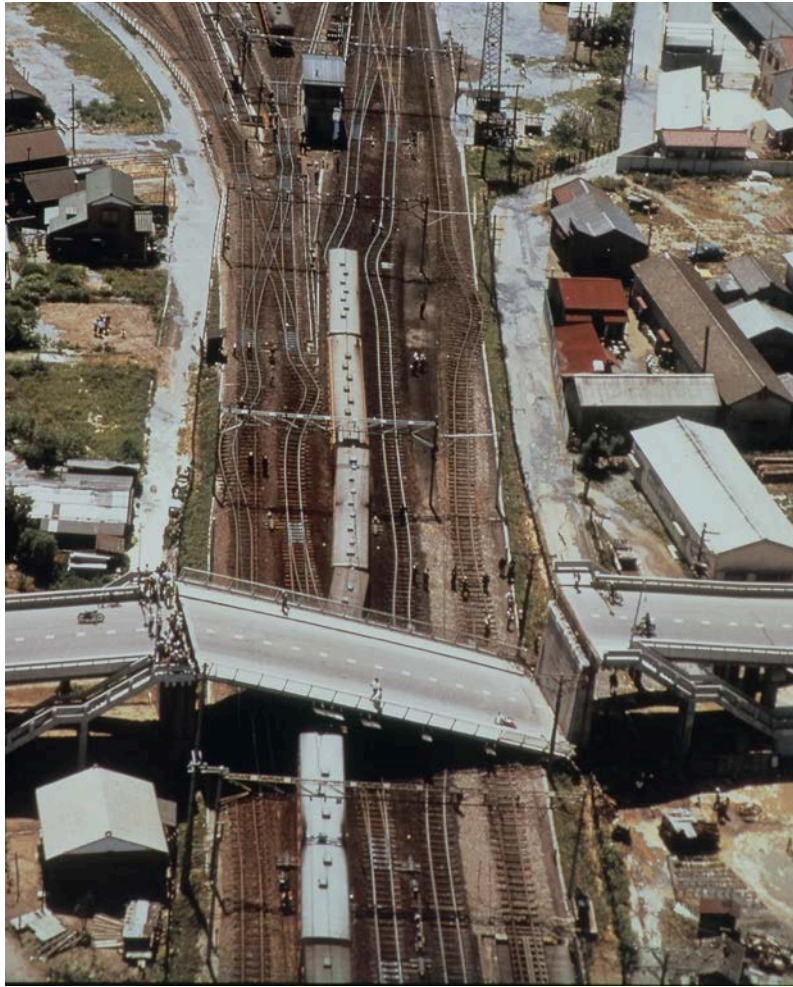
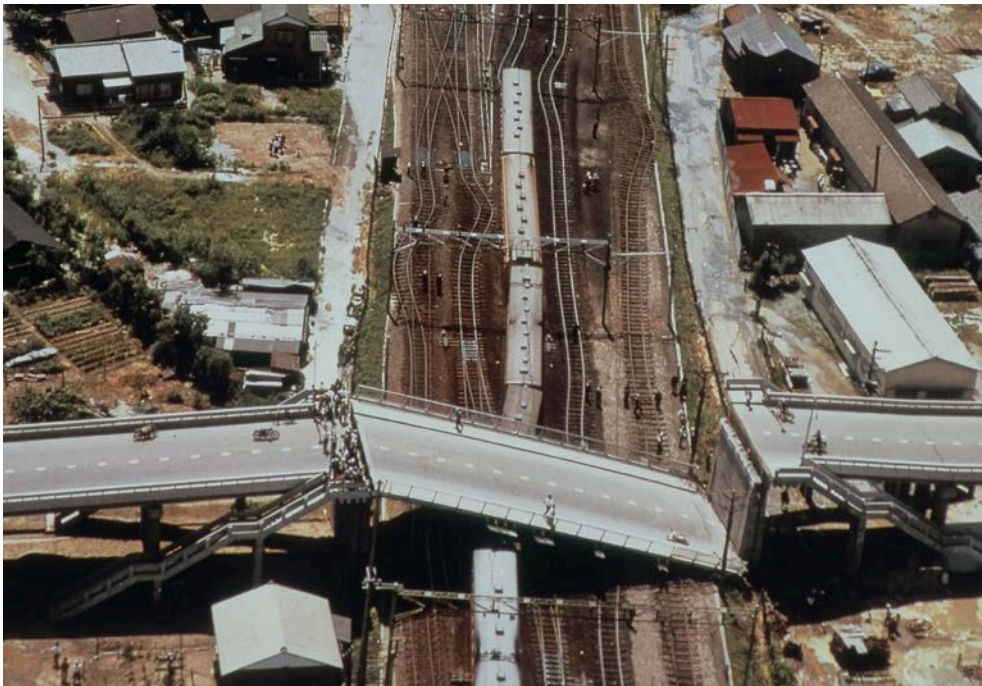
Fig. 46. Damage of railway overpass bridge (1) (still photo taken by Mr. Yuminamochi) 東跨線橋の落下(1)

Fig. 47. Damage of railway overpass bridge (2) (still photo taken by Mr. Yuminamochi) 東跨線橋の落下(2)

Fig. 48. Damage of railway overpass bridge (3) (still photo taken by Mr. Yuminamochi) 東跨線橋の落下(3)

Fig. 49. Damage of railway overpass bridge (4) (still photo taken by Mr. Yuminamochi) 東跨線橋の落下(4)

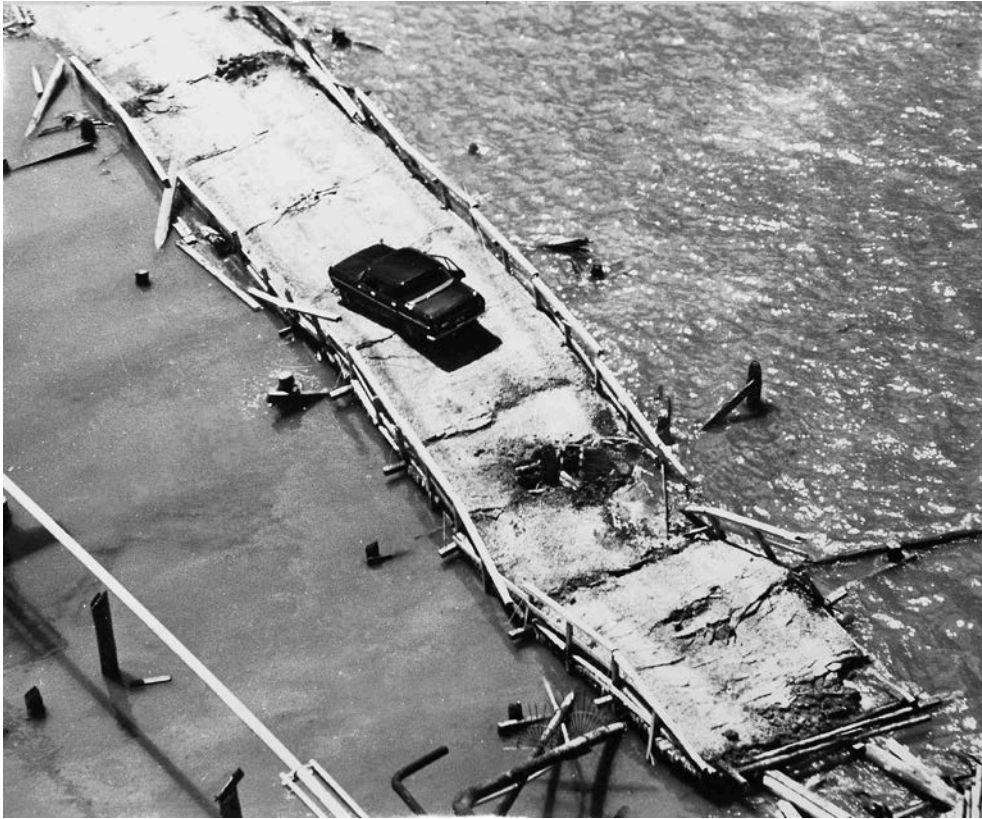
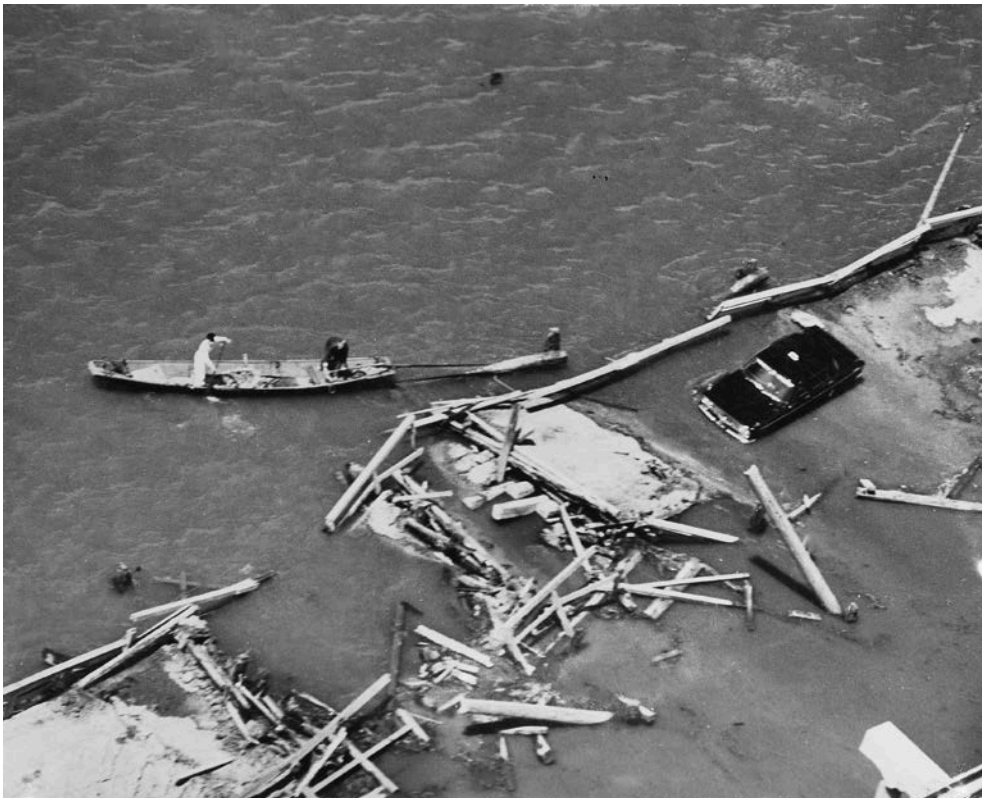
Fig. 50. Fall-down of Matsuhama Bridge across the Agano River (a new bridge was under construction next to this old one at the time of the earthquake) (still photo taken by Mr. Yuminamochi) 阿賀野川に架かる松浜橋（旧橋）の落橋

Fig. 51. Small boat helping people from a taxi on the Matsuhama Bridge (still photo taken by Mr. Yuminamochi) 松浜橋に取り残された自動車乗客を助ける小舟

as a wooden bridge again¹⁸⁾. When the earthquake occurred in 1964, its replacement was nearly completed. When the earthquake occurred, two vehicles were left on the old bridge and were involved in a trouble (Figs. 50 and 51). One span of the new bridge collapsed as well (Fig. 52) but was restored and set out its service in December, 1964¹⁸⁾. The old bridge was washed away by tsunami one hour after the earthquake²⁰⁾.

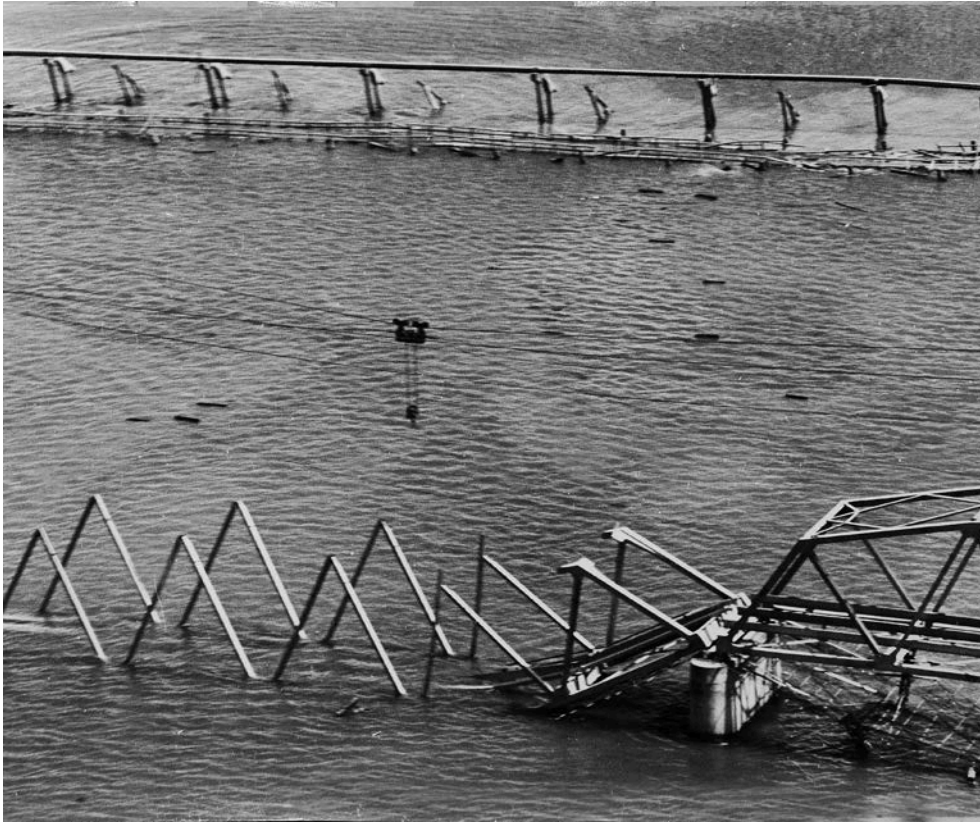
Fig. 52. Collapse of both old and new Matsuhama Bridge (the new bridge in front was under construction) (still photo taken by Mr. Yuminamochi) 工事中の松浜橋新橋も1スパン落橋

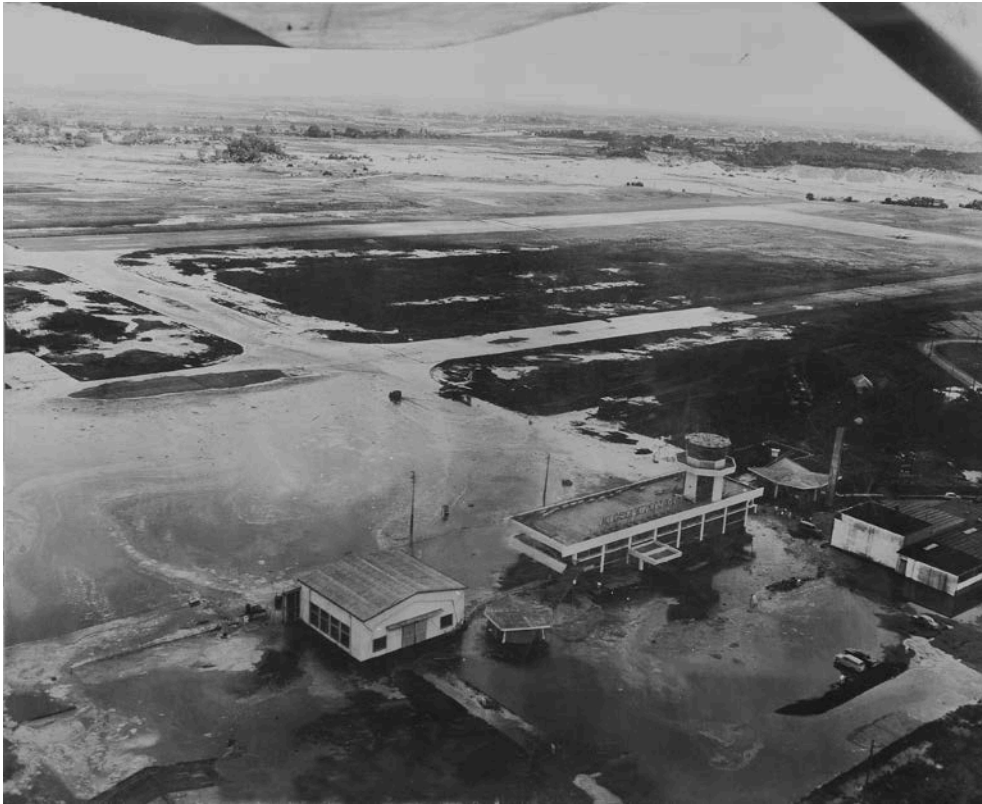
After recording the damage of the Matsuhama Bridge, the aircraft came back to the airport area where the ground surface had been totally flooded by the probable mixture of liquefaction-ejected water and tsunami water (Fig. 53). As stated before, the buildings in the airport did not have structural damage (Fig. 54). Nevertheless, the unacceptably large subsidence of 1.2 m made impossible the normal operation of the terminal building (Fig. 55). The airport authority continued the operation by using only the upper floor in place of the original ground floor and demolished the building in spring of 1965.

Fig. 53. Inundation of the Niigata Airport, viewed after flying over the city (still photo taken by Mr. Yuminamochi after his flight over the city) 水没した新潟空港エプロン

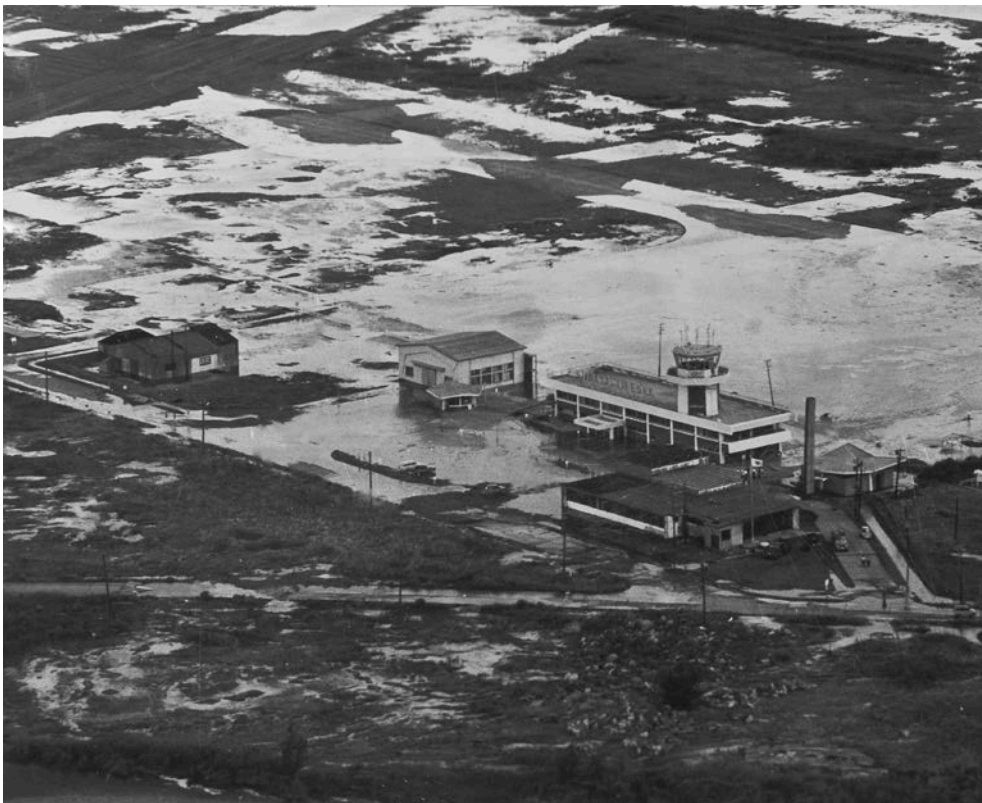
Fig. 54. No structural damage in the airport building in spite of its substantial liquefaction-induced subsidence (still photo taken by Mr. Yuminamochi) 甚大な液状化に比して構造物に被害の無いことが特徴

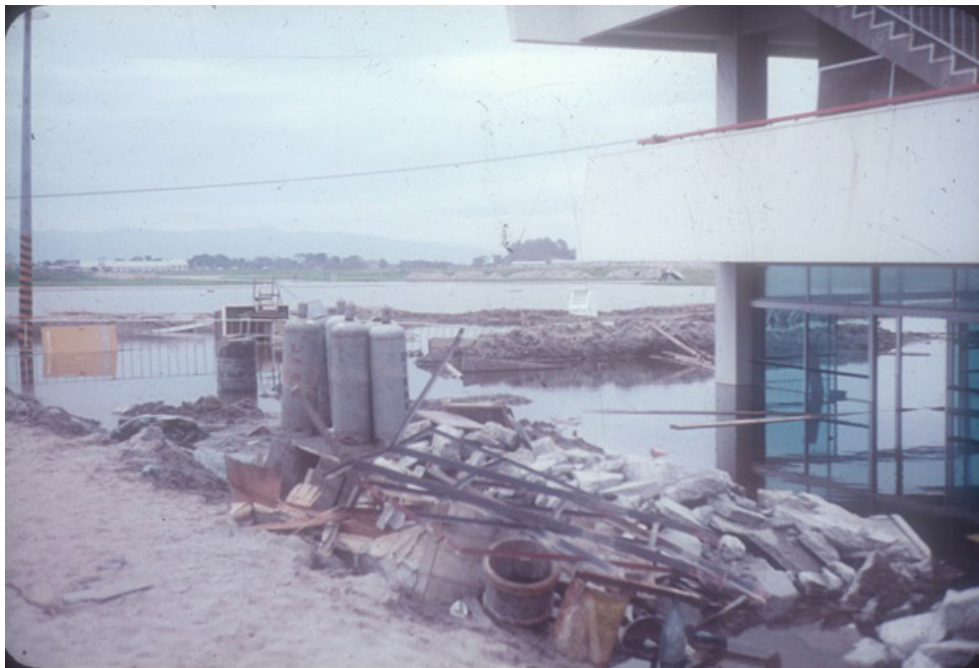
A question arises why this subsidence happened in spite of the pile foundation of the building. Fig. 56 compares the SPT-*N* profile obtained before the earthquake and the length of the timber piles. It may be possible that the piles were slightly too short to reach a good stable soil layer. However, it is unlikely that pile driving practice was stopped before hitting a hard soil stratum. Cracks of the runway are illustrated in Fig. 57.

Fig. 55. 1.2-meter subsidence of airport building caused by liquefaction (no damage in structure and window glasses) (University of Tokyo) 後日撮影した空港ビルの沈下状況

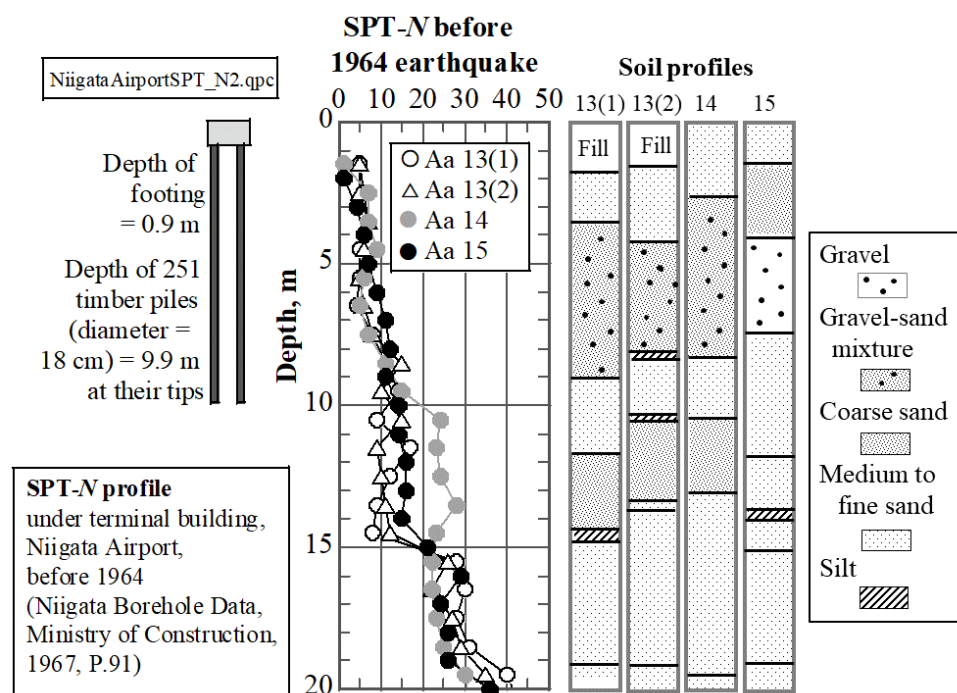
Fig. 56. Pre-earthquake borehole profiles at the site of the subsided terminal building²¹⁾ 新潟空港ビル地点の地盤調査結果（地震前に実施）

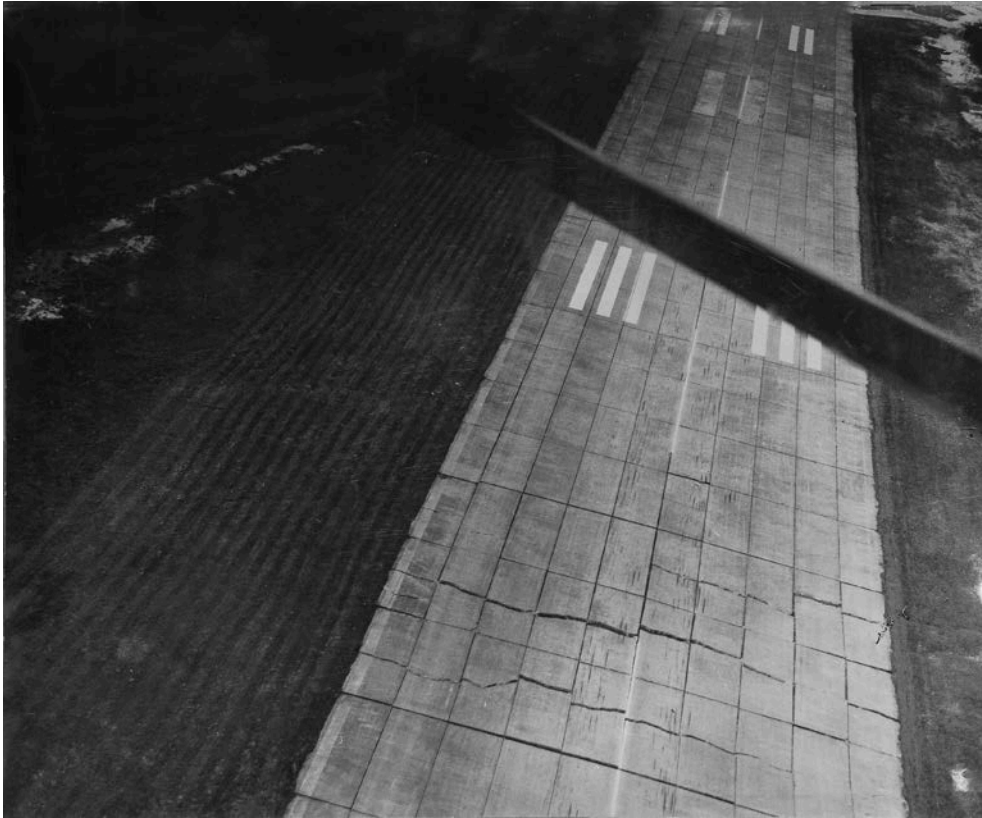
Fig. 57. Cracks and distortion of the airport runway due to heterogeneous subsidence after liquefaction (still photo taken by Mr. Yuminamochi) 滑走路の変状

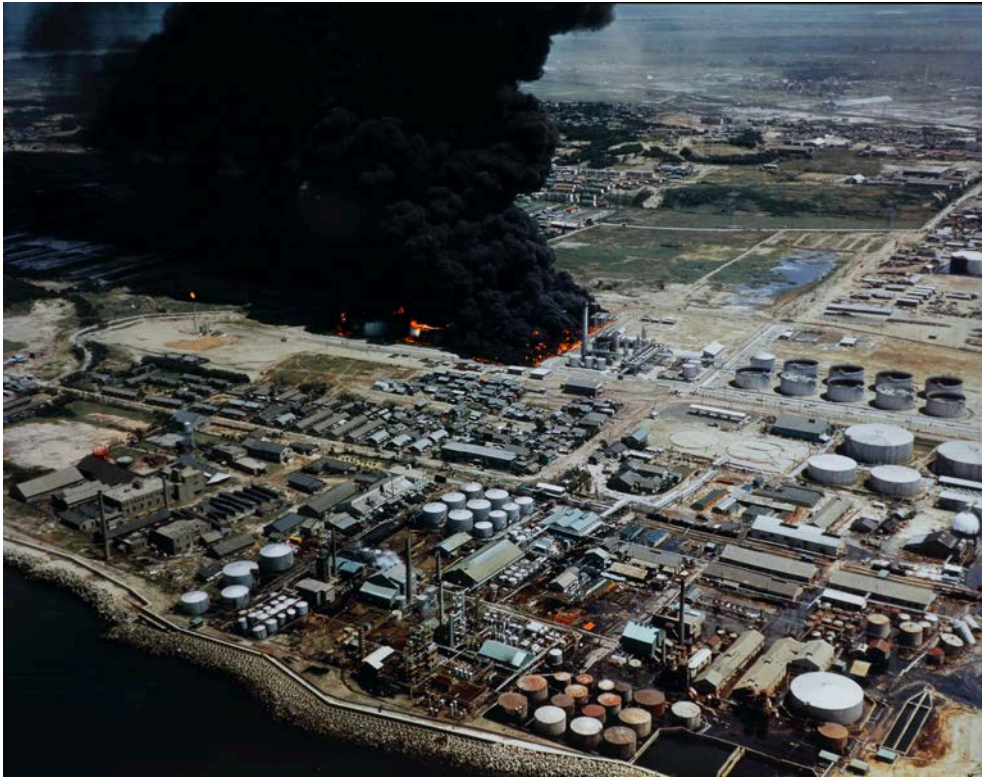
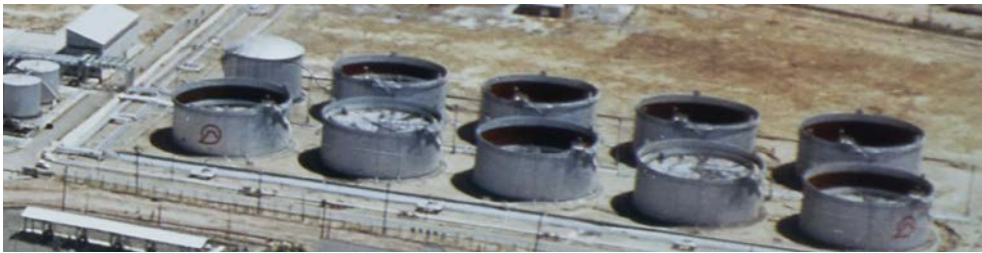
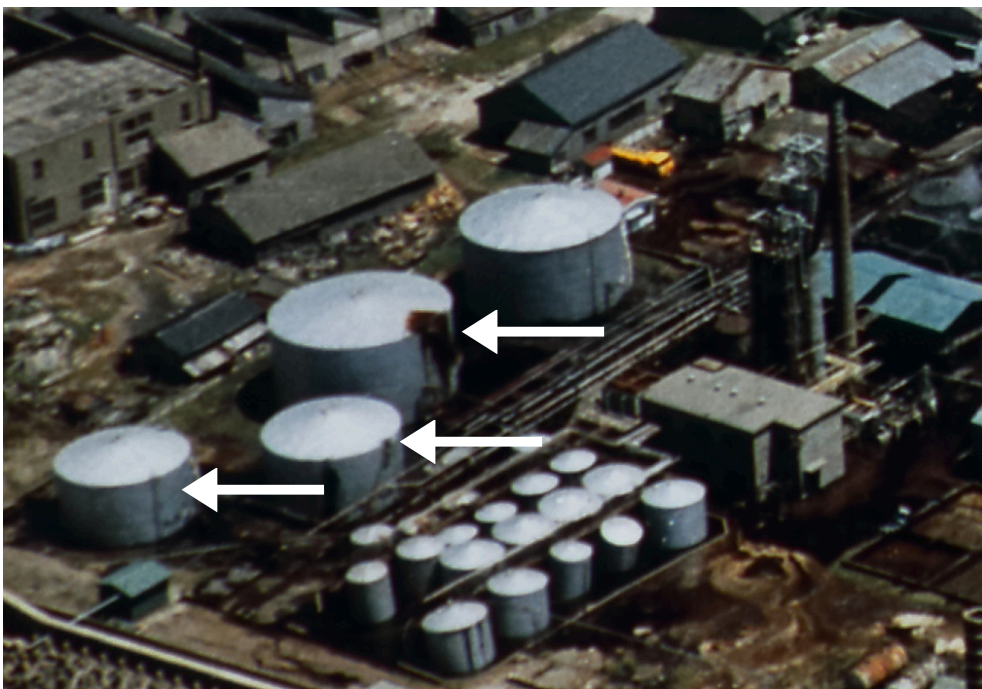
The photo taking was concluded thereafter by visiting again the oil refinery (Figs. 58 to 59) where the first fire was still going on, but the second fire had not started. The details of Fig. 58a are presented in Figs. 58b and 58c. In Fig. 58b, the roof of the tanks are distorted, suggesting the strong shaking and, possibly, the collision of the roof and the wall of the tank that set out fire. Fig. 58c shows brown smears or blots on the tank surface (shown by arrows), which are possibly the evidence of oil leakage. The leaked oil was set on fire later on the same day and probably initiated the second fire later in the evening of the same day.

(b) Broken roof of oil tanks (partially enlarged photograph) タンクの被害

(c) Possible oil leakage shown by brown smear on tank walls (partially enlarged photograph) タンク側面の茶色い部分は油漏れを意味するの
Fig .58. First fire in the oil refinery (1) (magnification of still photo taken by Mr. Yuminamochi) 製油所の状況(1) : タンク側壁に茶色い染みが見える
