MICROZONATION FOR SEISMIC GEOTECHNICAL HAZARDS AND ACTUAL DAMAGE DURING THE 2005 FUKUOKA-KEN SEIHO-OKI EARTHQUAKE

The 2005 Fukuoka-ken Seiho-oki earthquake caused damage to structures due to liquefaction, slope failure and strong shaking in Fukuoka City. One of the authors had conducted microzonation for liquefaction, slope failure and strong shaking about 17 years before the earthquake. After the earthquake, the authors compared the zoning map with the actual damage. The results showed that liquefied sites coincided fairly well with predicted zones in the reclaimed lands. However, they were slightly different in a big sand spit named Uminonakamichi. Failure occurred at several slopes inside the predicted areas, while damage to buildings occurred due to strong shaking along the Kego Fault. The damaged area was slightly different from the predicted area. Furthermore, a liquefaction analysis was conducted and the results of this analysis were compared with the results of microzonation in 1988. In this paper, the authors discuss the validity of microzonation based on this comparison.

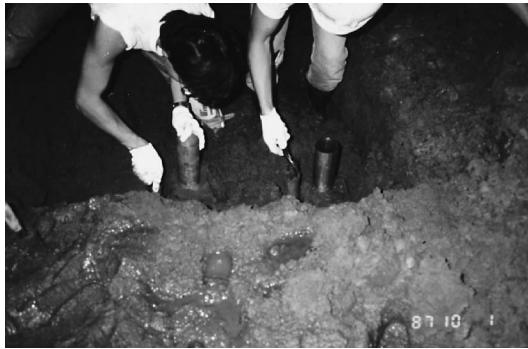
Photo 2 Block sampling at site No. 1

- (1) No. 1, No. 2 and No. 3: Undisturbed samples were taken by the block sampling method. Thin wall tubes of 75 mm in inner diameter, 79 mm in outer diameter and 15 cm in length were pushed into the ground from the bottom of the excavated ditches, as shown in Photo 2.
- (2) No. 4 and No. 5: Undisturbed samples were taken from bore holes by stationary piston samplers. Thin walled tubes of 75 mm in inner diameter, 79 mm in outer diameter and 100 cm in length were used.

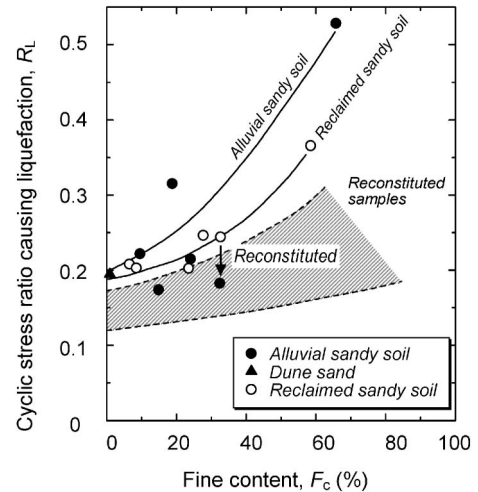
Fig. 5. Relationships between liquefaction strength and fine content of soils in Fukuoka City

$DA=5\%$) are plotted in Fig. 5. As shown in the figure, the liquefaction strength of alluvial sand was higher than those of the reclaimed sand, the dune sand and the reconstituted alluvial sand.

A value of 0.187 was added to the liquefaction strength ratio R of alluvial sand, on the basis of the results shown in Fig. 5. The alluvial sand has much fines though its mean diameter is fairly large, as shown in Fig. 4. This is the reason why the value of 0.187 must be added to the formula used in the specification for highway bridges.

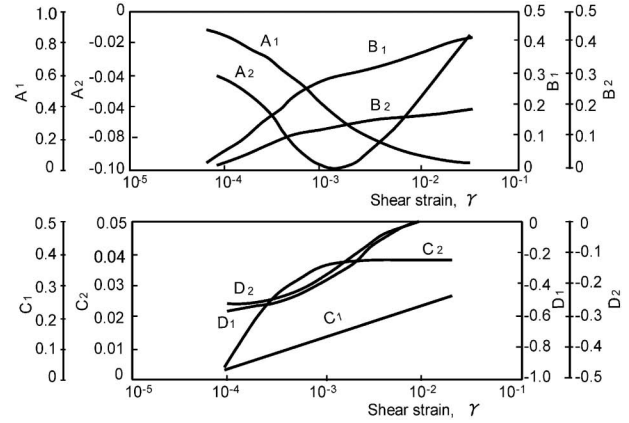
Fig. 8. Coefficients of Equation (3) (Yasuda and Yamaguchi, 1985)

A_1 to D_2 : coefficients shown in Fig. 8

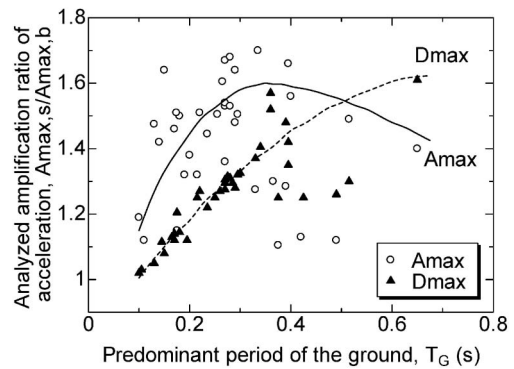
Fig. 9 Relationship between amplification ratio of acceleration, maximum displacement and predominant period of the ground for 1988 microzonation (After Fukuoka City Waterworks Bureau, 1989)

Figure 9 shows the relationships between the analyzed amplification ratio of acceleration, $A_{\max, s}/A_{\max, b}$, the predominant period of the ground, T_G , and the maximum surface displacement, D_{\max} . T_G (sec.) was calculated using the following equation:

The dotted points in Fig. 9 are scattered to some extent. However, assuming that there are comparatively unique relationships between T_G and $A_{\max, s}/A_{\max, b}$, and T_G and D_{\max} , $A_{\max, s}$ and D_{\max} in all boring sites along the 13 soil cross sections were predicted.

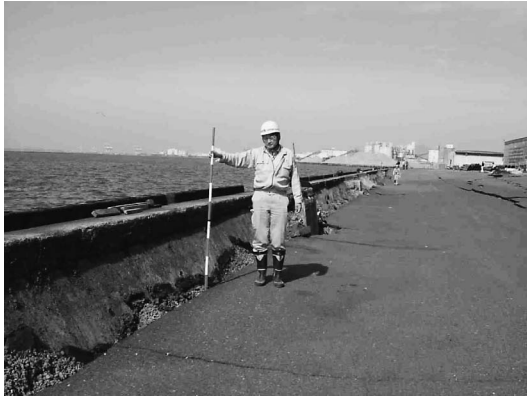
In contrast, in the former reclaimed land, liquefaction occurred at many sites. In Oki-hama, a quay wall tilted, as shown in Photo 3. The horizontal displacement of the quay wall was about 1 m. The ground behind the quay wall flowed toward the bay and subsided. The flow zone extended about 10 m from the quay wall. Several quay walls tilted a little in Nanotsu, Higashi-hama and Aratsu. Two small tanks settled about 10 to 20 cm due to liquefaction in Aratsu. In Momochi-hama, sand boils were observed at many sites, as shown in Photo 4. However,

Photo 3 Displacement of a quay wall and subsidence of the ground in Oki-hama

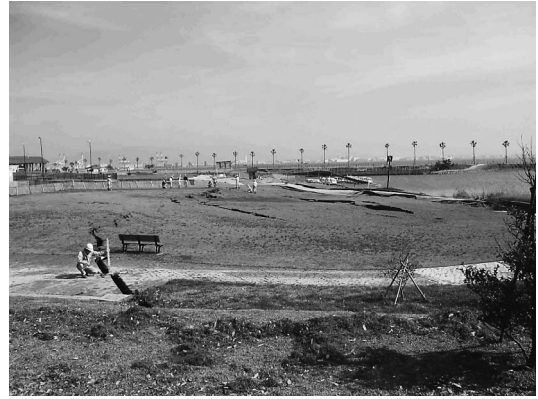
Photo 6 Liquefaction-induced flow at Uminonakamichi Seaside Park

Photo 6 shows liquefaction in Uminonakamichi. This site was newly developed for a park, named Uminonakamichi Seaside Park, by filling part of a pond with sand. Liquefaction occurred at this site and induced ground flow toward the remaining pond. The maximum horizontal displacement due to the flow was about 10 m. Simple piers and promenades were damaged due to the flow.

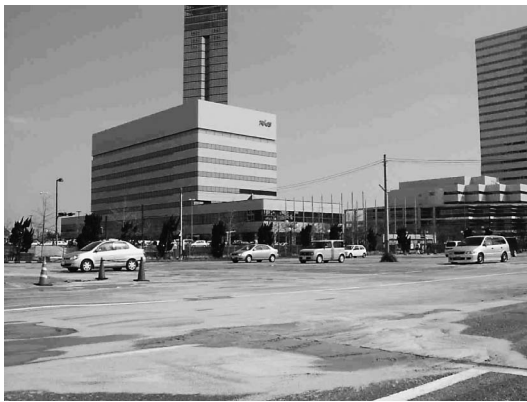
Photo 4 Boiled sand in Momochi-hama

no damage to buildings and timber houses occurred and obvious ground subsidence did not occur at the liquefied sites. Therefore, it is estimated that the liquefied layer was thin.

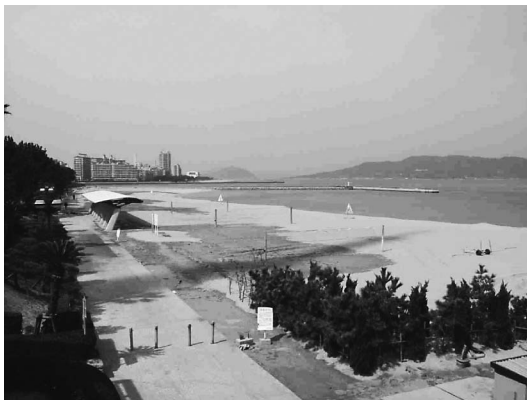
Photo 5 Liquefaction at the man-made beach in Atago-hama

There are two man-made beaches at the front of Momochi-hama and Atago-hama. Many large sand volcanoes were observed on the beaches, as shown in Photo 5. The ground was very loose and the water table was

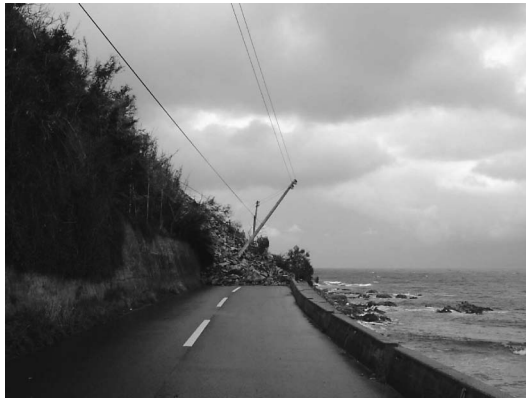
Photo 7 Slope failure in Shikano-shima island

Comparatively large slope failures occurred at three sites in Shikano-shima Island, as shown in Fig. 7. Photo 7 shows the biggest slide, which occurred on the east side of the island. Two other slides occurred on the west side of the island. Shadowed grids in Fig. 7 show the zones where several of the slopes were predicted to be unstable. The three sites in Shikano-shima are located mainly inside the landslide susceptible grids. Therefore, it can be said that the microzonation by the Kanagawa method was fairly valid for Shikano-shima island. However, in the east and south of Fukuoka City, no slope failure occurred in the grids where unstable slopes had been predicted. As the epicenter was located in the northwest, seismic intensity in the eastern and southern areas might have been too low to cause slope failure.

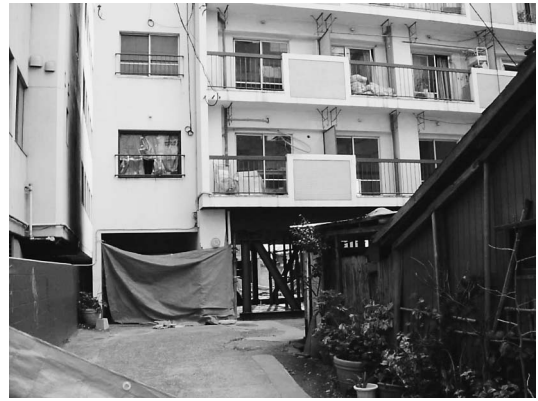
Photo 8 A damaged apartment above the Kego Fault

As shown in Photo 8, several buildings suffered damage near the Kego Fault in the downtown area of Fukuoka City. The closed circles in Fig. 13 show the locations of the damaged buildings, investigated by the Seibu Branch of the Japan Society of Civil Engineers (2005). The area predicted to be susceptible to strong shaking is also drawn in the figure. Four damaged buildings are located inside the predicted area. However, other damaged buildings are located slightly outside the predicted area. The reason why the damaged area was slightly different from the predicted area is not clear. However, one of the authors found a small differential settlement on a road where buildings were damaged, as shown in Photo 9. The

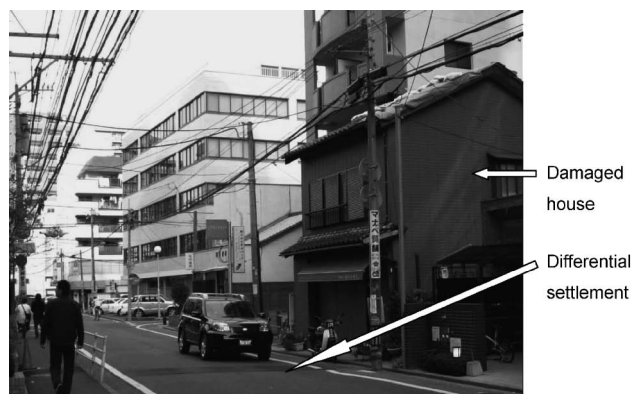
Photo 9 Differential settlement observed above the Kego Fault

site is just above the Kego Fault. One possibility is, therefore, that some vertical differential displacement occurred along the fault and caused the damage to the buildings. More study on the mechanism of the damage

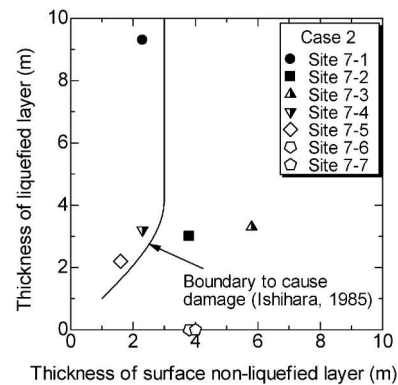
Fig. 16. Relationships between the thicknesses of liquefied layers and the non-liquefied layers estimated in three cases

Site 7-4, sand boil could be explained because the thicknesses of the liquefied and non-liquefied layers are near the boundary to cause sand boil, as shown in Fig. 16.
