PRELIMINARY RECONNAISSANCE REPORT ON
THE 2004 CHUETSU EARTHQUAKE (Mid Niigata Earthquake)

INVESTIGATION DETAILS

- Date: October 29 and 30, 2004
- Area: Ojiya, Kawaguchi, Tokamachi and Horiuchi
- Team members: I. Morimoto, T. Yamashita, T. Tochio, M. Kamei and M. Cubrinovski (Kiso-Jiban Consultants)

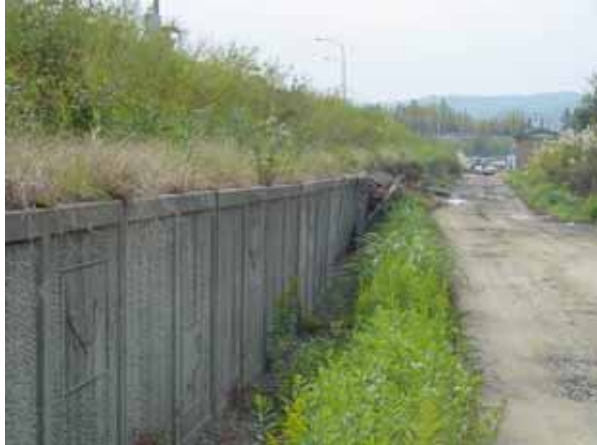
Lateral movement and collapse of the retaining wall at the foot of the embankment (Ojiya side)
