DAMAGES ON WATERFRONT GROUND DURING THE 1999 KOCAELI EARTHQUAKE IN TURKEY

ABSTRACT

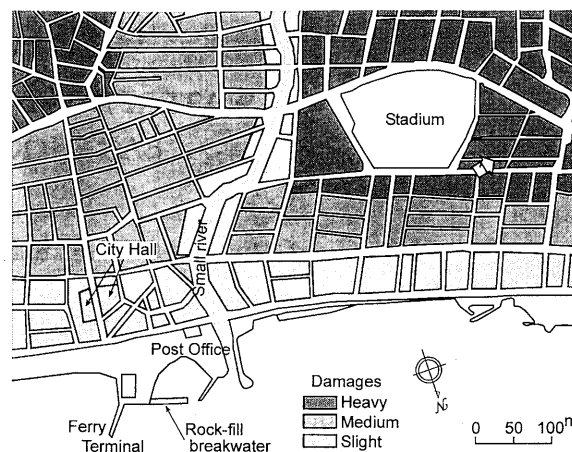
Fig. 2. Map of downtown Yalova city with damage distribution

The Yalova city is a middle size city located in the western side of the Izmit Bay area. Many buildings were damaged by an inertia force. Figure 2 shows damage distribution of the city. Damage was in general low in the area along the shoreline, and it became severe as the distance from the sea increased. In this figure and subse-

quent figures, hollow arrow symbols are locations where photographs were taken and the number denotes the photograph number. Totally collapsed buildings were frequently seen in heavily damaged areas, a typical example is shown in Photo. 1. On the contrary, geotechnical damage was small even along the shorelines. The only exception was a differential settlement in the rockfill breakwater near the ferry terminal.

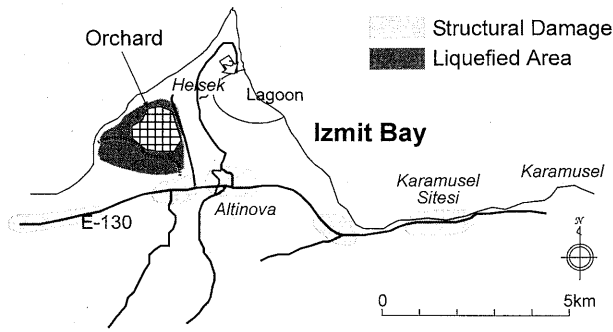
Fig. 3. Map showing the damaged area in the Altinova peninsula

There was a lagoon in the east of the Helsek district, Altinova Peninsula, whose location is shown in Fig. 3. This lagoon waterlogged only in high tide before the earthquake, but became to waterlog all the time after the earthquake, as shown in Photo. 2. Subsidence occurred mainly in this lagoon. A maximum subsidence have been of the same order as the tidal range, i.e., several tens cm at maximum. Evidence of liquefaction such as a sand boil was not observed in this region. The reason of the subsidence is not clear at present.

On the contrary, liquefaction was observed in the west of the peninsula, as shown in Fig. 3. Figure 4 shows a detailed map of this region. A significant amount of sand boils was observed at the orchard.

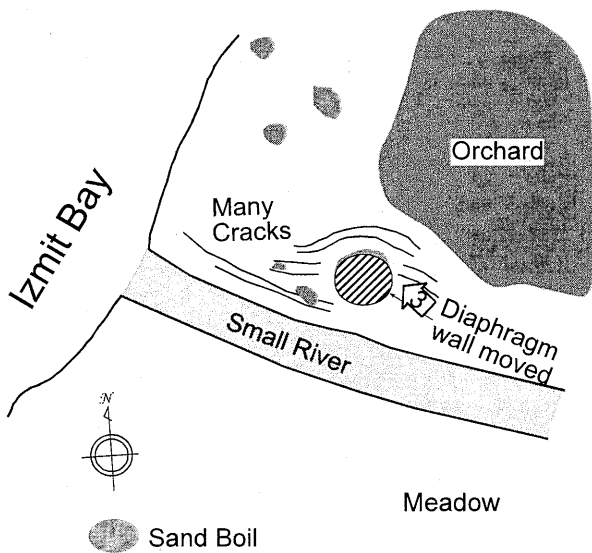
Fig. 4. Detailed map of the liquefied site in the Hersek district

A small river flowed into the Izmit Bay passing the orchard. Several cracks ran parallel to the river near the river-mouth as schematically shown in Fig. 4. Several sand boils were observed nearby. These observations suggest that a liquefaction-induced flow occurred.

parallel to the river were also seen as shown in Fig. 4 and Photo. 3, and blue colored sand boils were observed on the side opposite to the river. The pit seemed to move toward the river probably because the ground had become loosened by soil liquefaction.

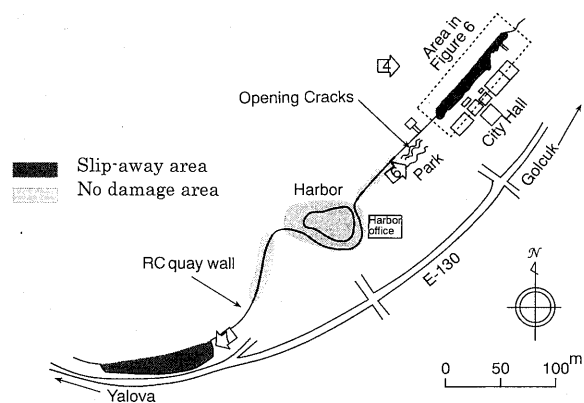
Fig. 5. Map in the vicinity of Karamusel

Karamusel city is the most western city among areas where significant ground failure was observed along the shoreline. Figure 5 shows a map in the vicinity of the Karamusel city with damage and no damaged area along the shoreline.

Flowed out ground was also observed in the western part of Fig. 5, as shown in Photo. 7. Reinforced concrete quay wall tore off at the boundary to the remained portion. In addition, cracks parallel to the old shoreline were frequent in the backfill ground. Sand boils were also observed. They did not, however, seem to be a cause of the flow in the fill. According to a interview of fishermen,

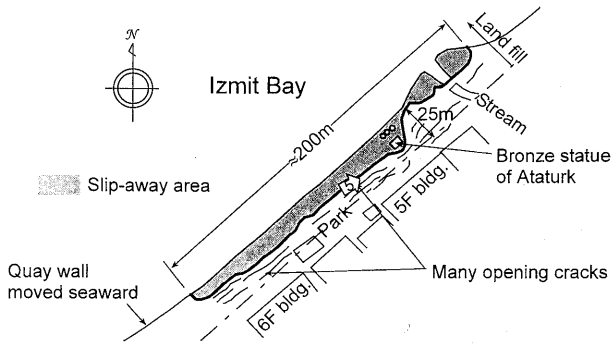
Fig. 6. Detailed map of lost shoreline at Karamursel

A fill area of about 200 m long and 25 m wide flowed out into the sea at the eastern end of this map. Details of this area are shown in Fig. 6 and Photo. 4. This fill was developed in 1968. Many cracks ran parallel to the shoreline on the rest of the fill and a little on the natural deposit. According to an interview with a resident, the seabed was about 100 m deep and the slope of the seabed was steep. The value of 100 m seems unlikely, so this report probably just indicates a deep and steep seabed. The section face of the remained part is shown in Photo. 5; the section is vertical. Considering the original deep and steep seabed and observation of damage, slope instability is supposed to have occurred here. Damage to buildings in the background was light.

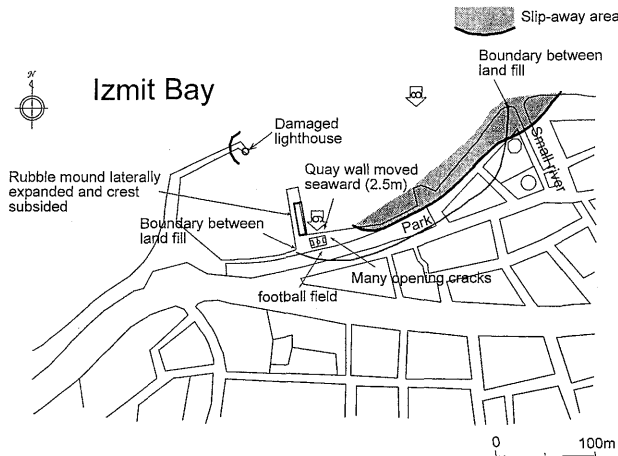
Fig. 7. Map in downtown of Ulasli

An area about 300 meters long and 40 m wide flowed out into the sea in the Ulasli city, as shown in Fig. 7 and Photo. 8. Most of the park was fill with the crashed rock taken from nearby mountains. The stone masonry quay wall was developed in 1986. Several cracks were observed in the backfill ground, which ran parallel to the shoreline. Evidence of liquefaction was not observed.

There was a small river on the east side of the park. The riverbed was fairly steep and the river-mouth was a fan shape, which suggests that this area is an alluvial fan deposit. Gravel with fairly large diameter has deposited near the river-mouth, which is supposed to have been carried by a flood. Loss of the ground, therefore, occurred not only in the fill but also in the natural deposit.

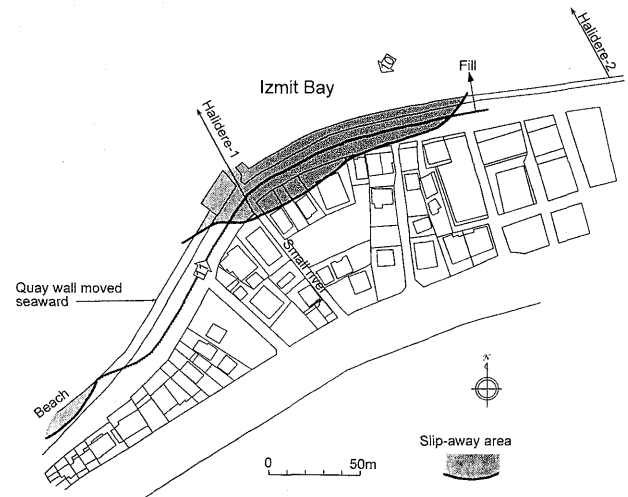
Fig. 8. Map of Halidere district with flowed out area

A piece of the north region about 200 m long and 20 m wide disappeared into the sea in the Halidere city, as shown in Fig. 8 and Photo. 10. The road broke as shown in Photo. 11, in which photographs taken before and after the earthquake are compared. A stream ran on the west of the damaged area, and the slope of the river is fairly steep at 6.5 degrees. This region is again supposed to be a fan deposit.

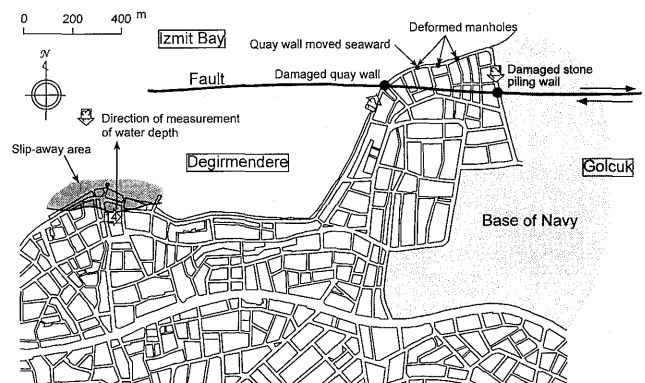
Fig. 11. Earthquake affected areas in Degirmendere

The earthquake affected area in the Degirmendere city is shown in Fig. 11. Two types of geotechnical damages were observed in the city. One was damage induced by a fault in the east of the city; structures were damaged by a surface fault. The other was a loss of the ground in the west of the city, which was probably caused by a submarine landslide the same as before mentioned cities.

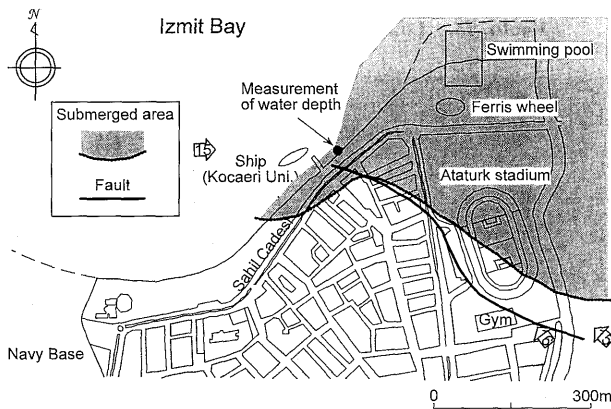
Fig. 13. Location of land subsidence and fault in Golcuk

A fault was found to run from the northwest to the southeast direction in the Kavakli district in the Golcuk city. This fault is assumed not to be a main fault but a branch fault because the main fault is assumed to run near the center of the Izmit Bay from the east end of the bay. The north part of the fault is shown in Fig. 13. There were many buildings significantly damaged by an inertia force in the south of this fault, but, they will not be described in this paper.

The main fault dislocated in a right-lateral way (Okamura and Matsuoka, 2000). There was, however, no horizontal offset; only a vertical offset was observed along this fault. The vertical offset was about 1.5 m at the east end of Fig. 13 and Photo. 15, and it gradually decreased to the west; it disappeared near the Sahil Cadesi (street).

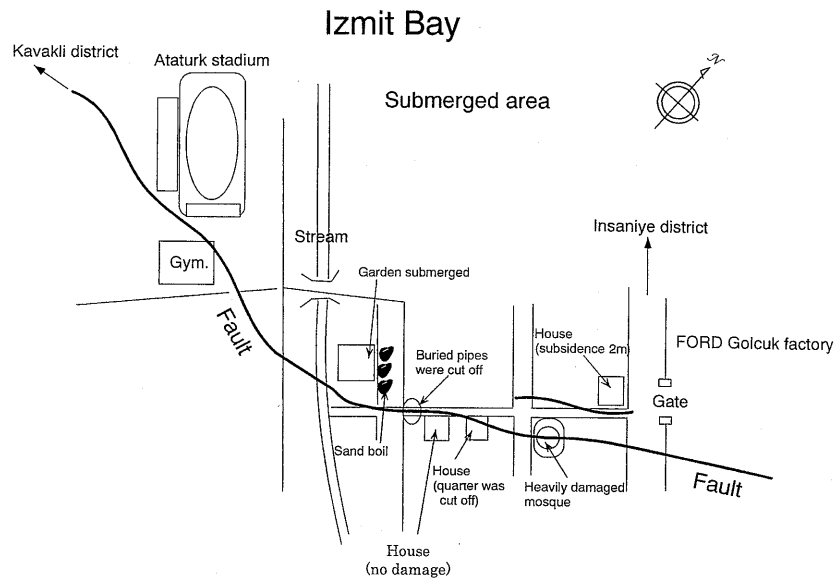
Fig. 14. Detailed map of fault and damage near the FORD Golcuk factory

The fault in Fig. 13 ran toward east or southeast outside the map, which is shown in Fig. 14. Structural damages were obtained along the fault due to vertical offset, as written in Fig. 14. The vertical offset of about 1.5 to 2 m continued inside the Ford Golcuk automotive factory located at the east end of Fig. 14 and continues more to the southeast direction.

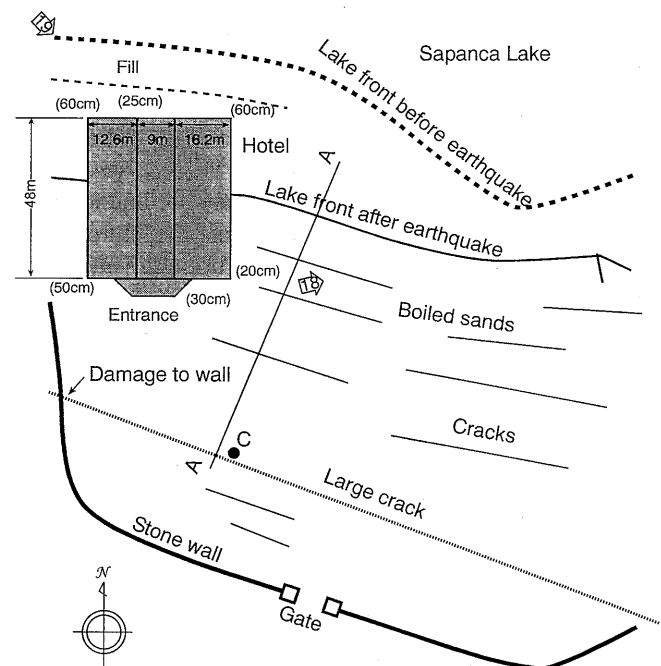
Fig. 15. Schematic figure showing damage at the Sapanca Hotel

A hotel employee who checked around the building at 7 AM the next morning after the earthquake found that the fill on the lake side had submerged a little, but the floor of the building did not submerged; settlement of the building and subsidence of the ground continued after the earthquake. He also reported that the huge sand boils and cracks in the yard were already there at that time.

The total amount of the settlement of the building can be evaluated roughly 1.5 m. On the other hand, settlement of the building relative to the ground surface is several tens cm, as shown in Fig. 15, in which relative settlement at the corner of the building is written in parentheses. Therefore, the ground itself is supposed to have subsided for about 1 m, as easily seen in
