Mr. Yuminamochi's photographs depicting ongoing liquefaction disaster
during the 1964 Niigata earthquake
1964 年新潟地震に際して液状化発生と震災直後の市内の状況を映像記録した
弓納持福夫氏の業績

Ikuro Towhata¹, Nozomu Yoshida²

ABSTRACT

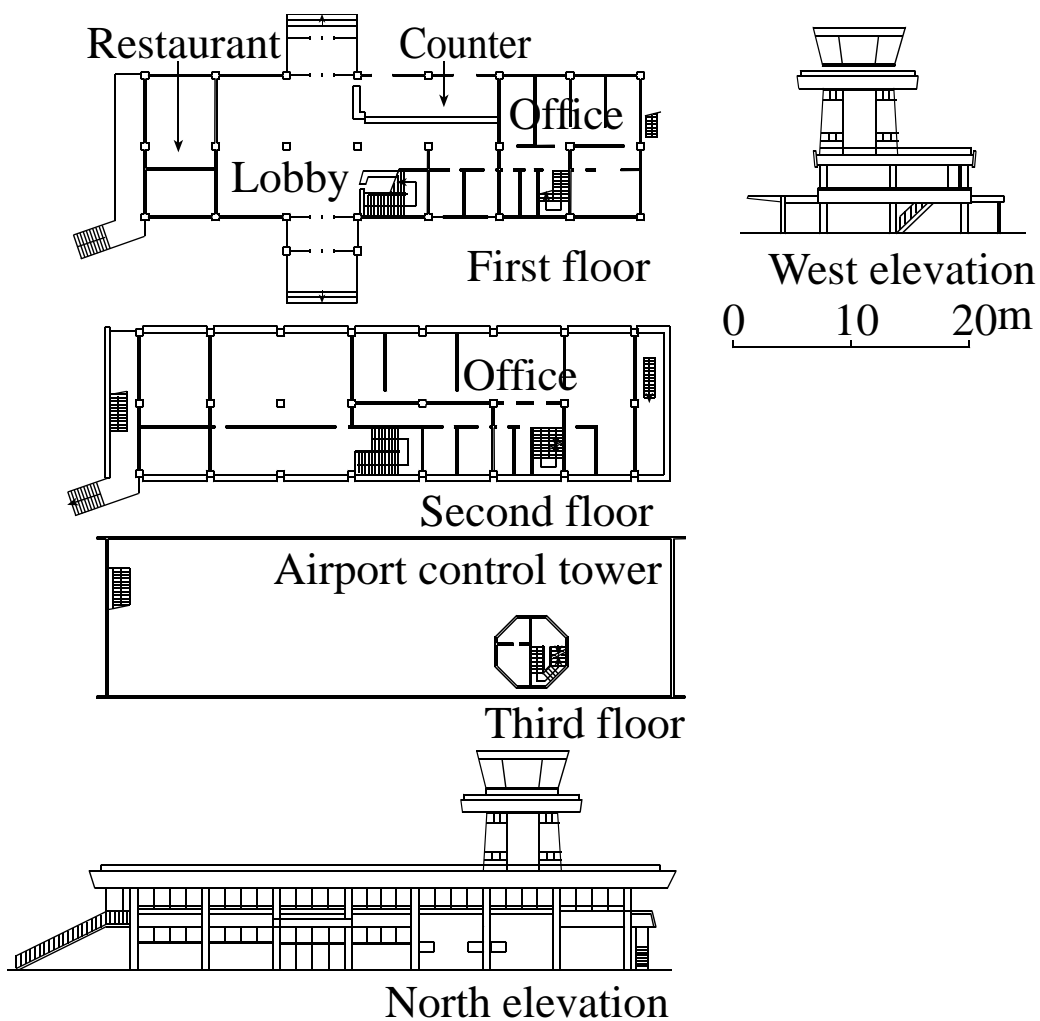
Fig. 5. Conceptual sketch of the terminal building in Niigata Airport (the liquefaction-induced subsidence of the first floor under the ground surface) 新潟空港ターミナルビル地震前の状況のスケッチ

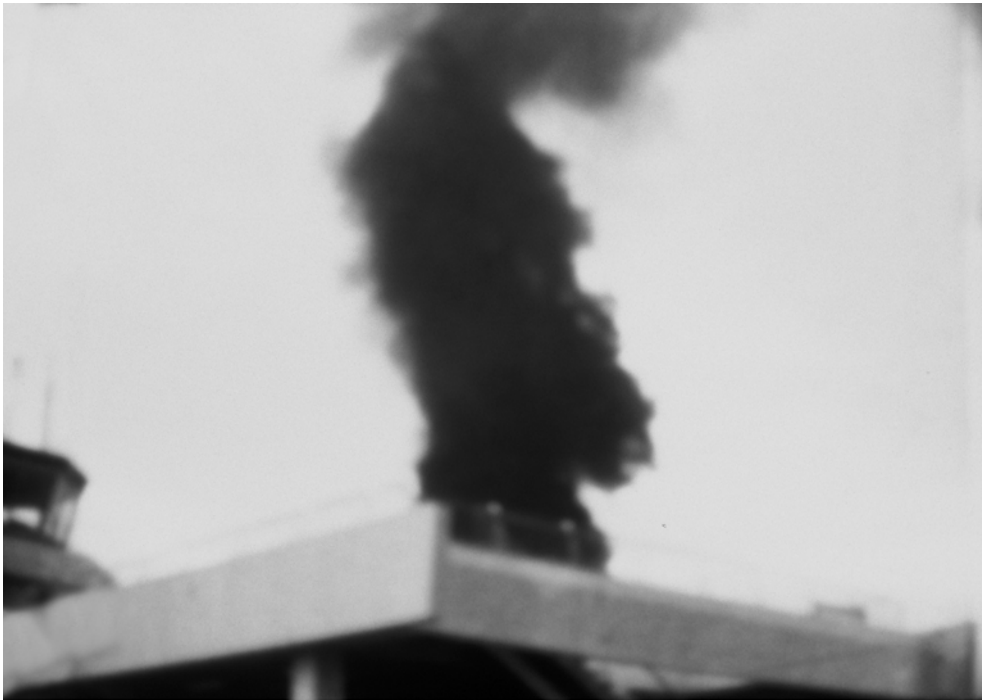
Soon after this moment, Fig. 8 of black smoke in the sky was taken. This smoke likely came from the fire in the oil refinery in the airport vicinity. Mr. Yuminamochi intended to record the timing of the fire by this photograph, saying that the smoke was recorded about three minutes after the onset of shaking⁶⁾. Therefore, it is reasonable that the fire started approximately at the same time as the onset of ground shaking. Then, Figs. 9 and 10 indicate that the ejected water spread rapidly into the airport apron where two aircrafts were ready to take off. Out of them, the smaller one was what Mr. Yuminamochi was going to take. Fig. 11 illustrates the terminal building again wherein the building is substantially submerged in the ejected water but no structural damage is seen in walls, columns and windows. The rate of motion picture was 18 frames per second. After these experiences, the pilot, Mr. Sato, told Mr. Yuminamochi to get aboard the aircraft to escape from this dangerous place.

Fig. 8. Black smoke coming from the oil refinery (captured and enlarged from Mr. Yuminamochi's motion picture) 製油所から上る黒煙

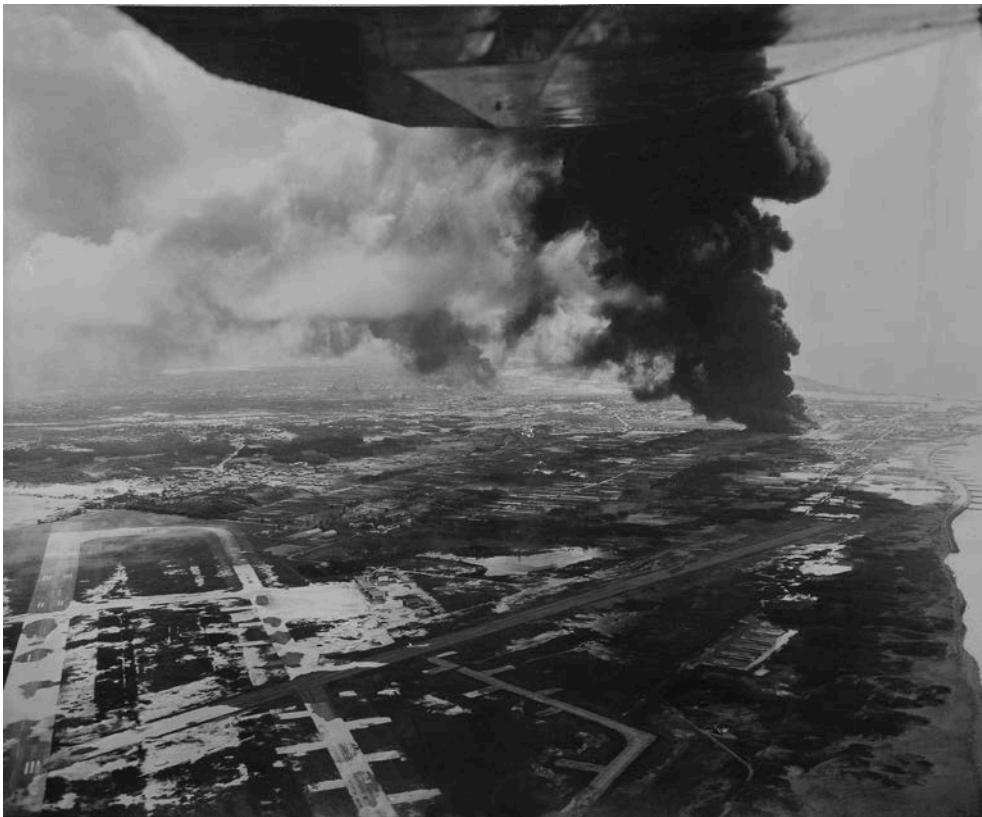
The still photographs are explained in what follows. Fig. 13 shows the fire in the oil refinery that is located between the airport and the Shinano River mouth (Fig. 12). Figs. 13 and 14 show that the surface of the airport was covered by liquefaction-ejected water. Note here that Mr. Yuminamochi got seated on the left side of the aircraft throughout his flight.

Fig. 14. One of the two runways of Niigata Airport towards the right from which the aircraft took off (still photo taken by Mr. Yuminamochi) 噴出水に覆われつつある滑走路

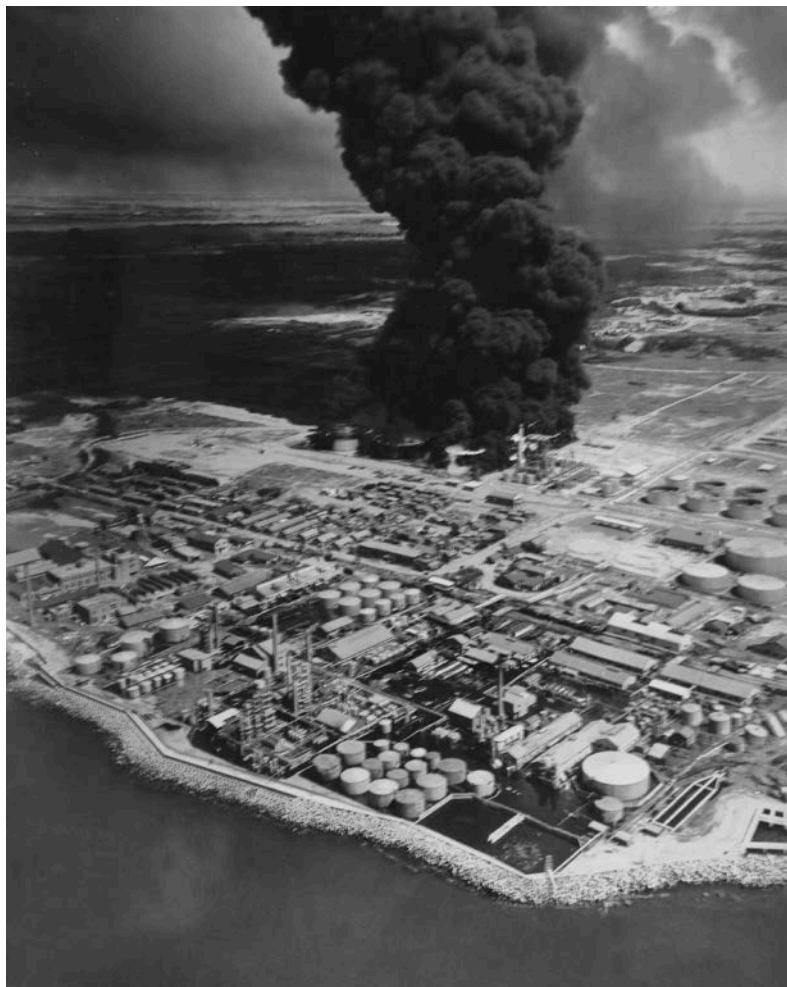
indicate the fire from shorter distances. Note herein that the fire occurred in the inland area, with no influence of tsunami inundation. The second fire near the sea area (Fig. 18) started later at 6 PM on the same day⁸⁾ and had not yet started when the photographs were taken. The second fire triggered explosions of many oil tanks. Until it was extinguished at around 5 PM on June 20th, 27 families lost their houses in addition to the abovementioned explosion of oil refinery facilities. The reason of the delayed occurrence of the second fire is unknown. Because the affected area was inundated by tsunami water, it is likely that the burning oil was transported into a bigger areas by the flow of water.

Fig. 18. The area of what was going to be the second fire of oil refinery near the sea (not yet started) in front of the first fire (still photo taken by Mr. Yuminamochi)
手前は夕刻になって発生することになる第二火災の現場

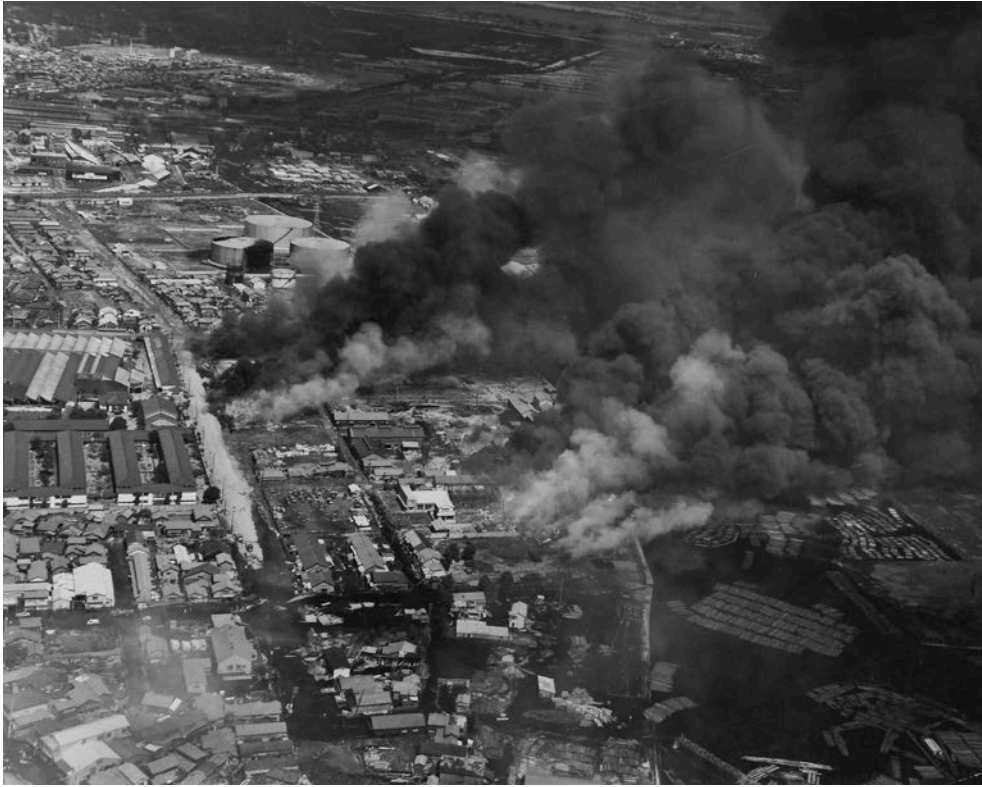
After viewing the oil refinery, the aircraft came into the city area. Two fires in Fig. 19 occurred near the Tsusen River (shown in Fig. 12), which is a minor canal today but used to be the bigger main channel of the Agano River until its flood in 1731. These two fires

Fig. 19. Fires in Matsushima-2 on the north bank of Tsusen River (still photo taken by Mr. Yuminamochi) 通船川北岸松島二丁目の火災

were extinguished by firefighters^{7), 8)} but recalled Mr. Yuminamochi of the catastrophic fire in Tokyo triggered by the 1923 gigantic Kanto earthquake. The fire in Fig. 20 on the left (north) bank of the Shinano River recalled him again of the disaster in 1923; his wife and a new-born baby remained in the city. Fortunately, the area of this fire near the Shinano River was flooded later by the water of tsunami that, at least partially^{7), 8)}, extinguished the fire and helped the city avoid catastrophic disaster.

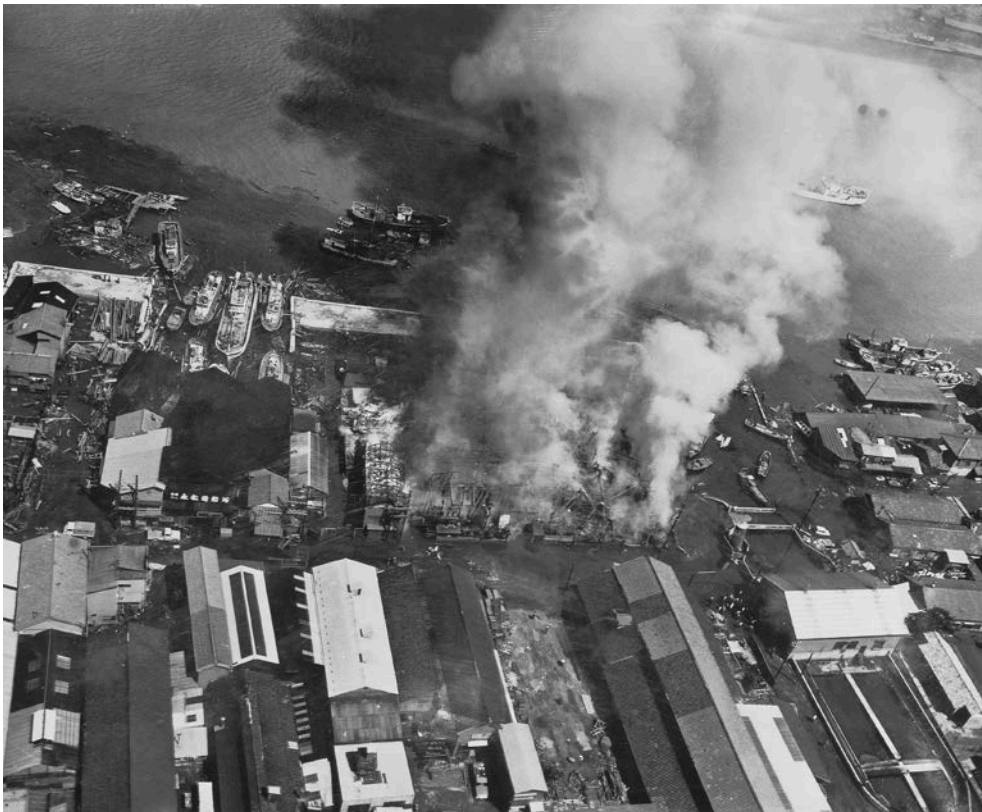
Fig. 20. Fire in Fujishima-3 on the left bank of Shinano River (still photo taken by Mr. Yuminamochi) 信濃川北岸藤島三丁目の火災

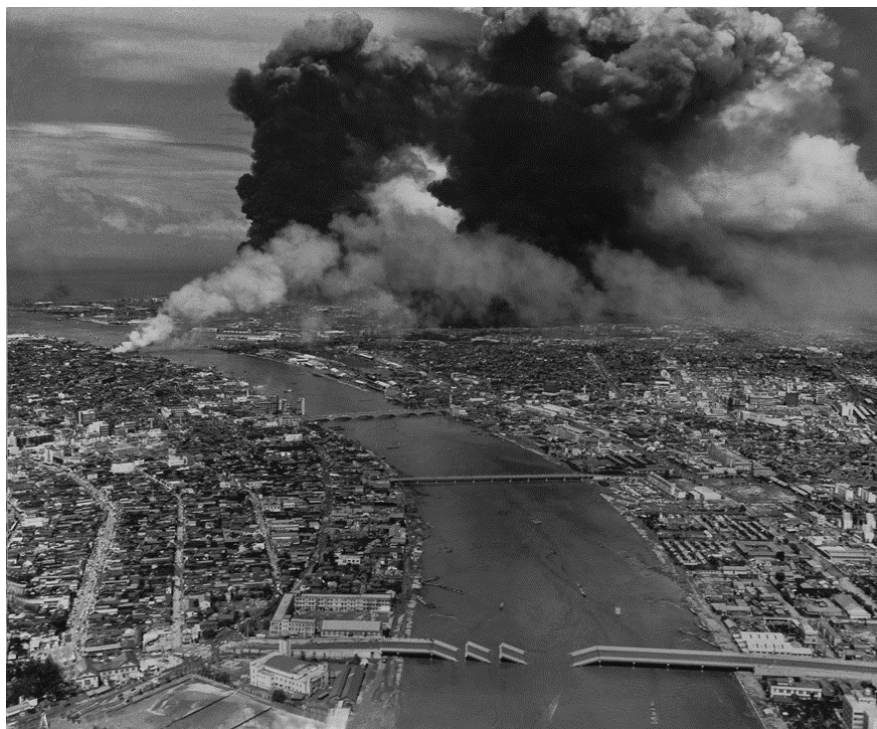
Figs. 29 and 30 were taken when the aircraft was flying near the Showa Bridge. This photographic view towards the downstream area recognizes three fires; white smoke on the northern side (left side) of the river came from the fire in Fig. 20. The dark smoke came from more downstream areas and seems to be a mixture of the fires in the oil refinery (Fig. 18) and the fire in factories (Fig. 19). Fig. 29 appeared in the New York Times on June 17¹³⁾.

Fig. 29. Aerial view from the Showa Bridge towards the mouth of the Shinano River (1) in which the three bridges are the fallen Showa Bridge on the front side, the Yachiyo Bridge in the middle and the Bandai arch bridge at the far distance (still photo taken by Mr. Yuminamochi) 昭和大橋上空から信濃川河口方向を望む

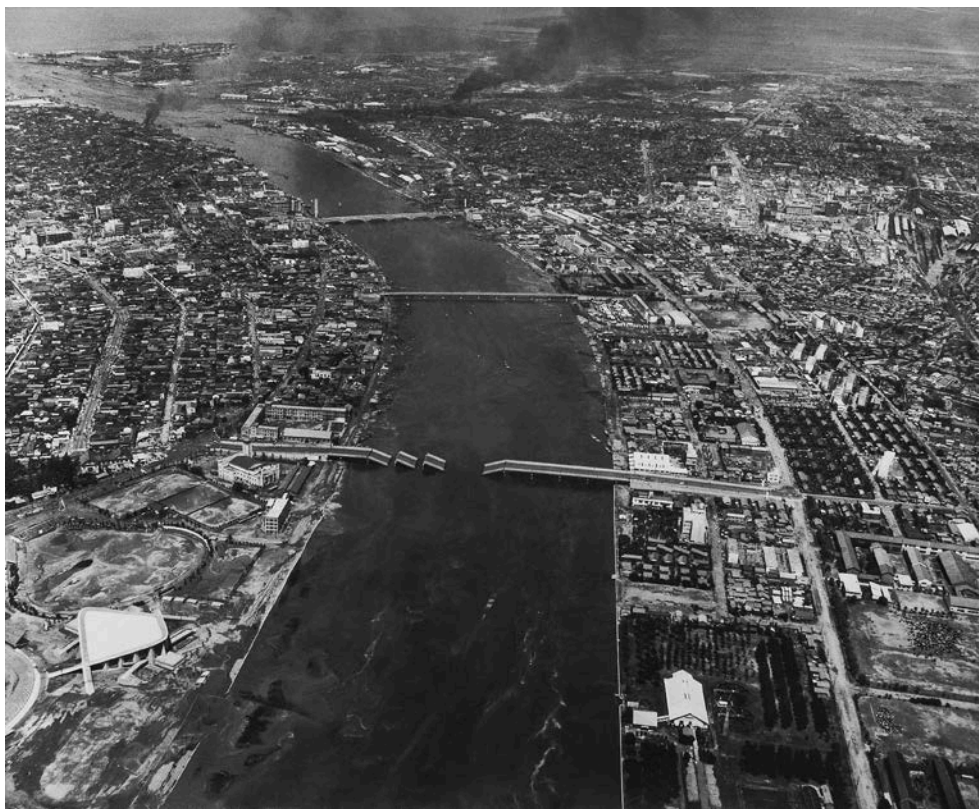
Fig. 30. Aerial view from the Showa Bridge towards the mouth of the Shinano River (2) (still photo taken by Mr. Yuminamochi) 昭和大橋上空から信濃川河口方向を望む

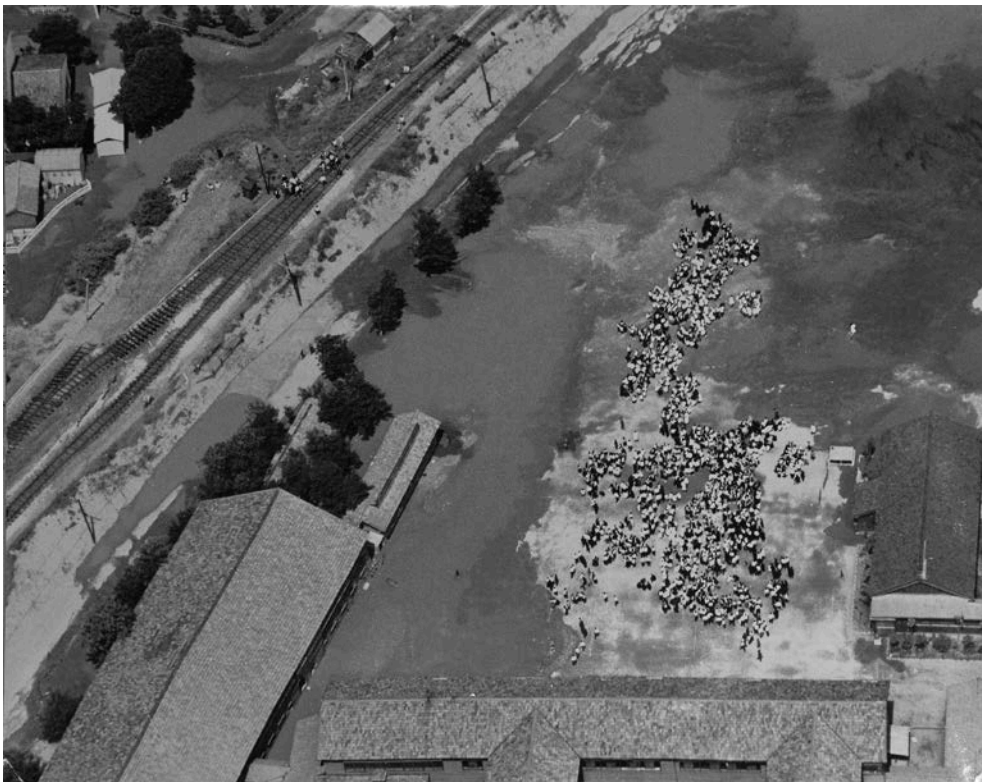
Fig. 36. People seeking for dry place near the Hakusan Station of Echigo Railway (still photo taken by Mr. Yuminamochi) 越後線白山駅周辺で、水におおわれていない場所に避難する人々

Figs. 36 and 37 depict the situation in the residential district near the Hakusan Railway Station. People are seeking for the areas that are not flooded by water (Fig. 36). The water in Fig. 37 came probably from liquefaction, whereas the other possible water source is inundation under tsunami water. The railway embankment in Fig. 36 was distorted significantly due to its subsidence into liquefied subsoil (Fig. 38).

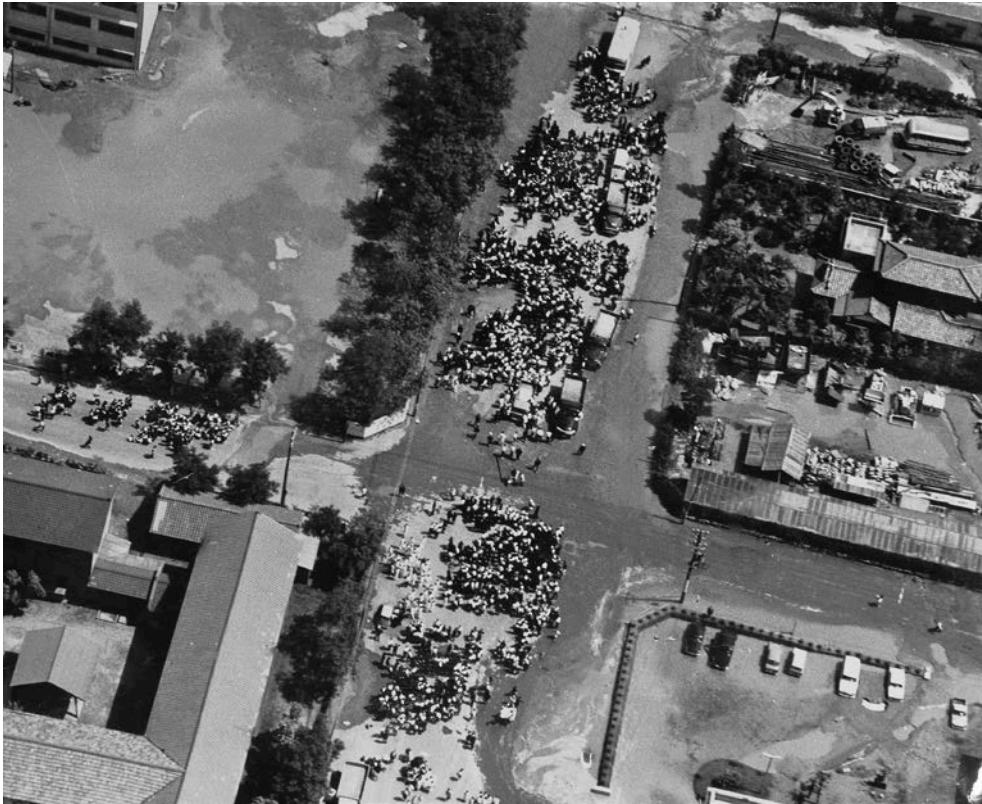
Fig. 37. People seeking for dry evacuation place (still photo taken by Mr. Yuminamochi) 乾いた地面に避難する人々

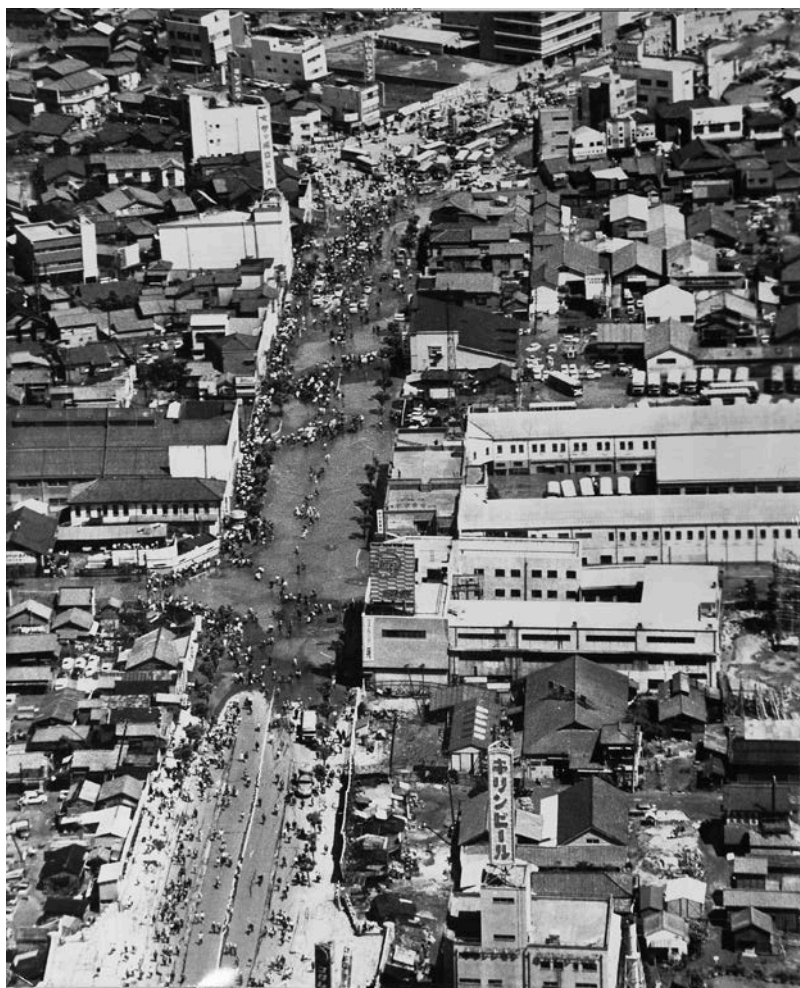
From Fig. 39 on, the views are presented on the situation near the Niigata Station on the southern side of the Shinano River. First, Fig. 39 depicts the situation along the East Main Street from the Bandai Bridge (below the bottom of this picture) towards the south. In the middle of this picture, the road surface is entirely flooded (by liquefaction water, tsunami inundation, or their mixture). To the further south, Fig. 40 illustrates a similarly affected situation in the area of the East Main Street and the Akashi Street. Pay attention to the tilting of an RC building. This building is more closely presented in Figs. 41, 42 and 43. In spite of its substantial subsidence and tilting, there is no structural damage; walls, columns and windows are intact. It deserves attention in Fig. 40 that other buildings did not undergo noticeable tilting or subsidence. Possibly, local soil conditions were different from place to place but there is no further evidence. Fig. 42 illustrates a clear contrast in damage extents of this RC modern building and a more classical wooden two-storey house. The latter exhibits virtually no subsidence probably because its contact weight (weight per unit footprint area) was lighter than that of the RC building and was less likely to subside into the liquefied ground. The direction of tilting of the RC building (Fig. 42) was towards its back side most likely due to the eccentricity of its gravity center, as suggested by the additional roof structure. Fig. 43 clearly demonstrates the subsidence of this building into liquefied subsoil. The intact glass of window is noteworthy, implying that liquefaction unlikely causes structural damage of buildings and houses.

Fig. 39. View on the south bank of the Shinano River; from the Bandai Bridge along the East Main Street, towards the Niigata Railway Station (still photo taken by Mr. Yuminamochi) 万代橋上空から新潟駅方向を望む

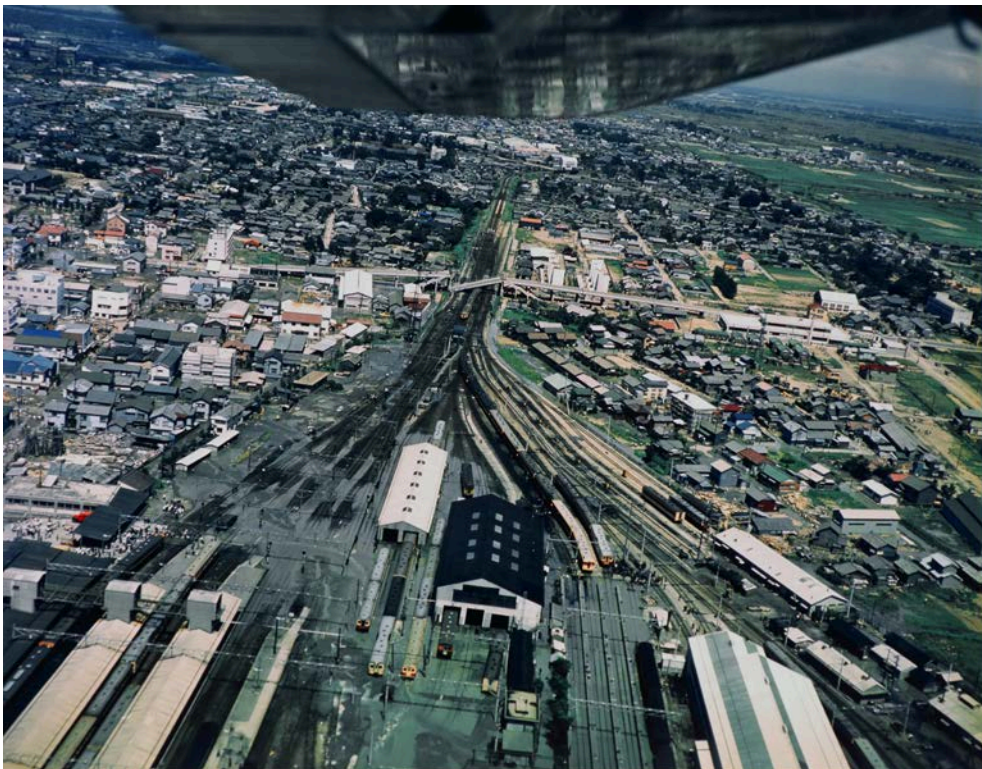
Fig. 44 indicates the northern side of the Niigata Central Railway Station. The dark color on the surface implies the ejected liquefied sand and water, but another possibility is the leakage from broken water pipelines. A more serious problem happened to the east of this station where an overpass bridge fell down onto a train (Figs. 45 to 49). Substantial distortion and probably buckling of rails are visible in these photos. It is also found in Fig. 45 that the ground surface in the station is covered by grayish materials that are most probably liquefaction sand ejecta. A similar material is also found in Fig. 46 to 49 on both sides of the railway track. Any relationship between liquefaction and the damage of the overpass is not known.

Fig. 45. View towards the east of Niigata Central Station (still photo taken by Mr. Yuminamochi) 新潟駅東方の鉄道線路の状況

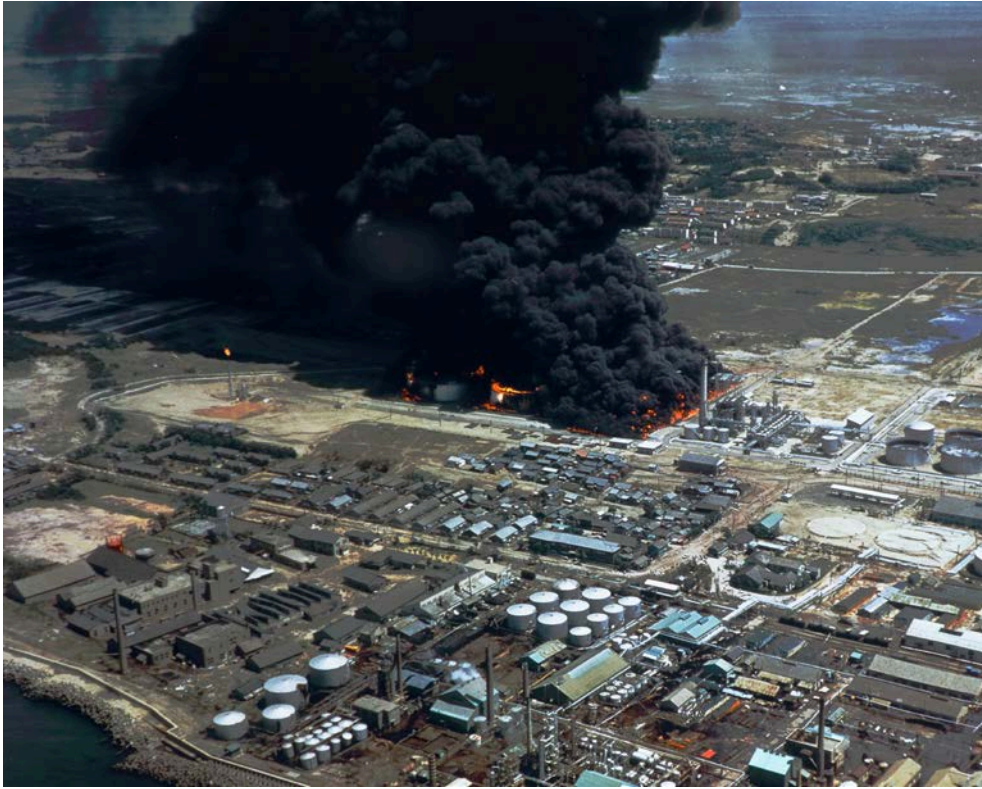
The photo taking was concluded thereafter by visiting again the oil refinery (Figs. 58 to 59) where the first fire was still going on, but the second fire had not started. The details of Fig. 58a are presented in Figs. 58b and 58c. In Fig. 58b, the roof of the tanks are distorted, suggesting the strong shaking and, possibly, the collision of the roof and the wall of the tank that set out fire. Fig. 58c shows brown smears or blots on the tank surface (shown by arrows), which are possibly the evidence of oil leakage. The leaked oil was set on fire later on the same day and probably initiated the second fire later in the evening of the same day.

Fig. 59. First fire in the oil refinery (2) (still photo taken by Mr. Yuminamochi) 製油所の状況(2)
