PRELIMINARY RECONNAISSANCE REPORT ON
THE 2004 CHUETSU EARTHQUAKE (Mid Niigata Earthquake)

INVESTIGATION DETAILS

- Date: October 29 and 30, 2004
- Area: Ojiya, Kawaguchi, Tokamachi and Horiuchi
- Team members: I. Morimoto, T. Yamashita, T. Tochio, M. Kamei and M. Cubrinovski (Kiso-Jiban Consultants)

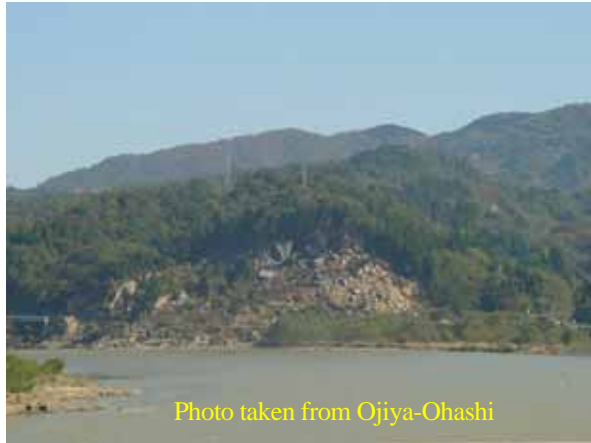
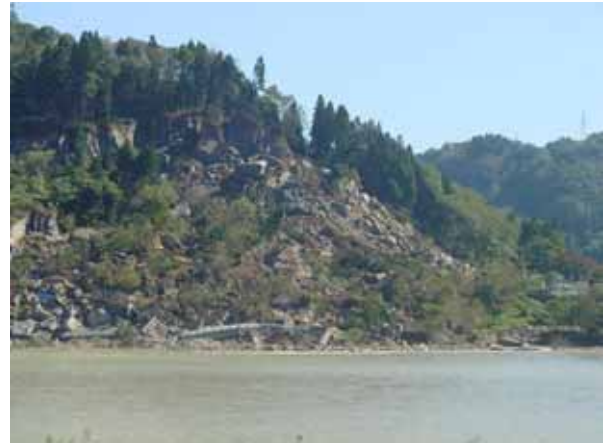
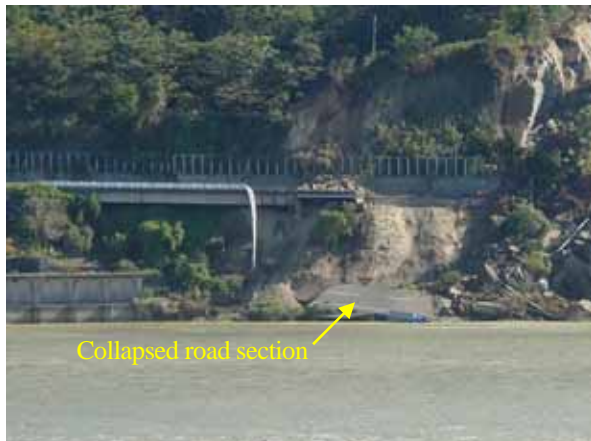
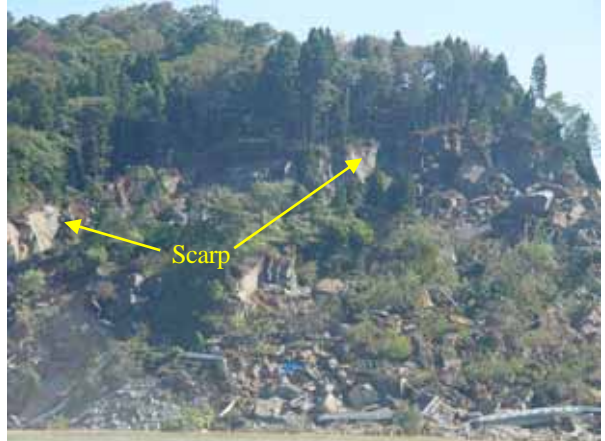
(1) Large landslide took place in the area of Myoken-machi where a section of Road No. 589 was crosscut and buried into slide debris. Part of the road collapsed into the river. The slide was about 250 m wide and the debris included rocks and large boulders. **Location -1**

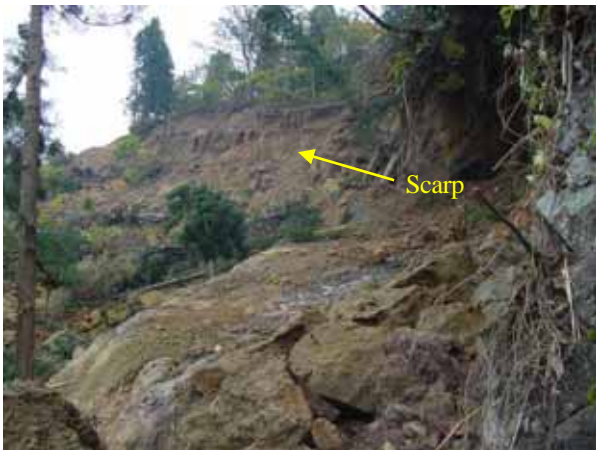
Upper part of the slide (showing the scarp)

Debris in the mid part of the slide

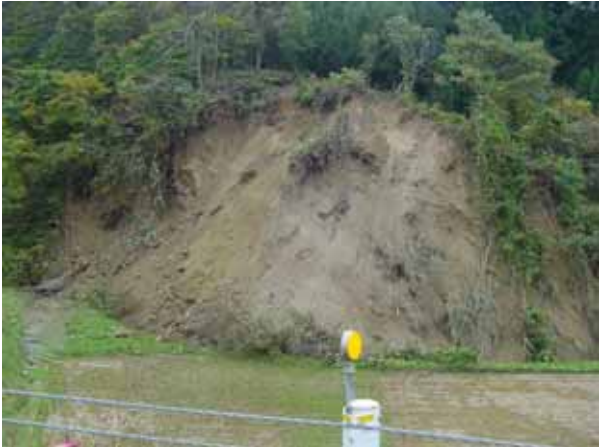
(4) Slides and rock falls took place at numerous locations on steep slopes, mountain walls and road cuts.

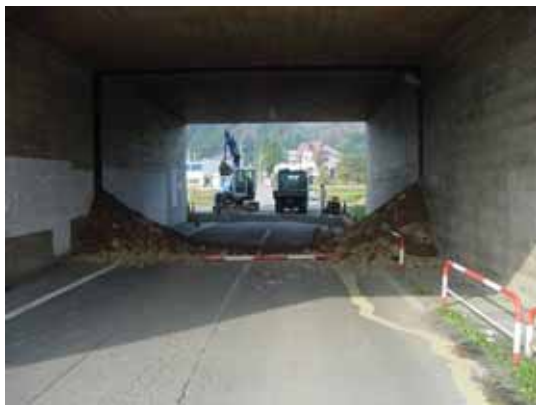
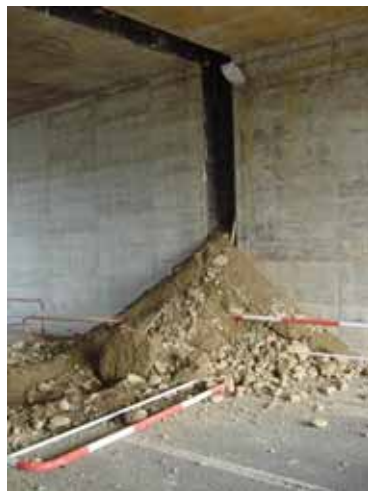
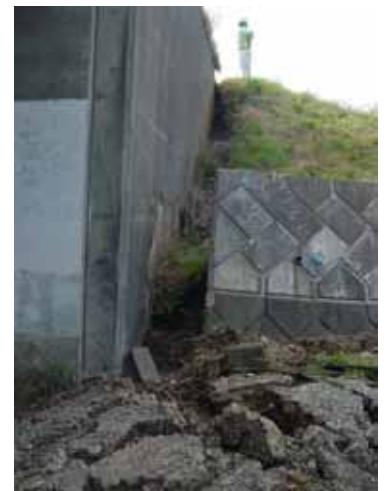
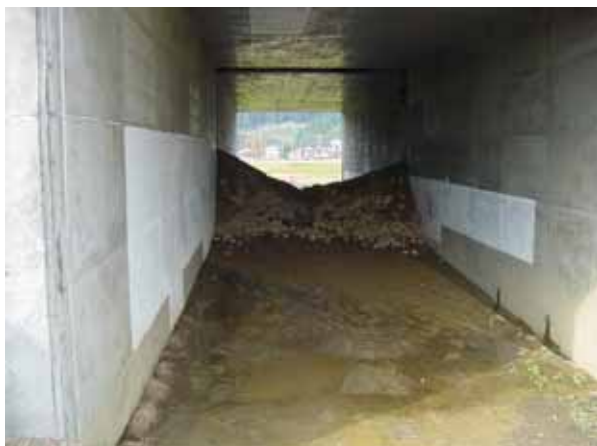
Lateral movement and collapse of the retaining wall (mountain side); Concrete culvert in the underpass of the highway

The culvert composed of two sections moved laterally towards the embankment slopes splitting the mid connection and creating opening from which fill soils fell down and partially buried the underpass. The concrete slab sunk about 15-20 cm.

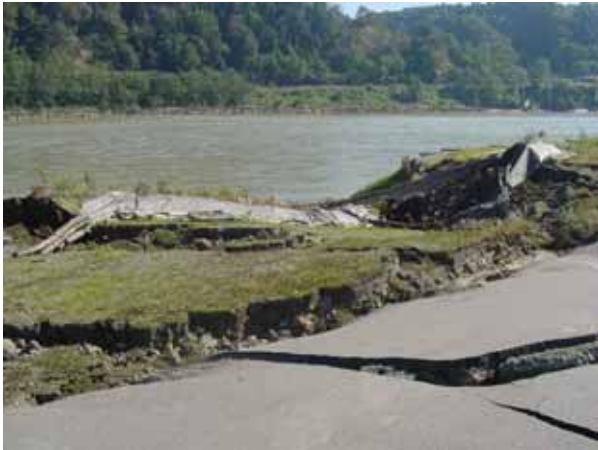
Ground distortion behind the quay wall;

Sand boils

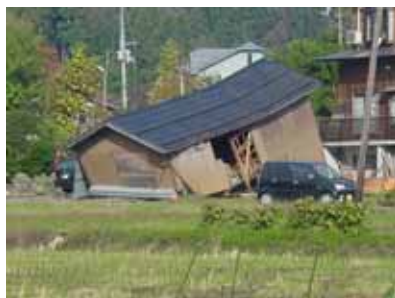
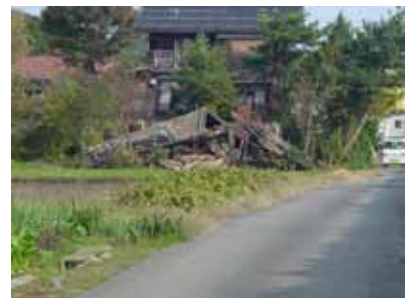
Collapsed old wooden houses in Ojiya and in the area of Ojiya IC

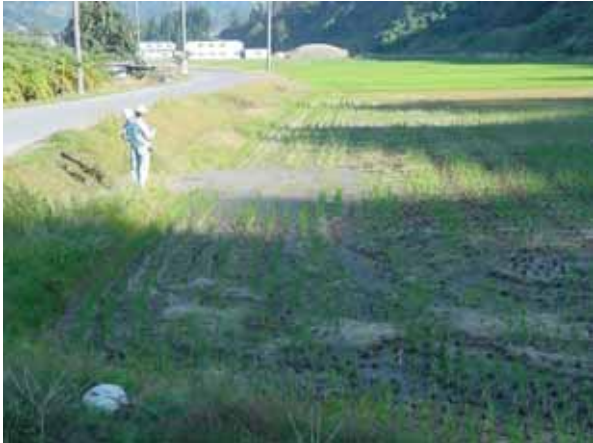
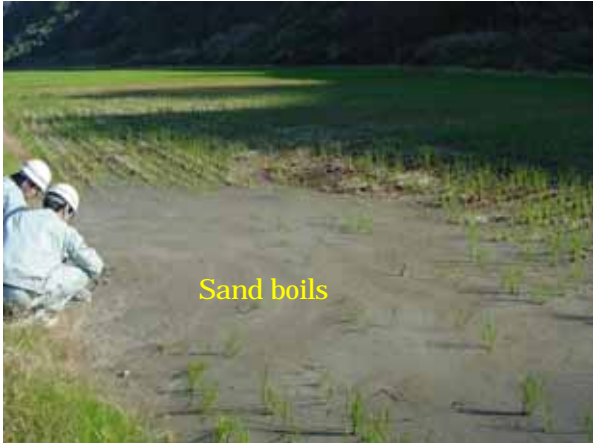
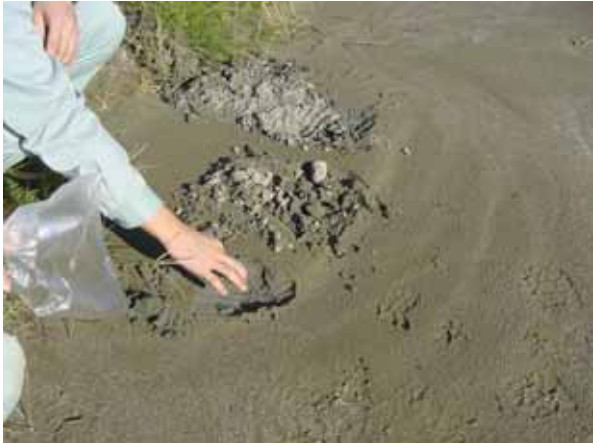
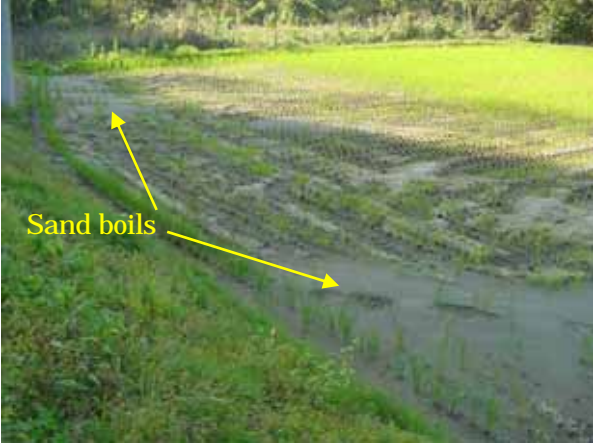
Scattered sand boils were seen in farm lands at several locations of the investigated area.
