2010年Chile, Maule地震

2010年
2月27日
Mw=8.8

現地調査を行った
のは2010年3月28
日~4月4日

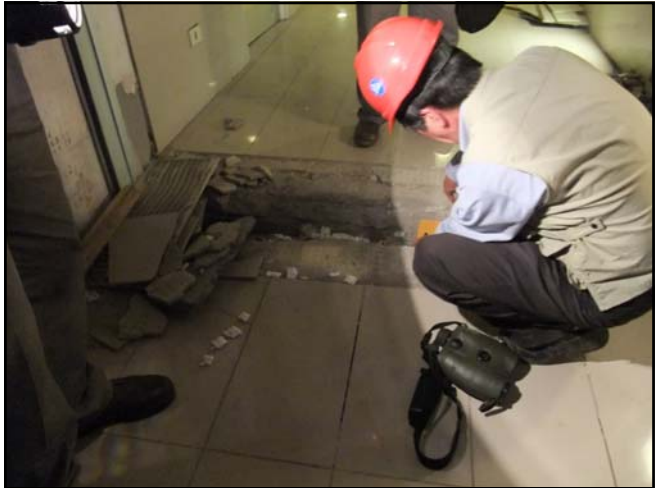
Settlement of the buildings of the Hospital Principal in Curanilahue due to liquefaction of backfilled sand?

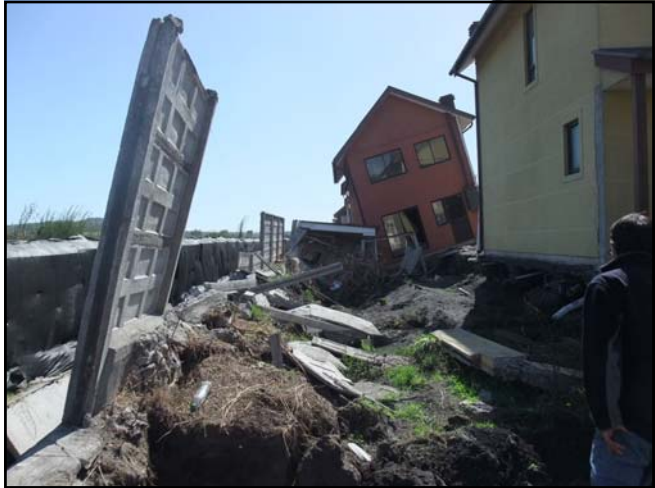
Pushed about

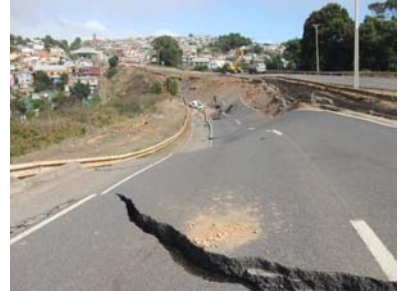
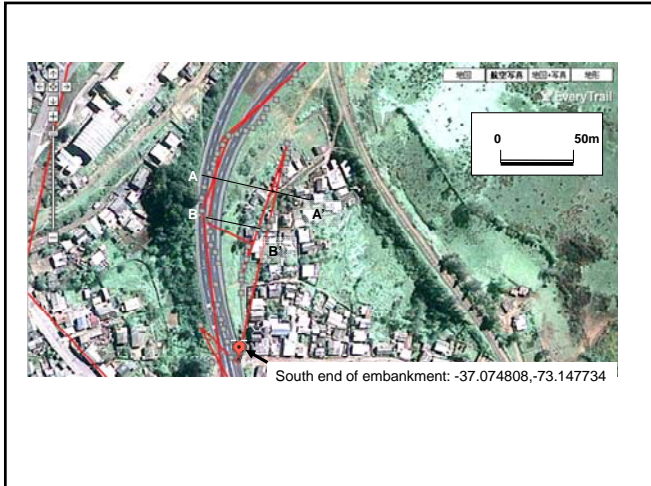
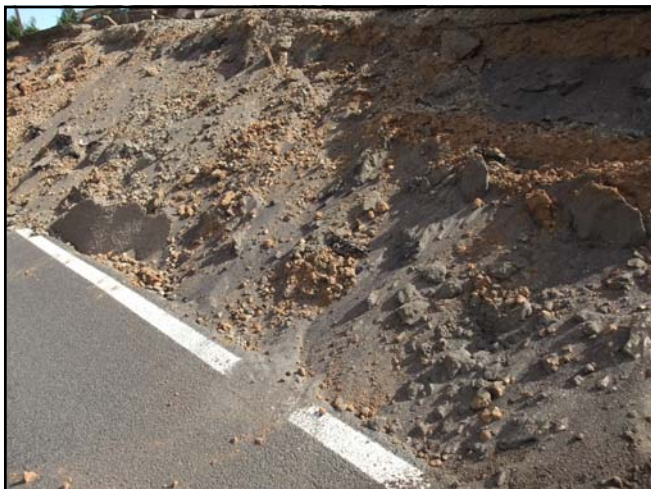
Damage to road embankments and bridges on soft clayey grounds

Measured cross section

Summary of soil condition of failed road embankments

- (1) Filled on swampy ground
- (2) Surface soil is soft and clayey
- (3) Water table is shallow
- (4) Embankment material is clean sand in Lota Norte

RECOMMENDATION
 In design of road embankments

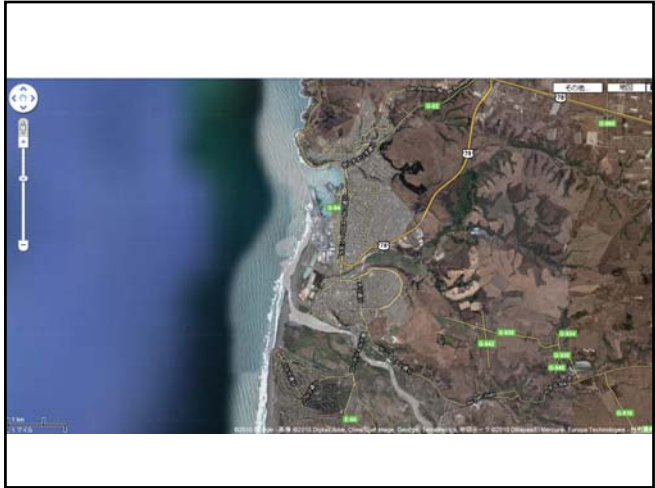
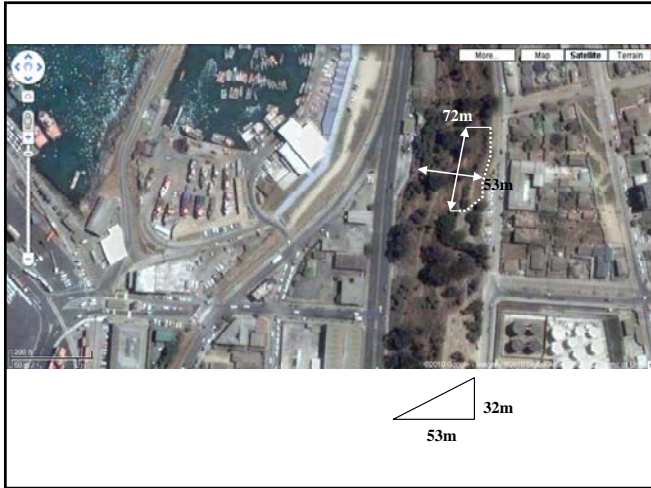
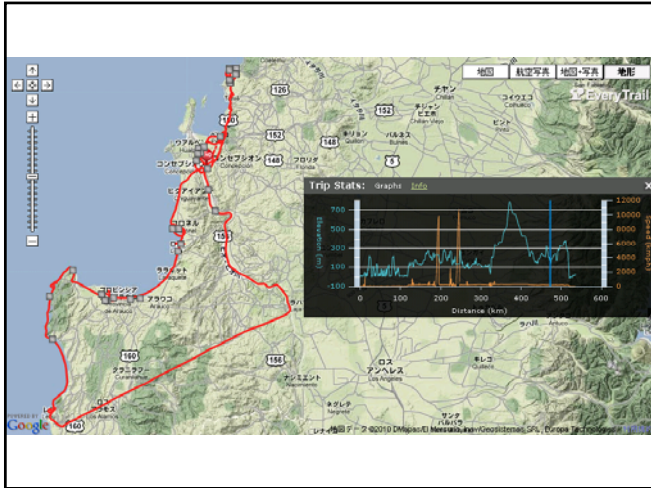
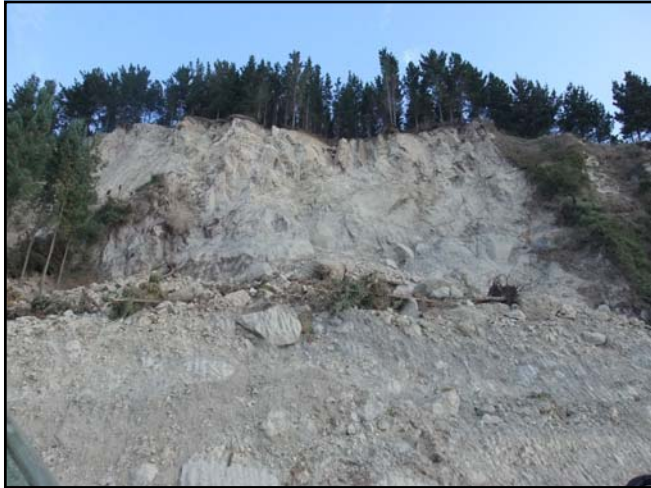
海岸部の斜面崩壊・隆起

San Antonio
海岸段丘斜面の崩壊

Arauco
海岸の斜面の崩壊

隆起

Surveyed from helicopter
